ORNL-5039  
UC-41-Health and Safety

EXPEDIENT SHELTER CONSTRUCTION AND  
OCCUPANCY EXPERIMENTS

Cresson H. Kearny

MARCH 1976

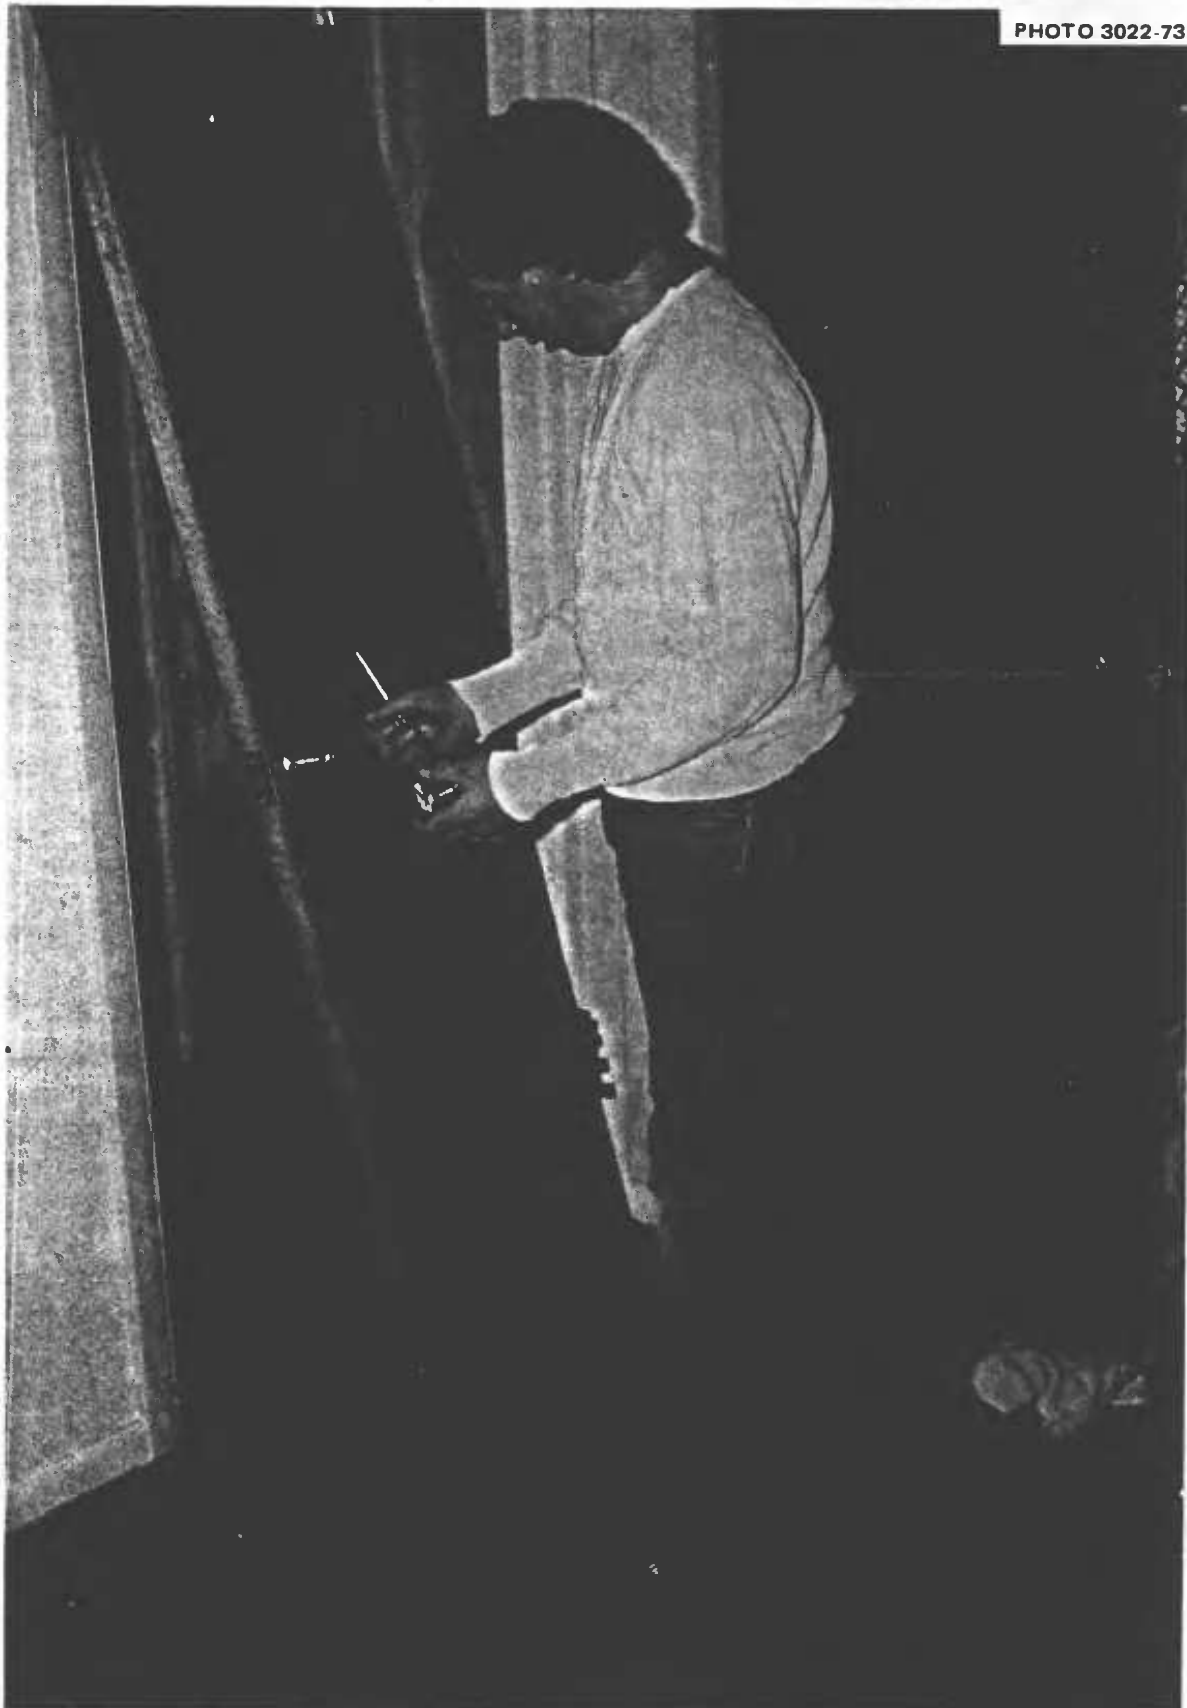
**Fig. 2.1. Start by an untrained, unskilled family of the second proof-testing of the written instructions for building a Door-Covered Trench Shelter. Starting at 6 AM on November 24, 1973, son Tad, age 14, and other children removed the doorknobs from one of the six interior doors that this fatherless family of six readied for use.**

The six doors actually used were all new, inexpensive, hollow-core interior doors, 32 in X 6 ft 8 in. X 1 $\frac{3}{8}$  in., with  $\frac{1}{8}$  in. mahogany veneer, and weighing 20 $\frac{1}{2}$  lb each.

The latter were purchased by the author, and of course lacked hinges or doorknobs.

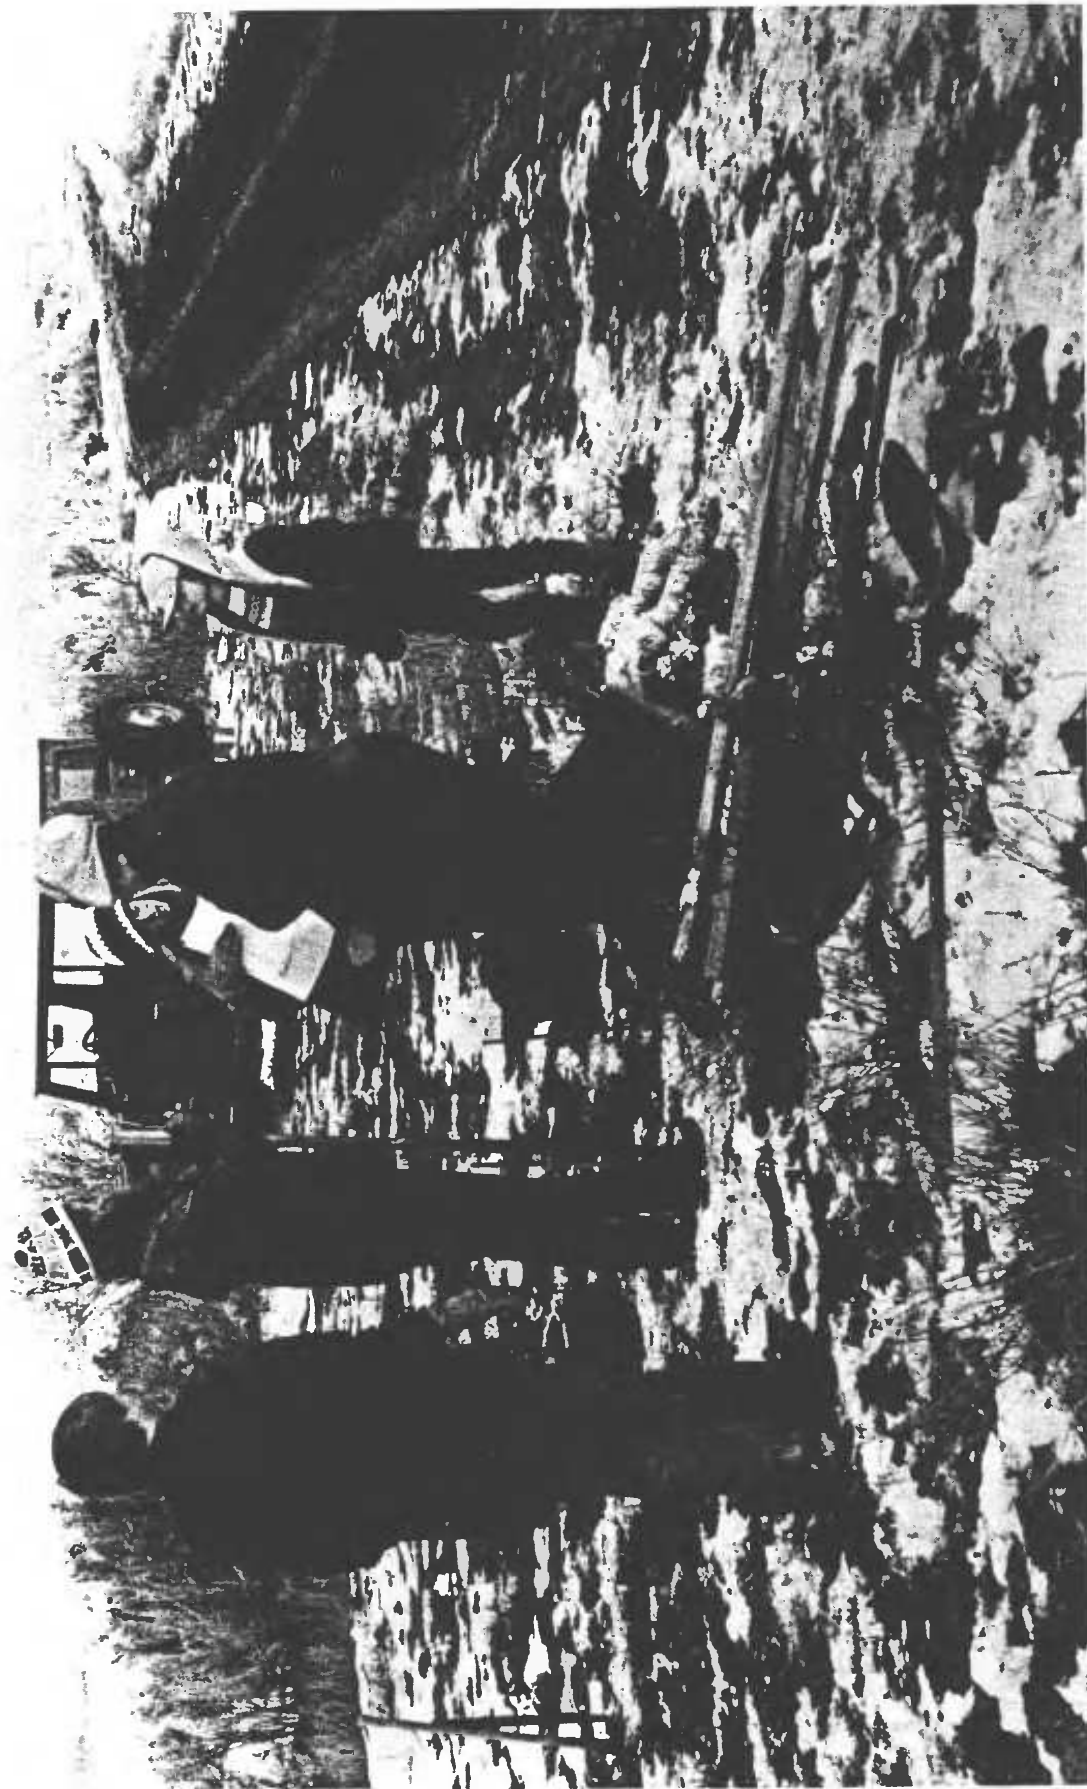
PHOTO 3080-73

Fig. 2.2. Starting to stake out the shelter trench near Montrose, Colorado, at 7:17 AM. The six doors, some tools, water, etc., were carried in a station wagon. The ground was frozen only about an inch deep. Pictured are the mother, a registered nurse and head of this family, Mary (14), Tad (14), Elizabeth (11), and David (8). Julie (18), a student nurse, had to work at the hospital and was unable to join in the work until 3:45 PM. No man worked building this shelter.

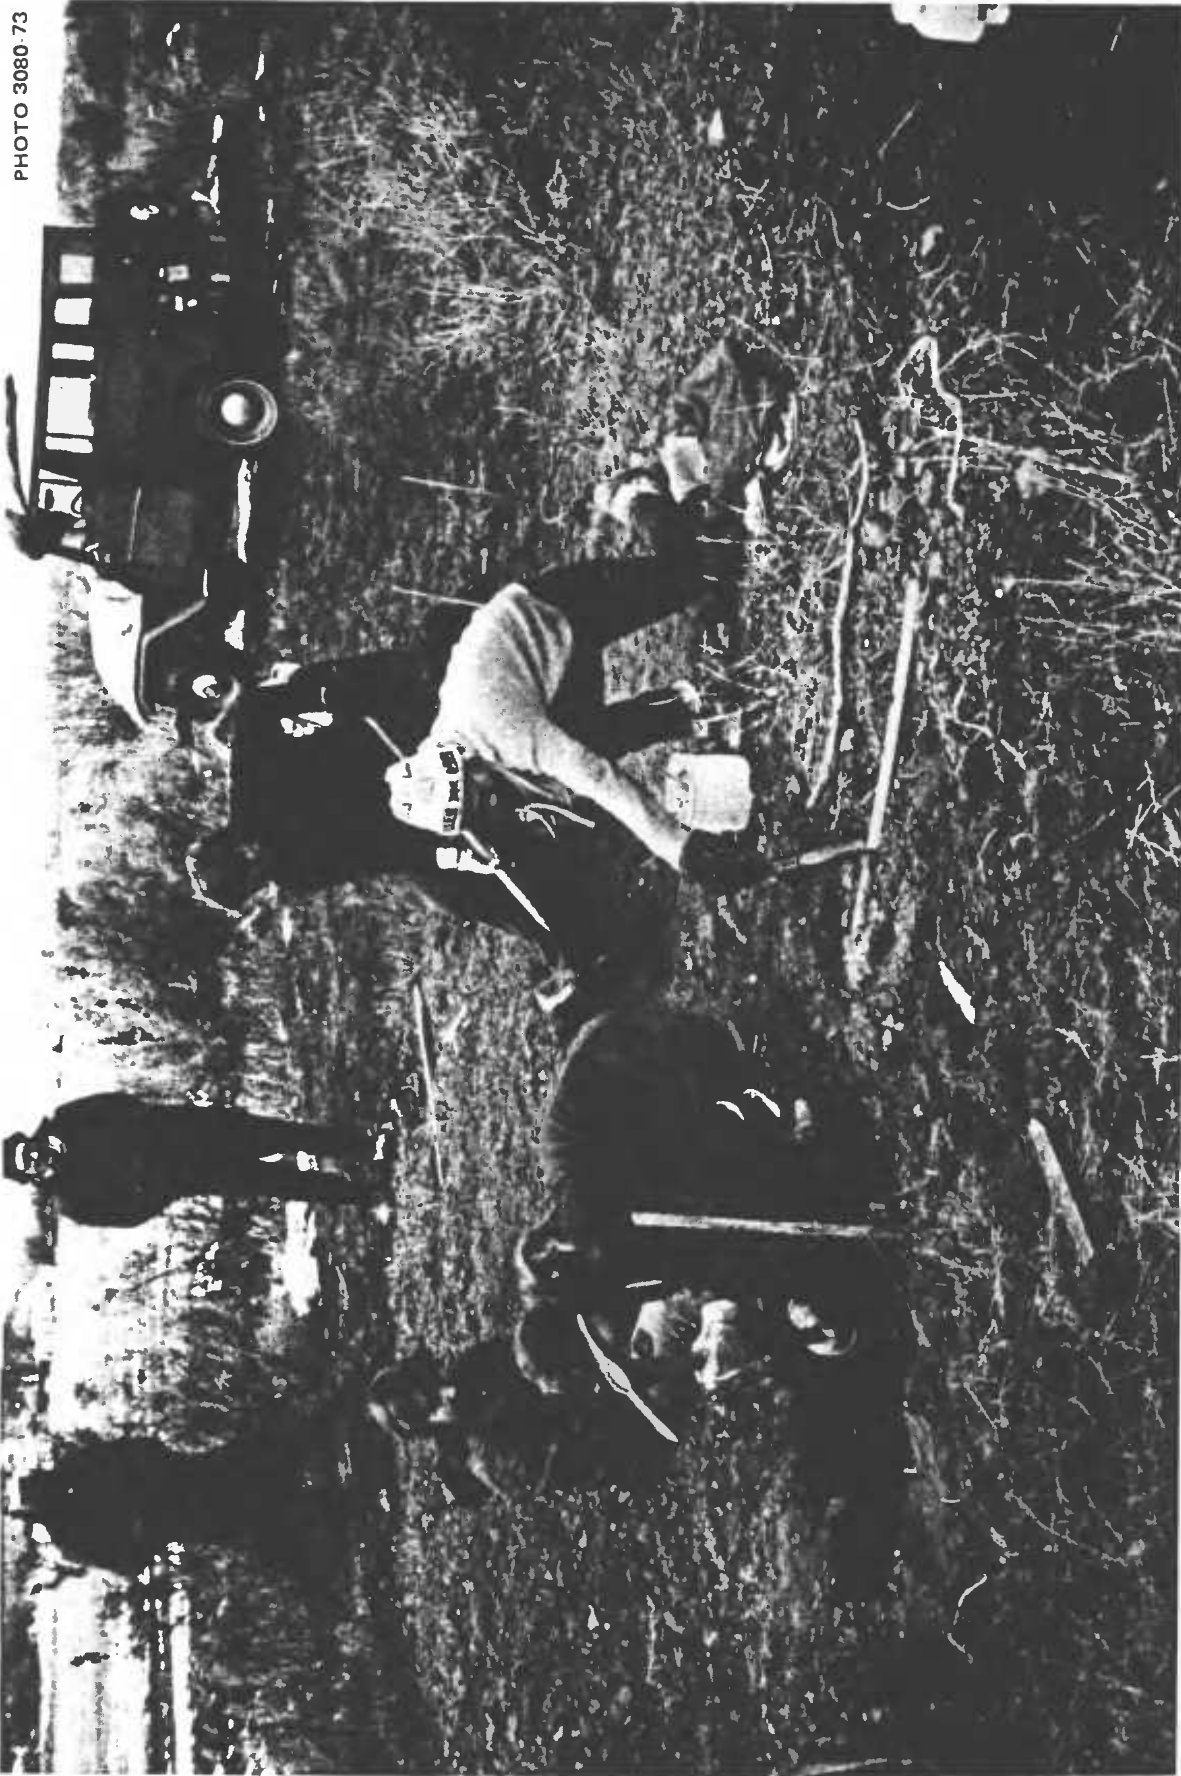
Fig. 2.3. The mother dug inefficiently with her dull shovel by pushing it with her foot. She dug the trench too narrow until it was almost completed – in spite of having read the instructions to the contrary. Until the second day, no member of this family learned to swing their dull old pick properly, by letting one hand slip toward the other as the pick descended. Nor did they know how to use their other tools properly.

Nevertheless, they won their bonus for completing their six-door shelter in less than 36 hours and received a total of \$400.

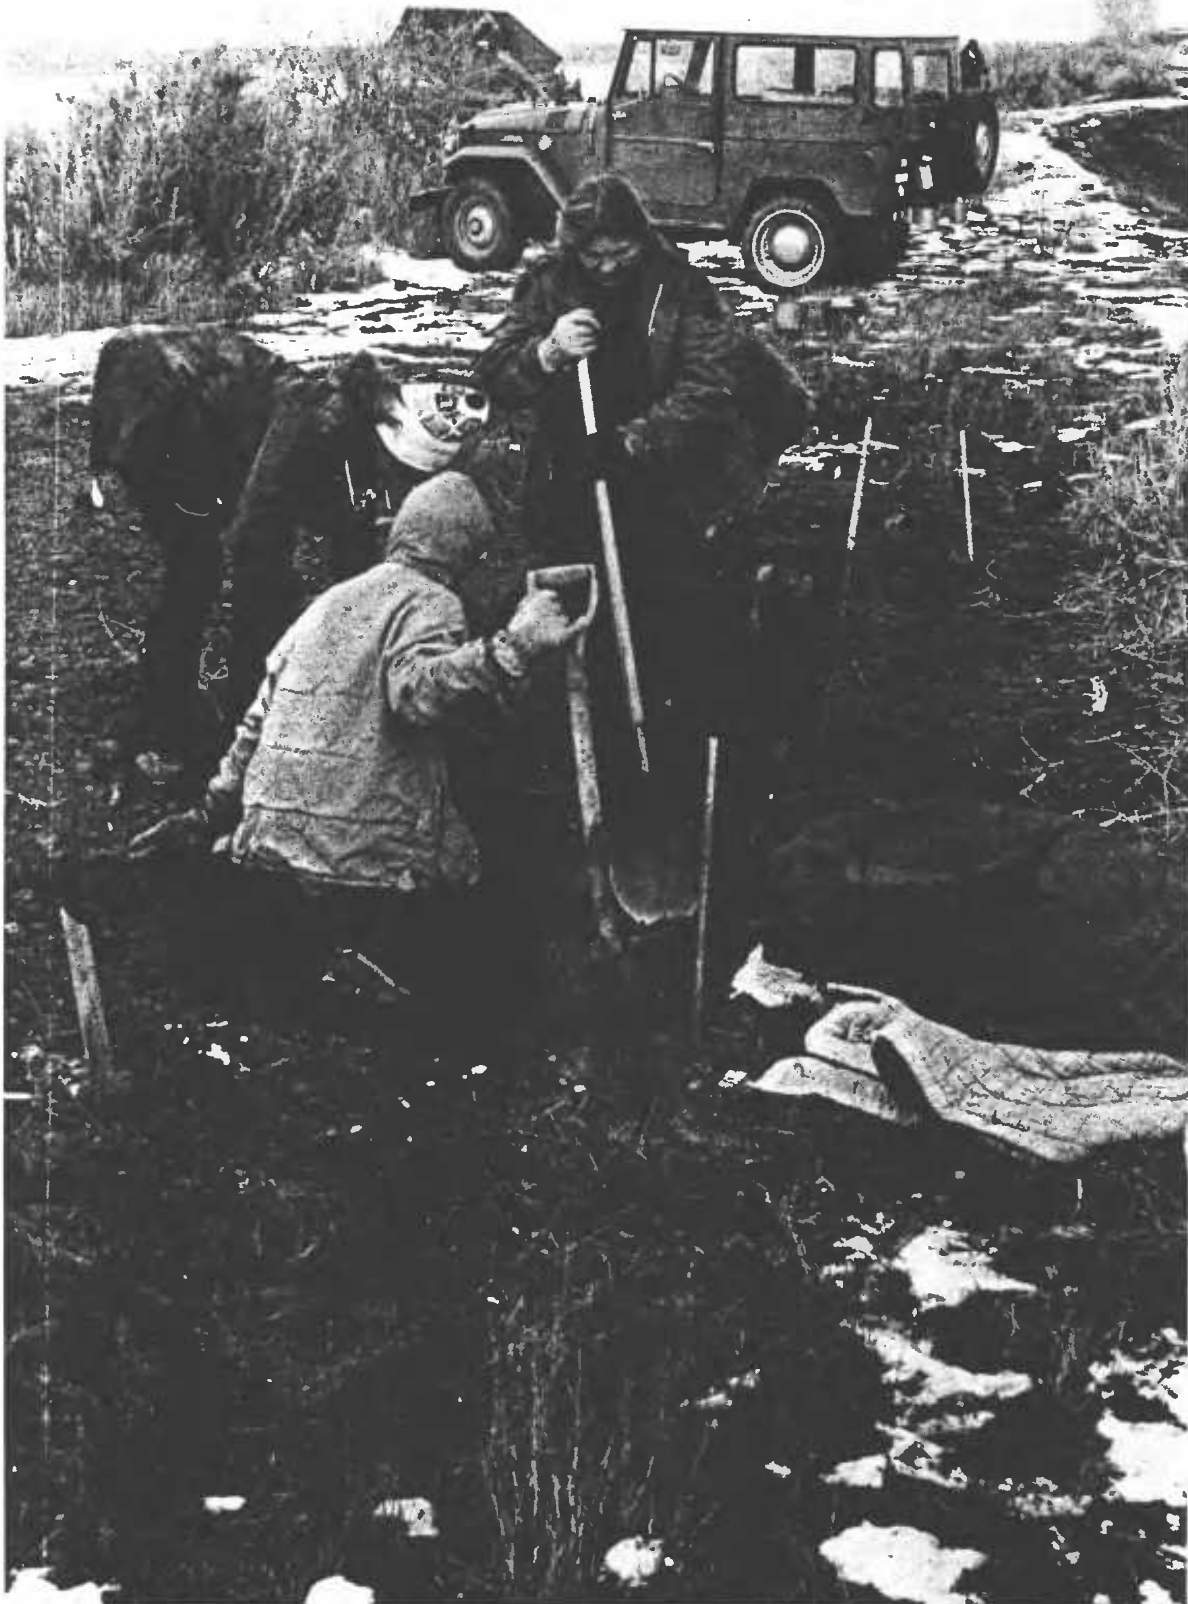
PHOTO 3073-73

Fig. 2.5. Instead of sharpening their pick and using it, this family mostly pried and scraped away the dry, hard clay-loam with shovels, inch by inch.

Note how the trench narrowed downward, an error that later required several person-hours of work to correct. All six workers quit for the day at 5:20 PM, tired.

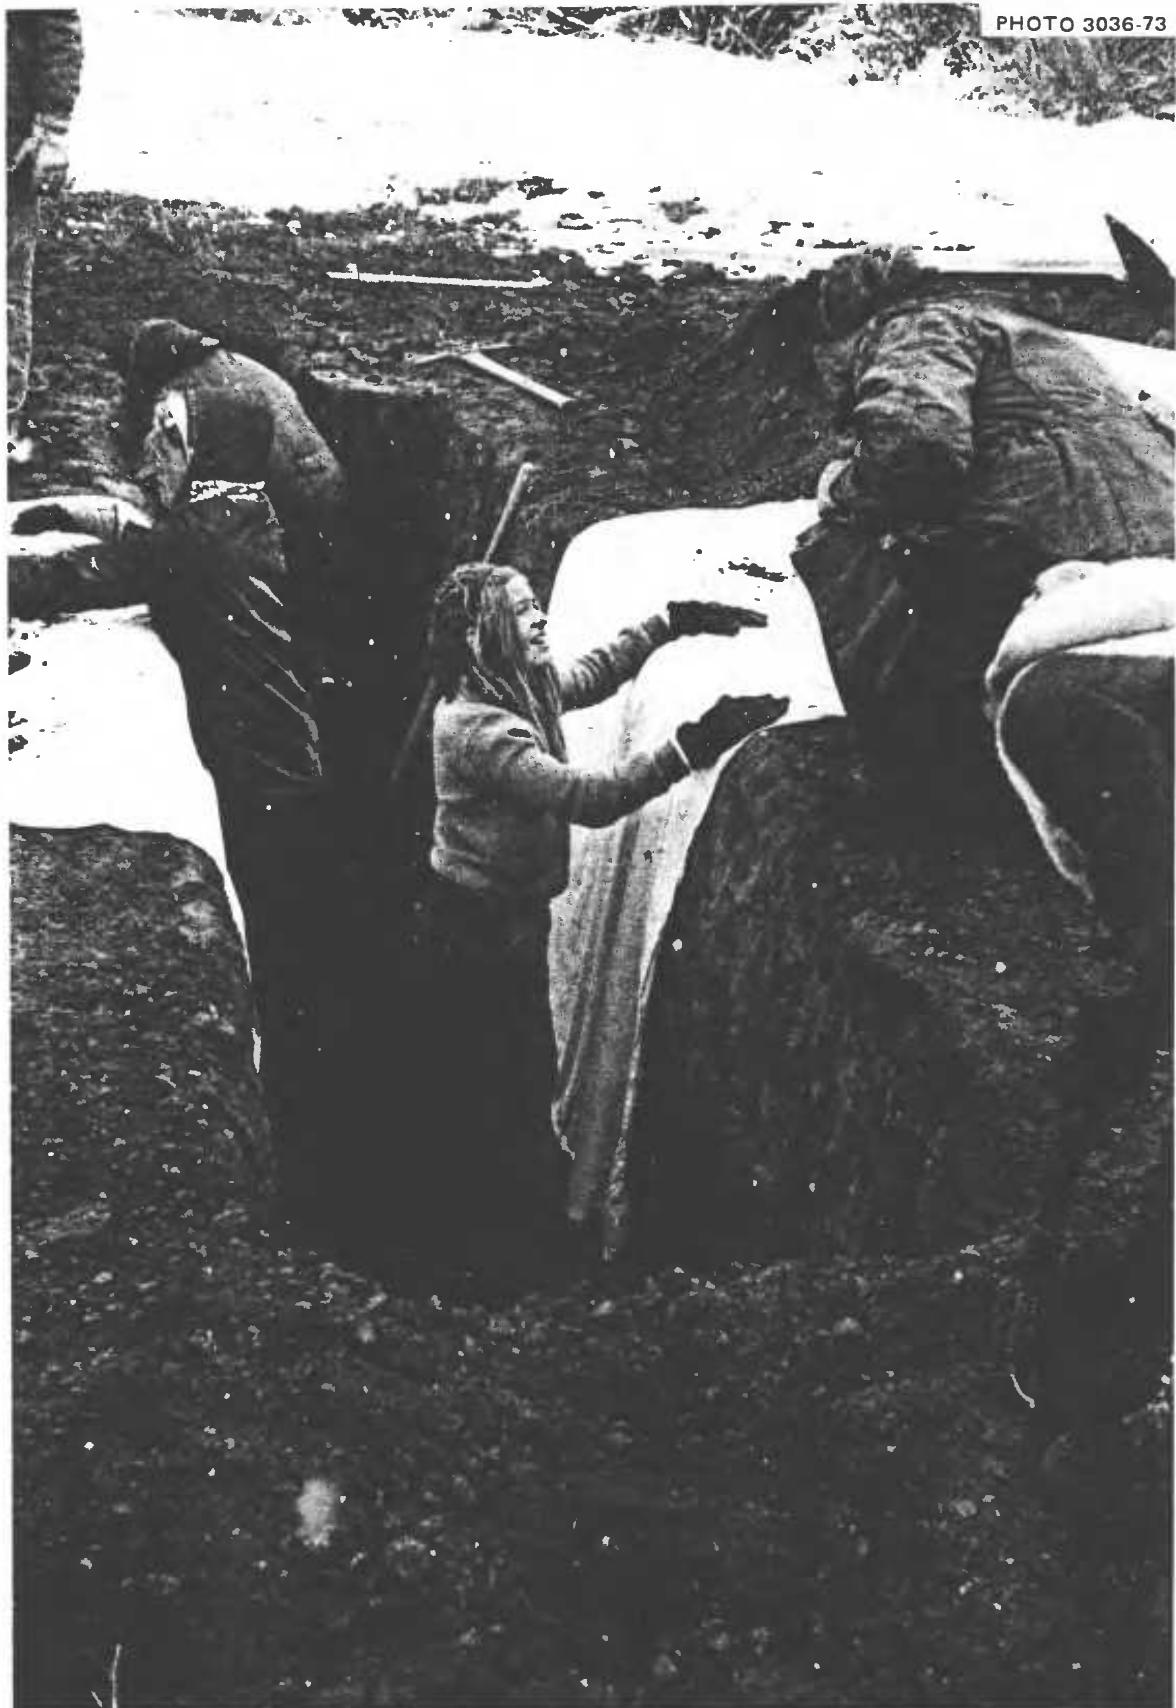
PHOTO 3037-73

**Fig. 2.8. Placing bedsheet coverings on the  $4\frac{1}{2}$ -ft-high trench walls. Such coverings make the trench cleaner, warmer, and easier to illuminate.**

At the far end of this 15-ft-long, 3-ft-wide, and  $4\frac{1}{2}$ -ft-deep main trench, Tad is digging the steps in the 18-in.-wide, 24-in.-long entryway trench.

The trench was completed at 11:55 AM on the second day, 30 hours after Kearny handed this family the building instructions.

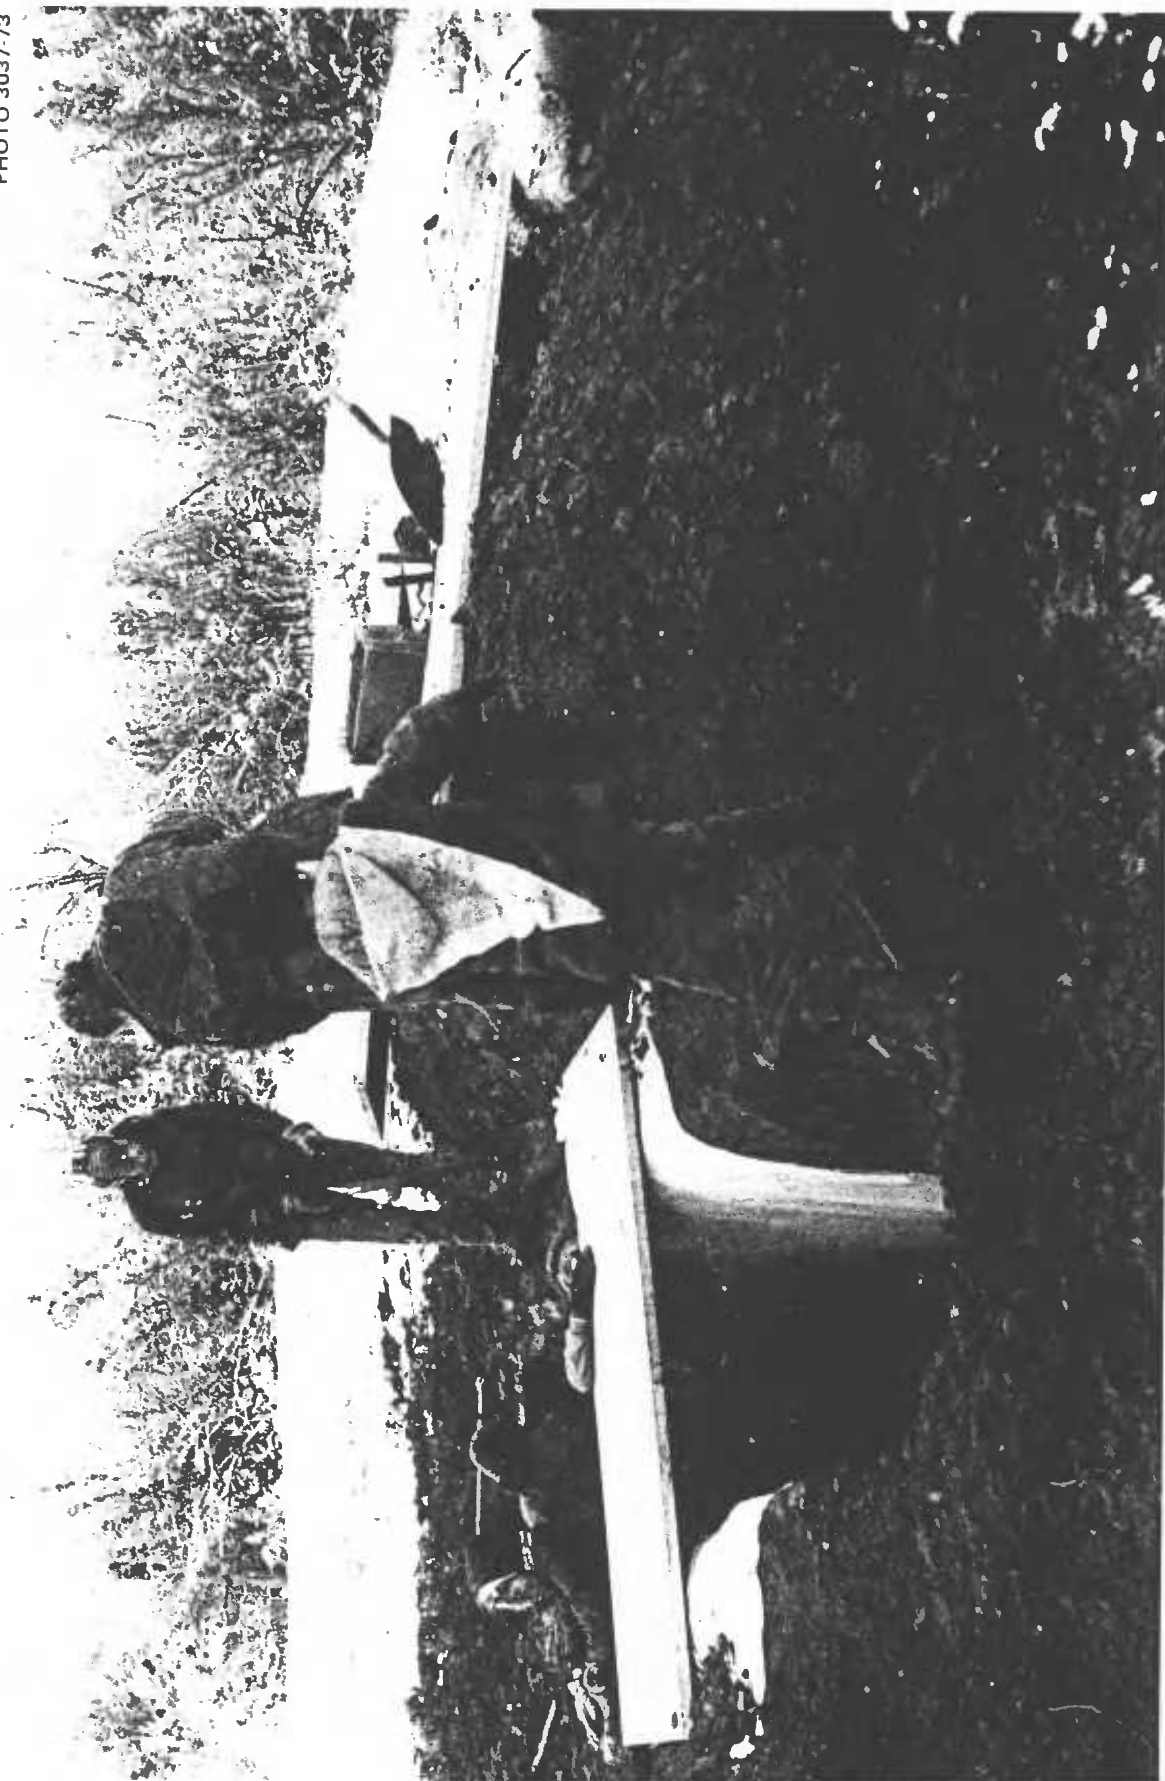
PHOTO 3079-73

Fig. 2.9. Placing the first of six interior, hollow-core doors over the completed trench. The earth on the wall-lining sheet was removed before the second door was positioned.

Although the trench was dug to be only 36 inches wide, in places some of the doors had to span more than a 48-in. width before they were covered with earth. The weight of the covering earth bowed some doors down almost an inch, until a part rested on the edge of the trench — thus reducing the effective span to about 40 to 42 inches.

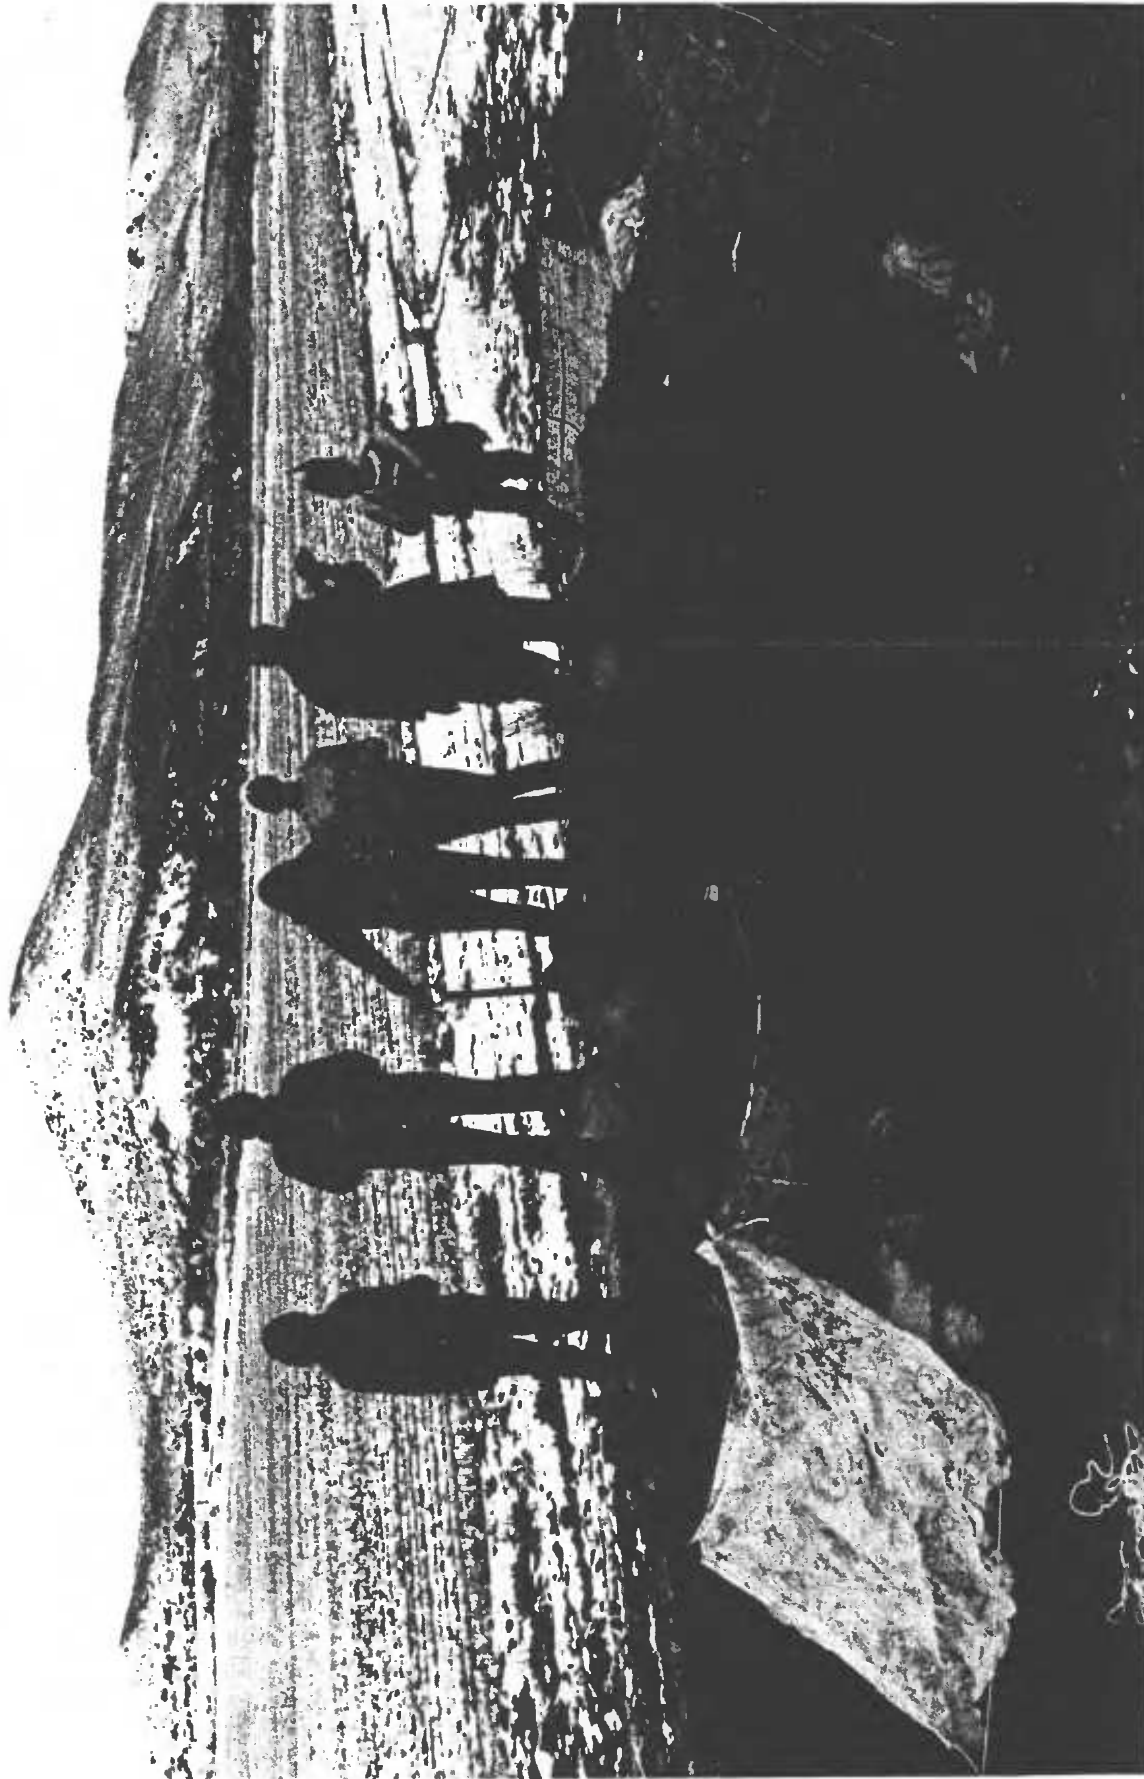
PHOTO 3042-73

**Fig. 2.11. Completed Door-Covered Trench Shelter, with canopies made of plastic tablecloths inexpertly rigged over the two openings.**

Because at this date Kearny did not realize what great depths of earth covering such hollow-core doors bridging a narrow trench would hold, the instructions given to this family specified only an 18-in. covering. This family, so tired by this time that they were shouting at each other, shoveled only about 15 in. of earth over the doors.

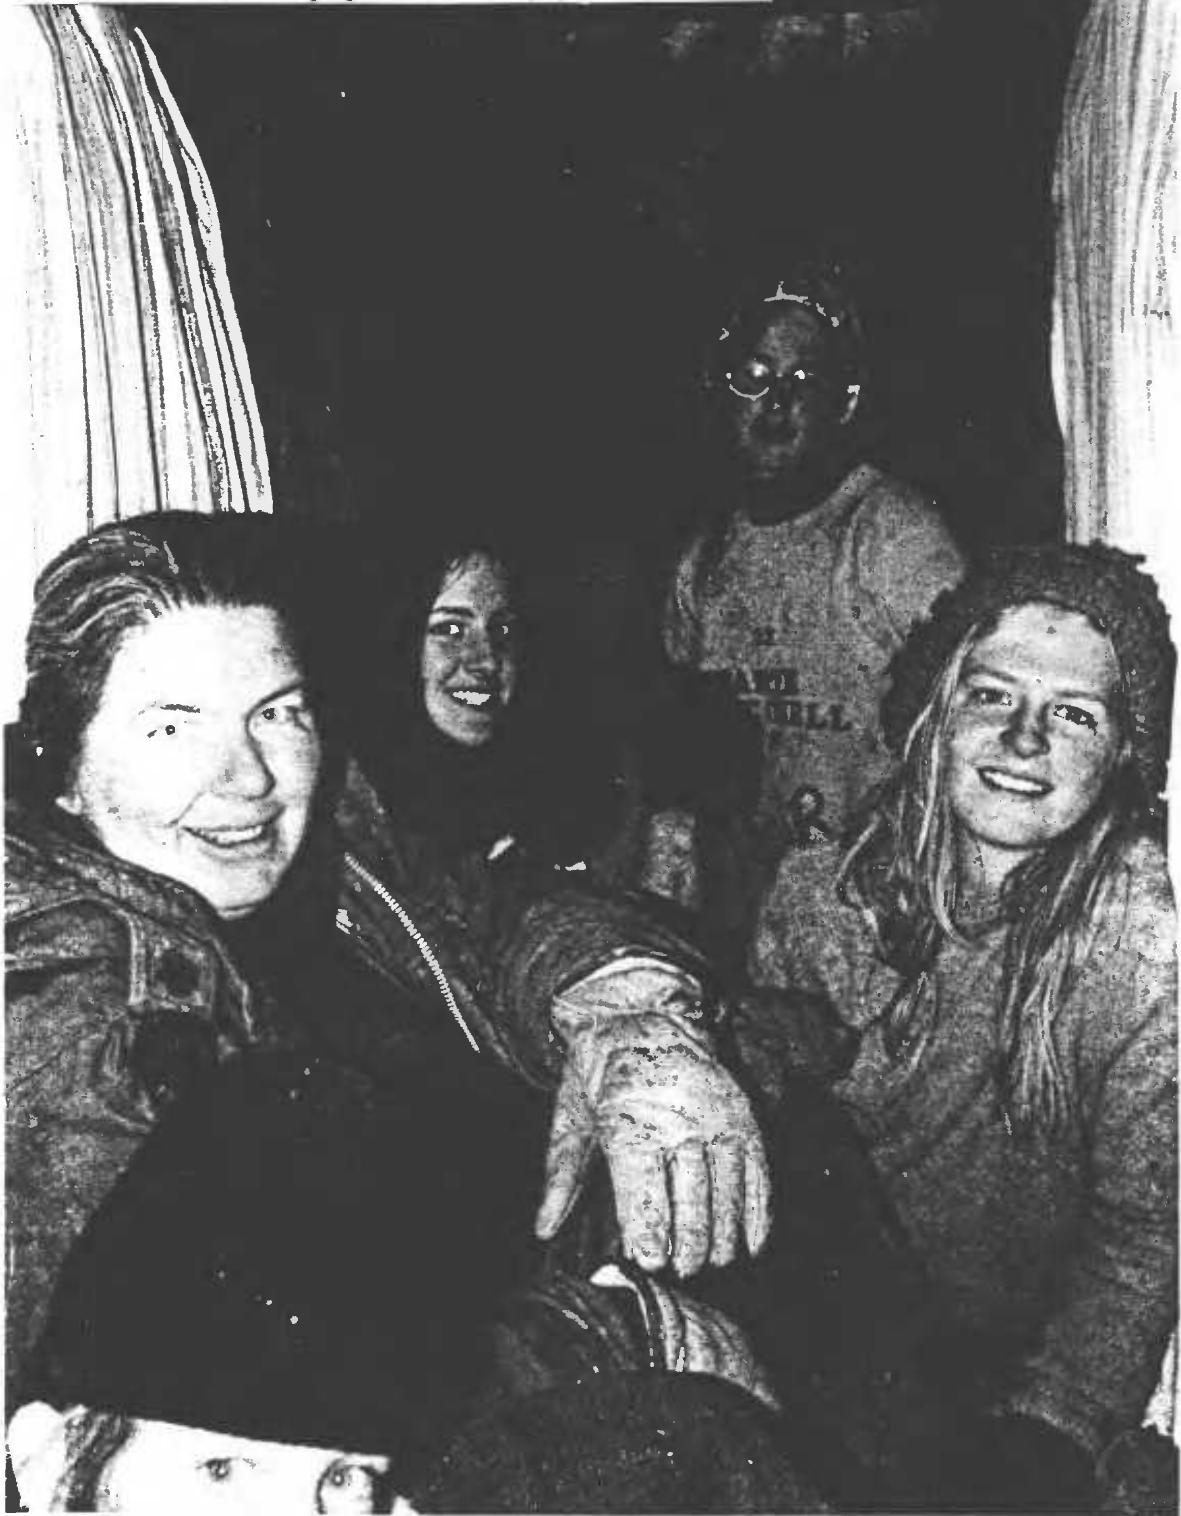
Fig. 2.12. Inside their completed Door-Covered Trench Shelter, and all pepped up by their success in finishing an unexpectedly hard job. They completed their shelter at 3:50 PM on November 25, about 34 hours after first receiving the instructions on November 24.

**CONCLUSION:** Not only does this shelter afford fallout protection (about PF 250) in line with the current threats, but also it gives much better fire and blast protection than do most basements. In a Defense Nuclear Agency blast test, a Door-Covered Trench Shelter withstood 5 pounds per square inch blast overpressure. The shock and drag effects accompanying a 5 psi overpressure from a large nuclear weapon would topple a strongly built high-rise building.

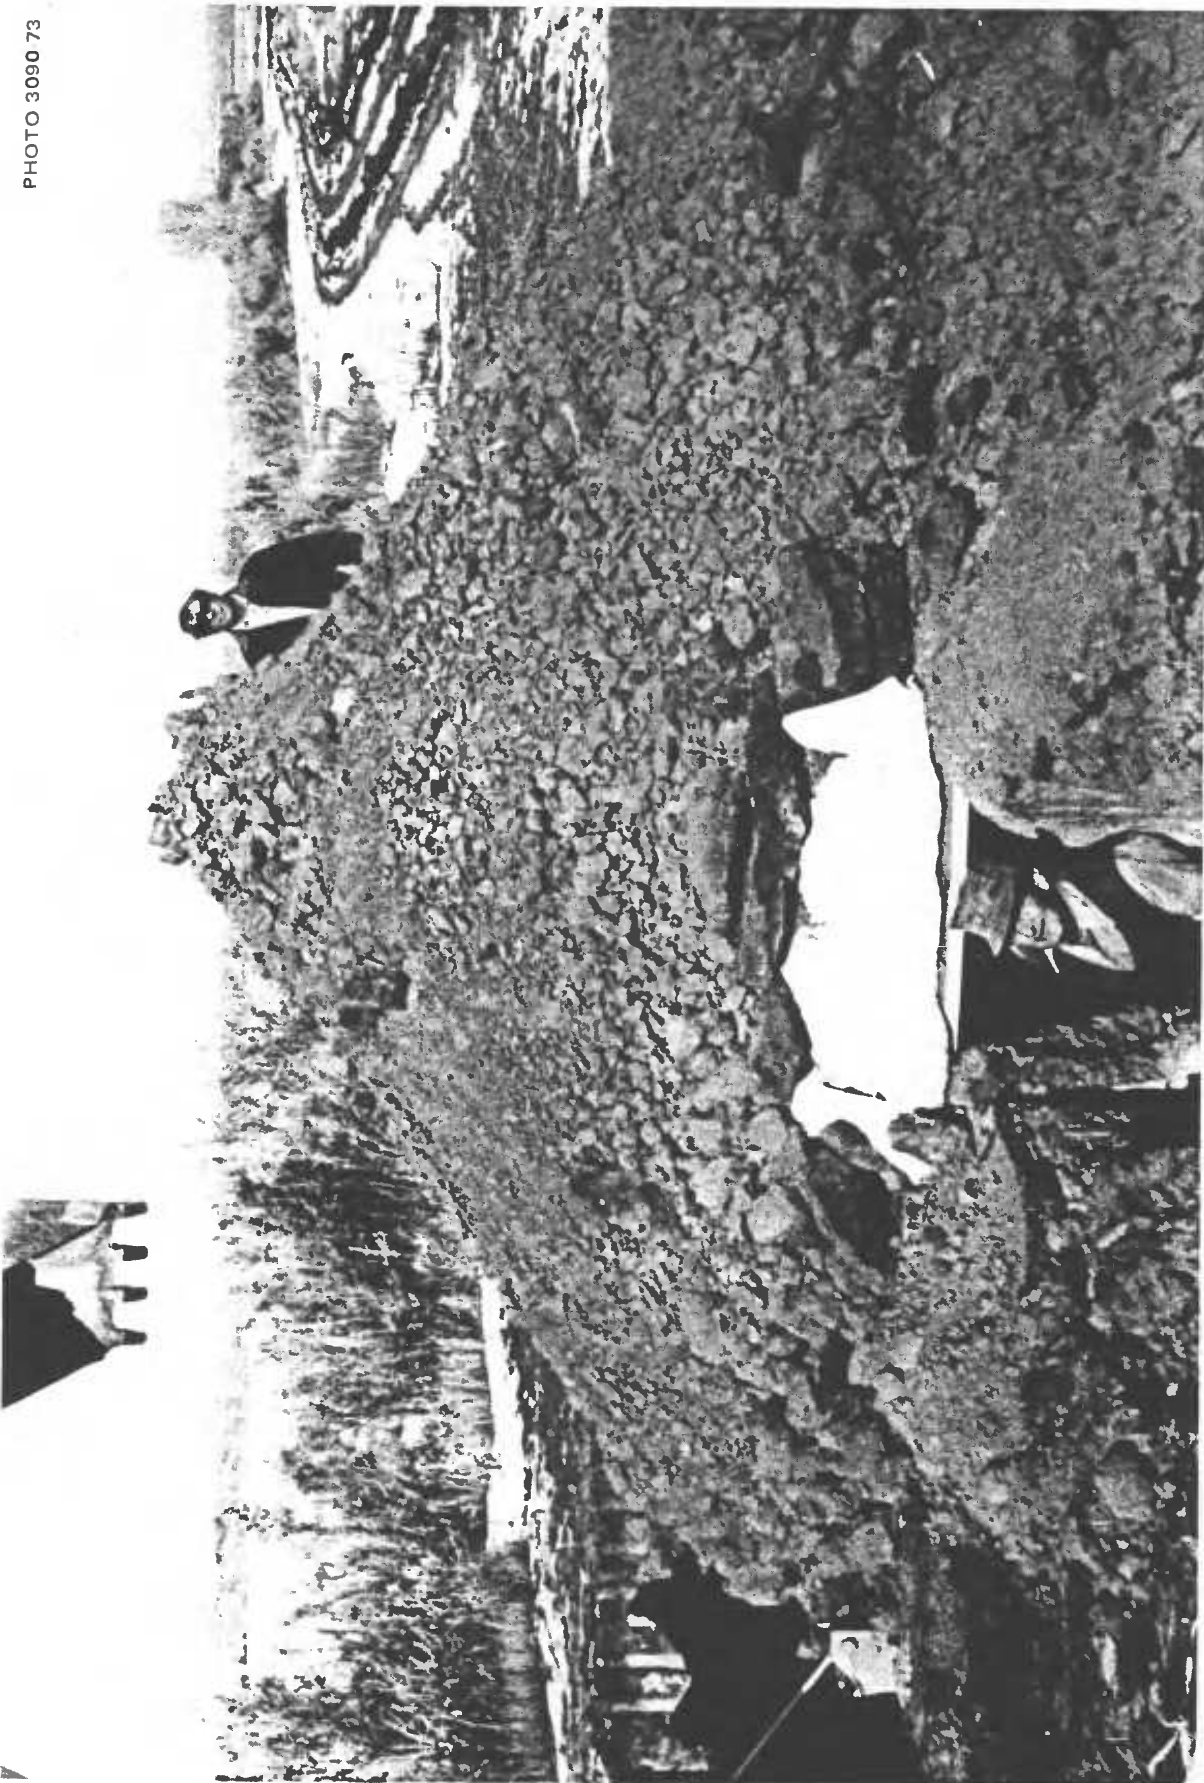
**Fig. 3.2. View of the same shelter from the entryway end. An observation trench had been dug out from the entryway, so that deflections of the roof doors could be observed safely.**

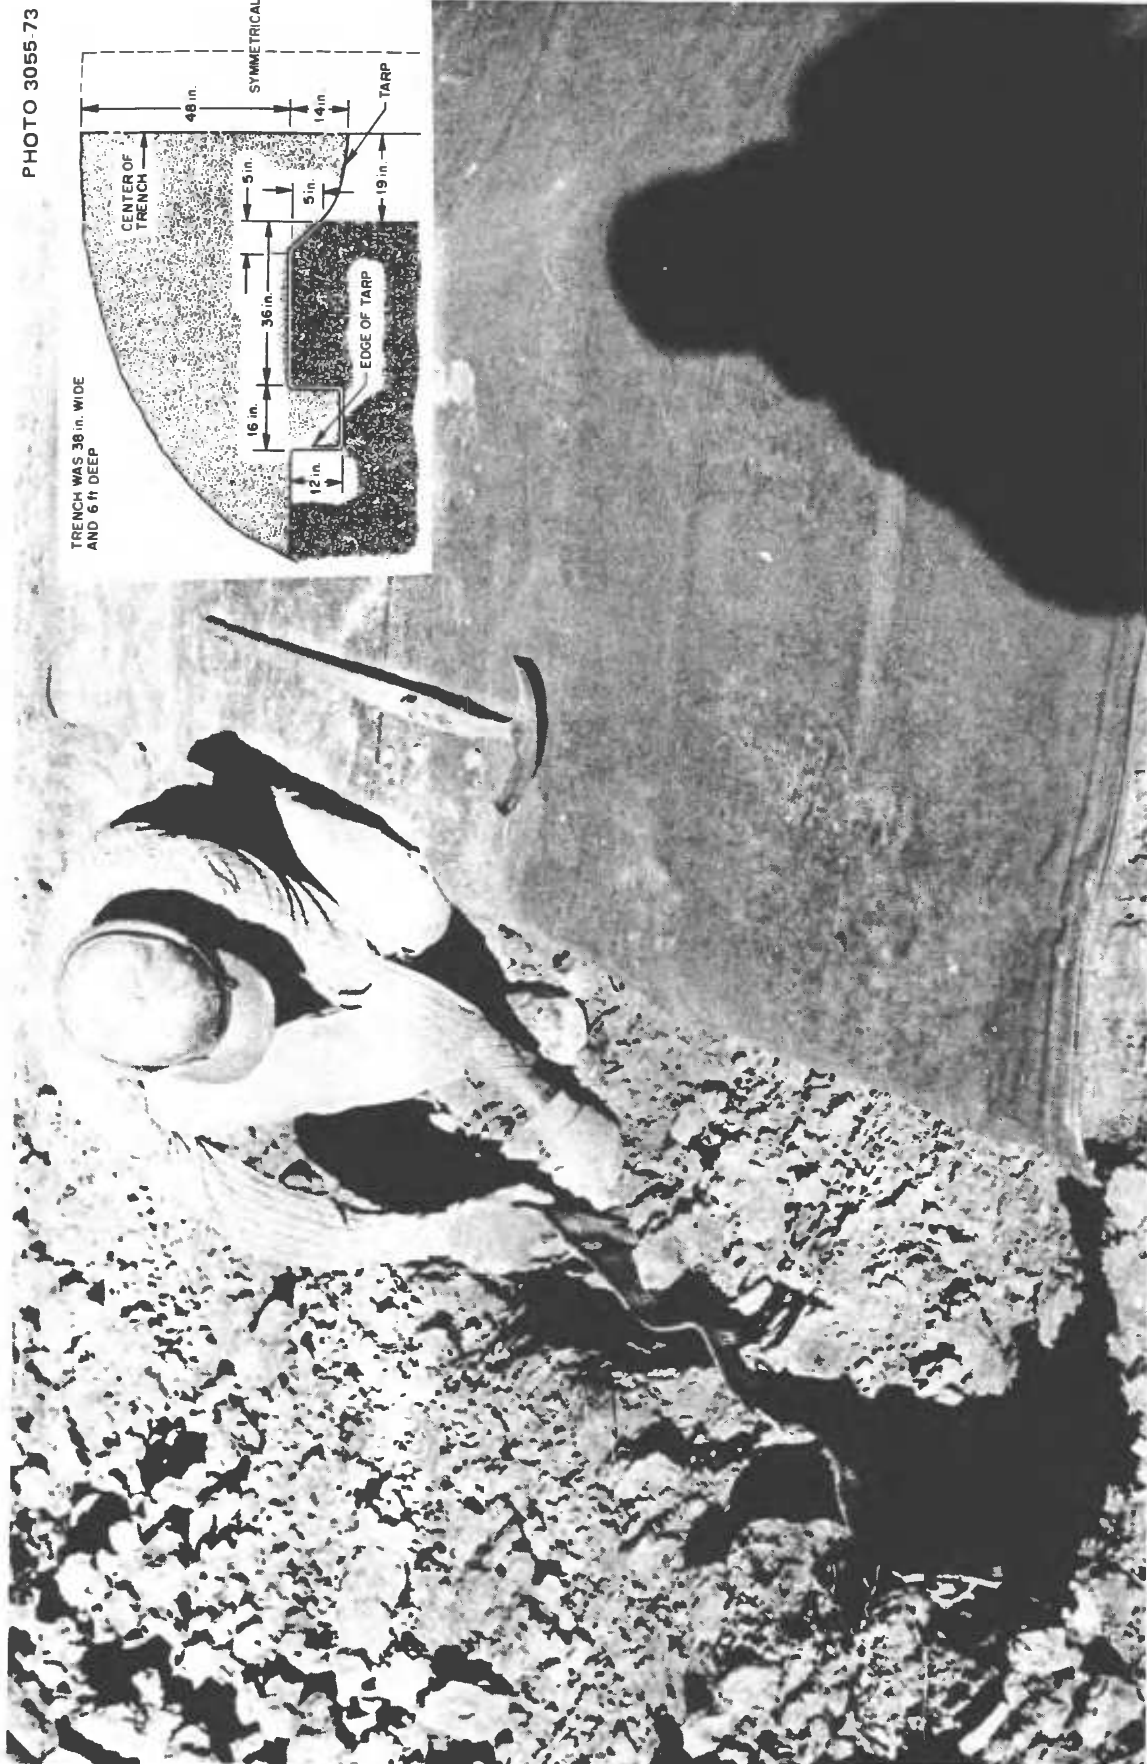
PHOTO 3055-73

TRENCH WAS 36 in. WIDE  
AND 6 ft DEEP

Fig. 3.11. Building the best of two successful Tarp-Roofed Trench Shelters constructed on Dec. 1, 1973, on the Kearny farm near Montrose, Colorado. C. H. Kearny designed this shelter after the November tests of the Door-Covered Trench Shelter had convinced him that, if the principles of earth arching and friction are used properly, then blast shelters can be built in many areas by roofing a trench with only a tarp or a strong rug, and then intelligently covering the tarp or rug with earth.

A workman is shown placing dry, crumbly clay-loam earth over one edge of the tarp. This edge had been placed in one of the two rectangular side trenches, as indicated by the sketch.
