ORNL-5039  
UC-41-Health and Safety

EXPEDIENT SHELTER CONSTRUCTION AND  
OCCUPANCY EXPERIMENTS

Cresson H. Kearny

MARCH 1976

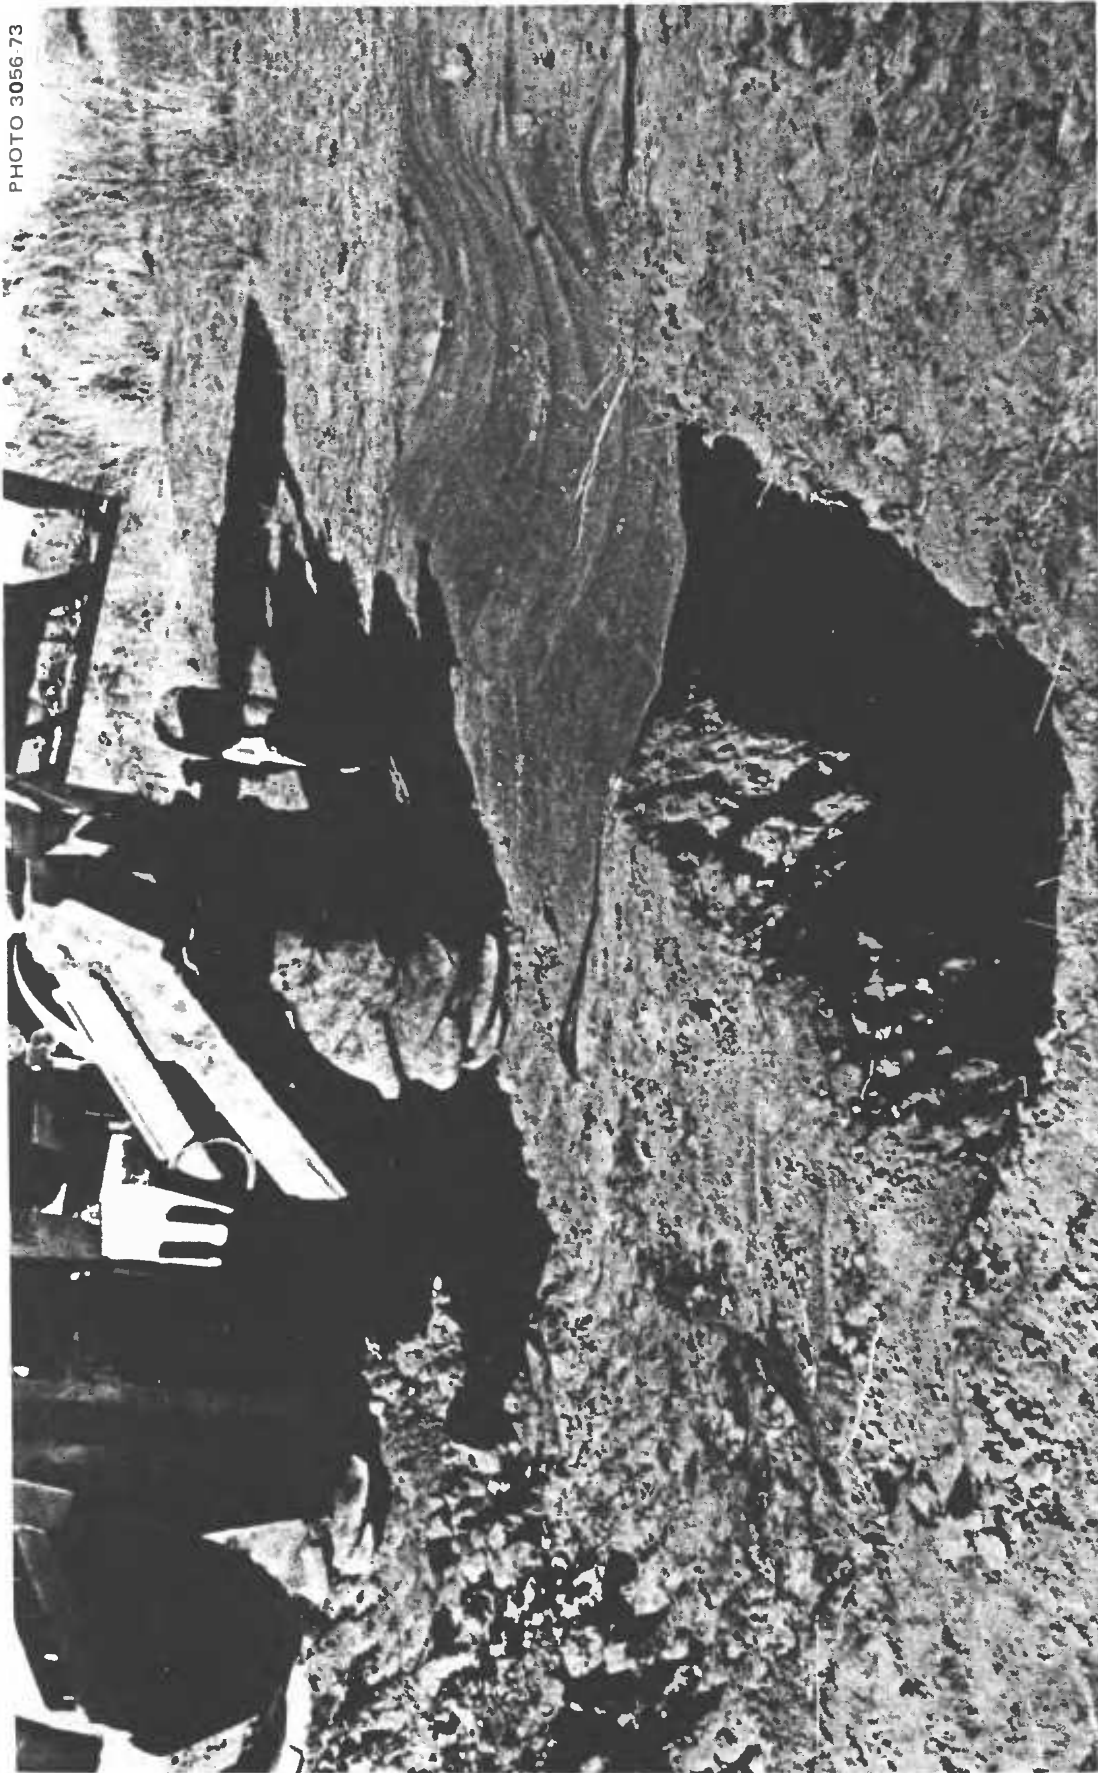
**Fig. 3.12.** Compacting the earth over one edge of the tarp. This edge has been placed in one of the two 16-in.-wide by 12-in.-deep rectangular trenches, each of which was dug parallel to and 3 ft from the vertical walls of the shelter trench. Packing with this wide-wheeled backhoe did not compact the earth as well as hand-tamping it with a pole.

The shelter trench was 3 ft wide. The tarp was of 12-ounce cotton duck and measured 11 ft 4 in. X 15 ft 4 in. This new, inexpensive tarp was laid with its length (which was the direction of its three-component stitched-together strips) across the trench. The downward bow, or sag, of the uncovered tarp, as pictured, was 6 to 8 in.

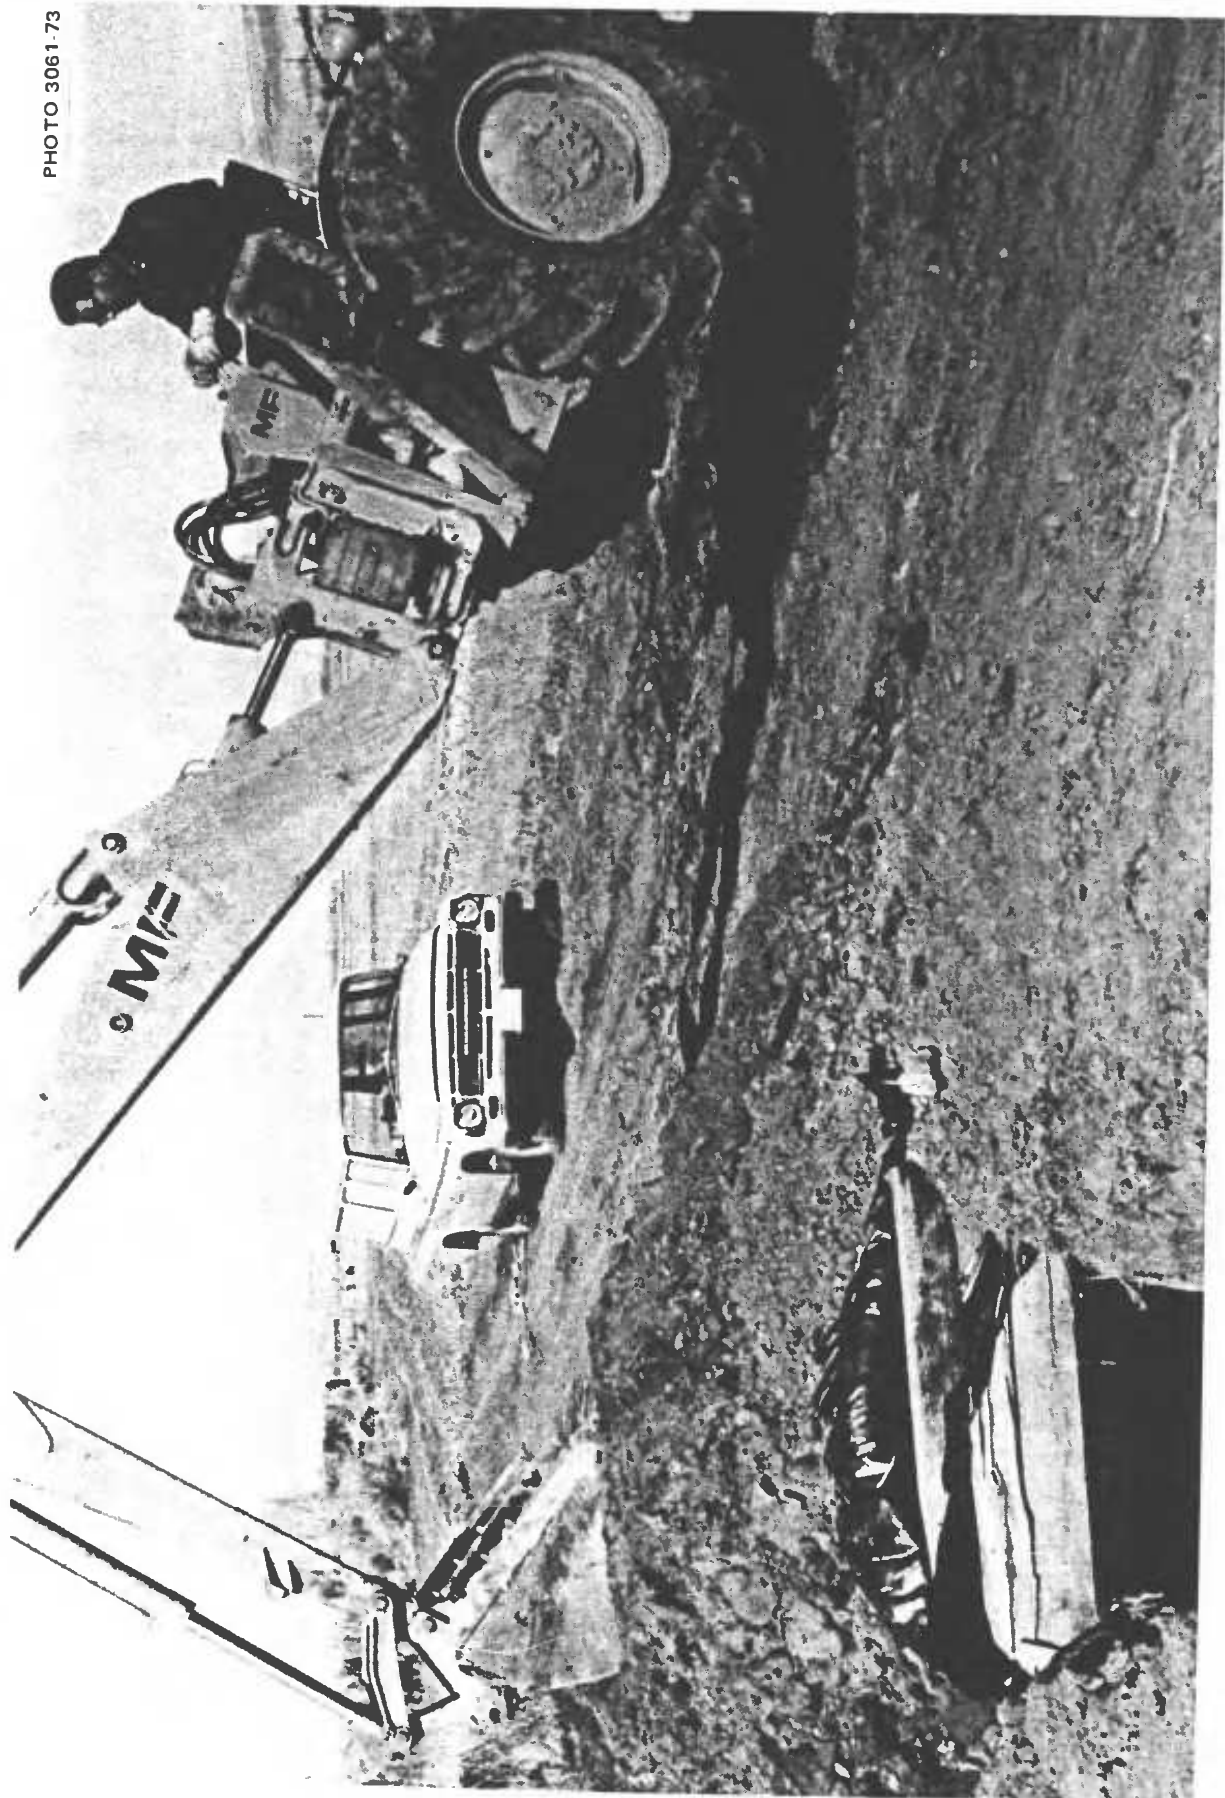
PHOTO 3061-73

**Fig. 3.13.** Stressing the Tarp-Roofed Trench Shelter, a 6-ton backhoe, supported only by its buckets, pressed down repeatedly with its front bucket on a 62-in.-deep mound of loose earth. The mounding of loose earth caused the tarp to bow downward (sag) into a catenary curve. The compaction caused the tarp to stretch, resulting in an increase of the maximum sag from 8 to 14 in.

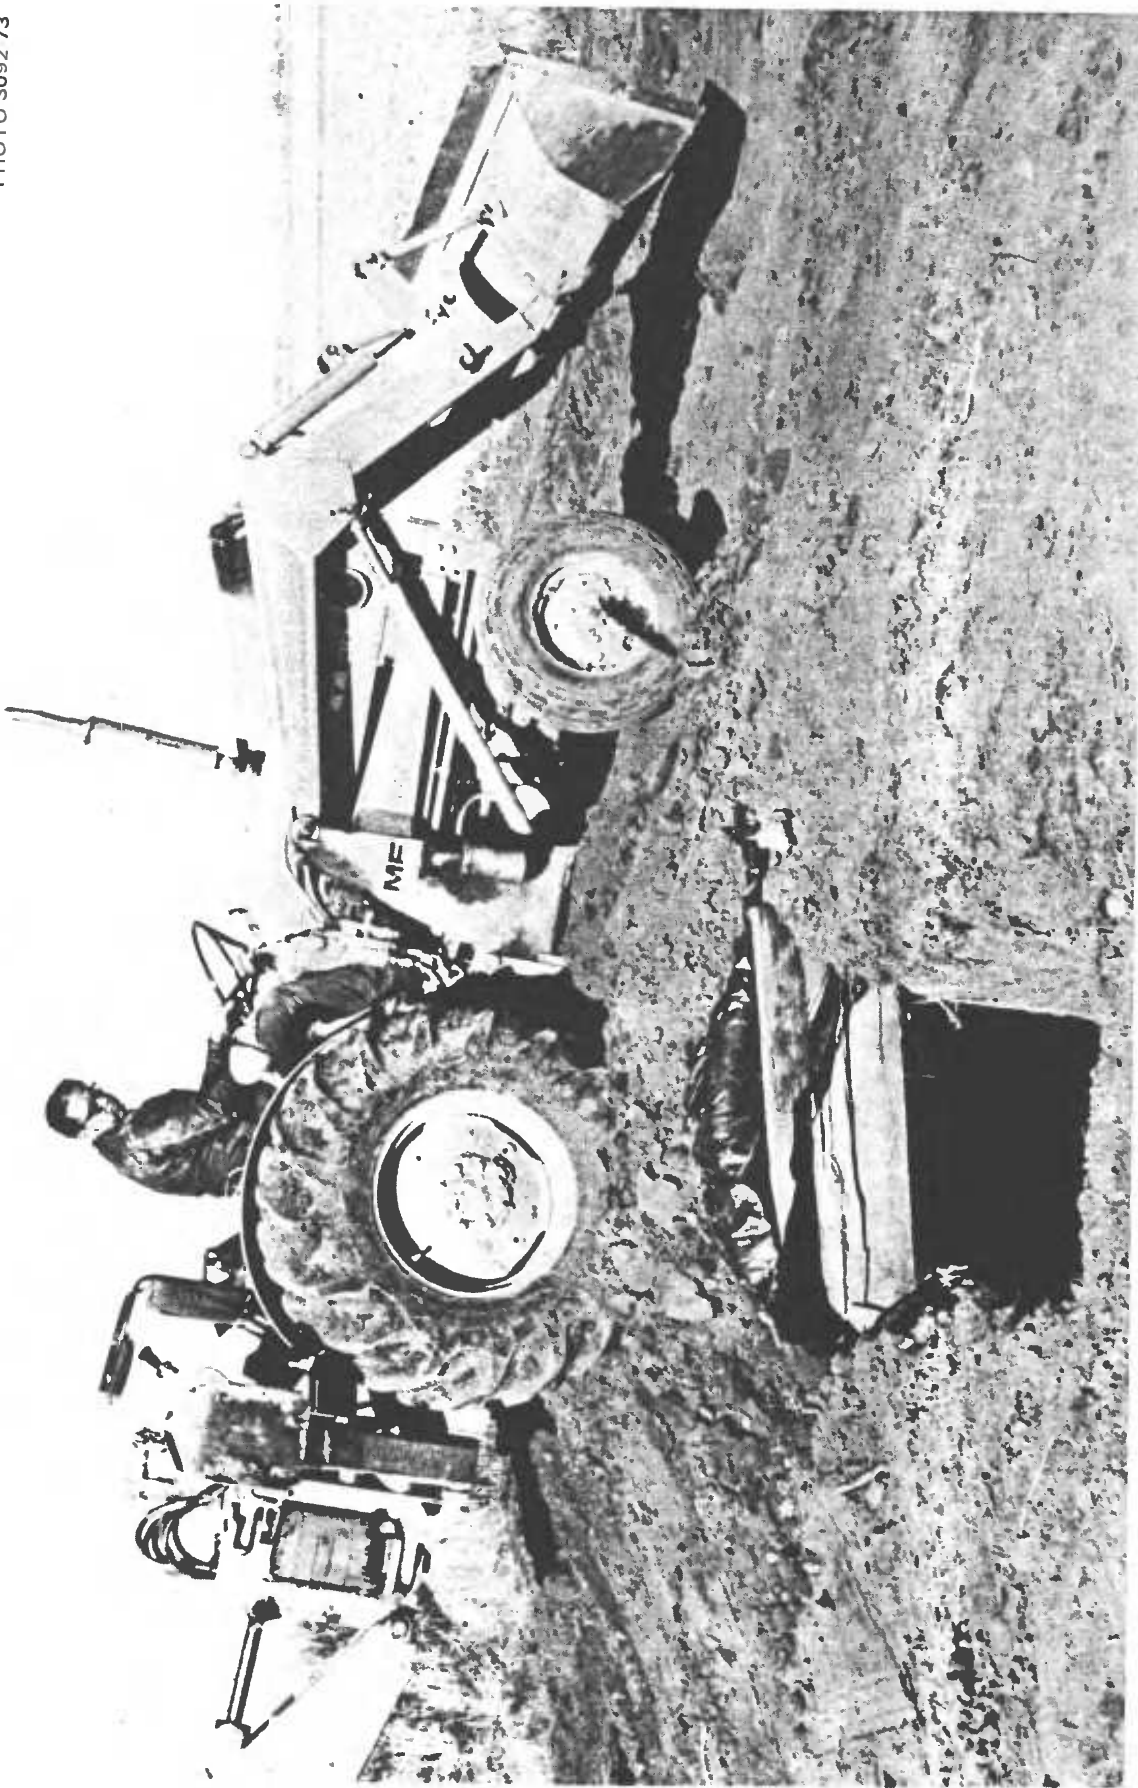
**Fig. 3.14. Stressing the Tarp-Roofed Trench Shelter, after the thickness of its earth cover had been reduced to about 3½ ft, by driving a 6-ton MF-30 backhoe back and forth across it. The downward bow, or sag, of the tarp catenary remained the same (14 in.).**

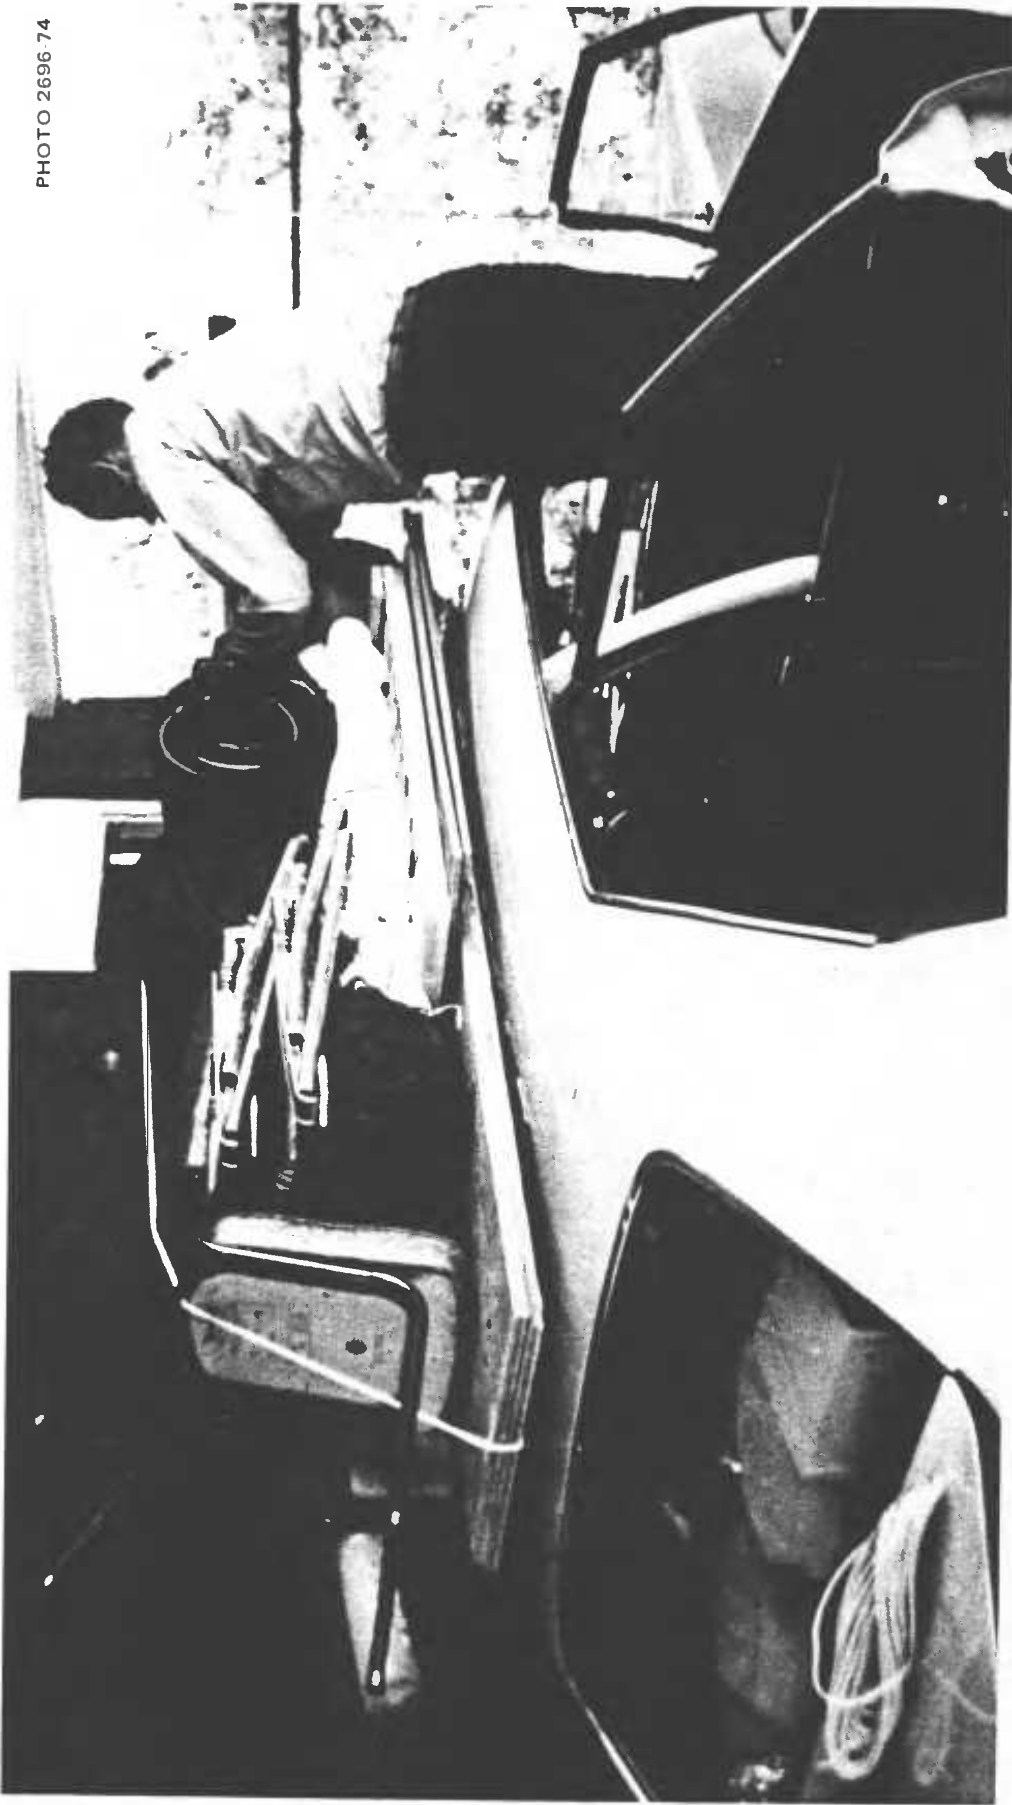
**Fig. 4.1. Loading the family car, a 4-door Maverick, preparatory to evacuating.** Ten days before the agreed starting date (August 13, 1974) of this test, this 6-person family had agreed to build a trench shelter  $3\frac{1}{2}$  ft wide,  $4\frac{1}{2}$  ft deep, and 15 ft long, with an entrance trench 22 in. wide. No plans or instructions were supplied before the starting hour, 5 PM on August 13. Therefore, the prudent father of this family had built, before August 13, an essential ventilating pump (a KAP, 20 in. wide  $\times$  36 in. high) and prefabricated components of a 21-in.-wide, double-deck bunk. Also, he sawed plywood into several threshold boards to keep the edges of earth steps and ledges from being broken off. Furthermore, after having built a rough mockup of this small shelter in his home basement, he had decided to carry on top of the family car three folding chairs and one straight chair, to avoid getting sore backs from sitting for days with no good back support.

Between the car top and the plywood, the father sensibly placed a narrow shag rug. The sleeping bags also provided resiliency that kept the load on top from slipping after it was tied on.

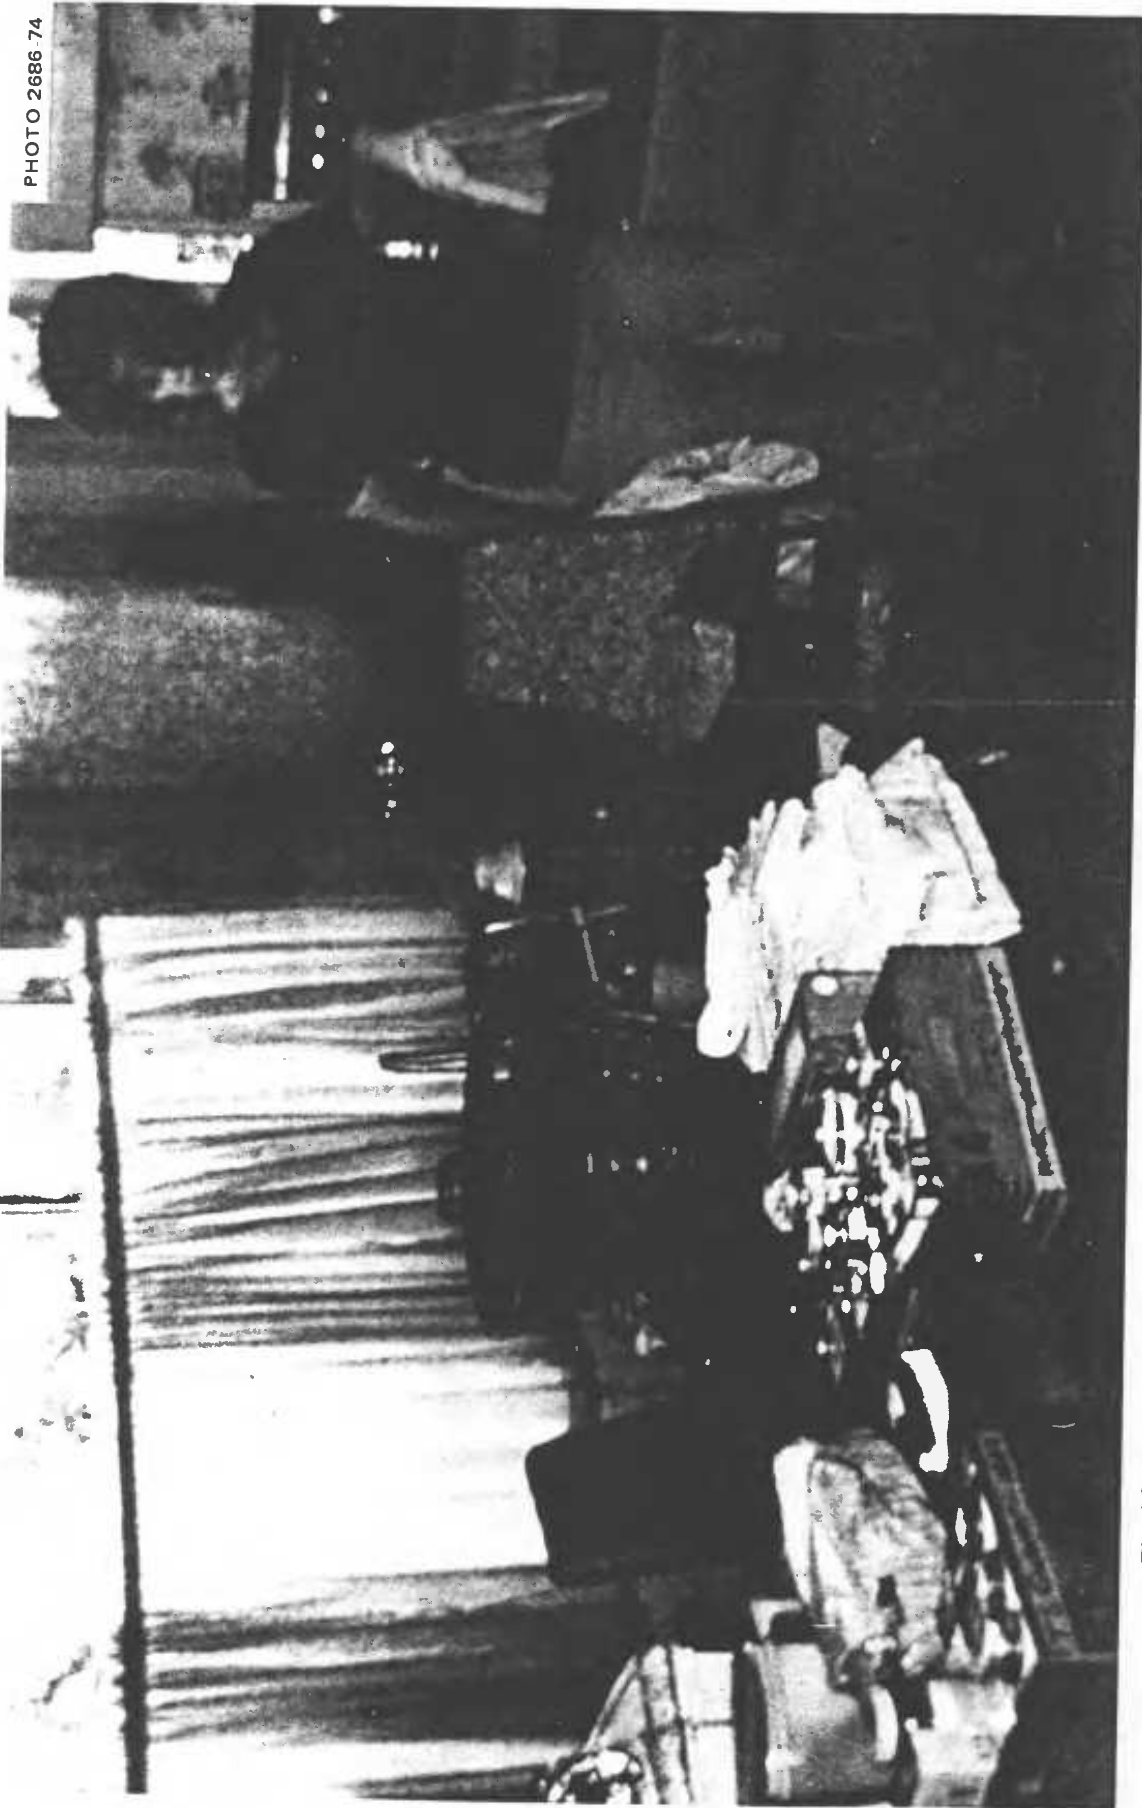
PHOTO 2686-74

**Fig. 4.2. Food assembled ready for evacuation loading.** Food was one of the 12 categories of items that the Evacuation Check List (Table 1) advised this family to take with them. The family planned to use the wooden boxes for bunk ends. This family was given the Evacuation Check List and the detailed shelter-building instructions at 5 PM on August 13, 1974. They

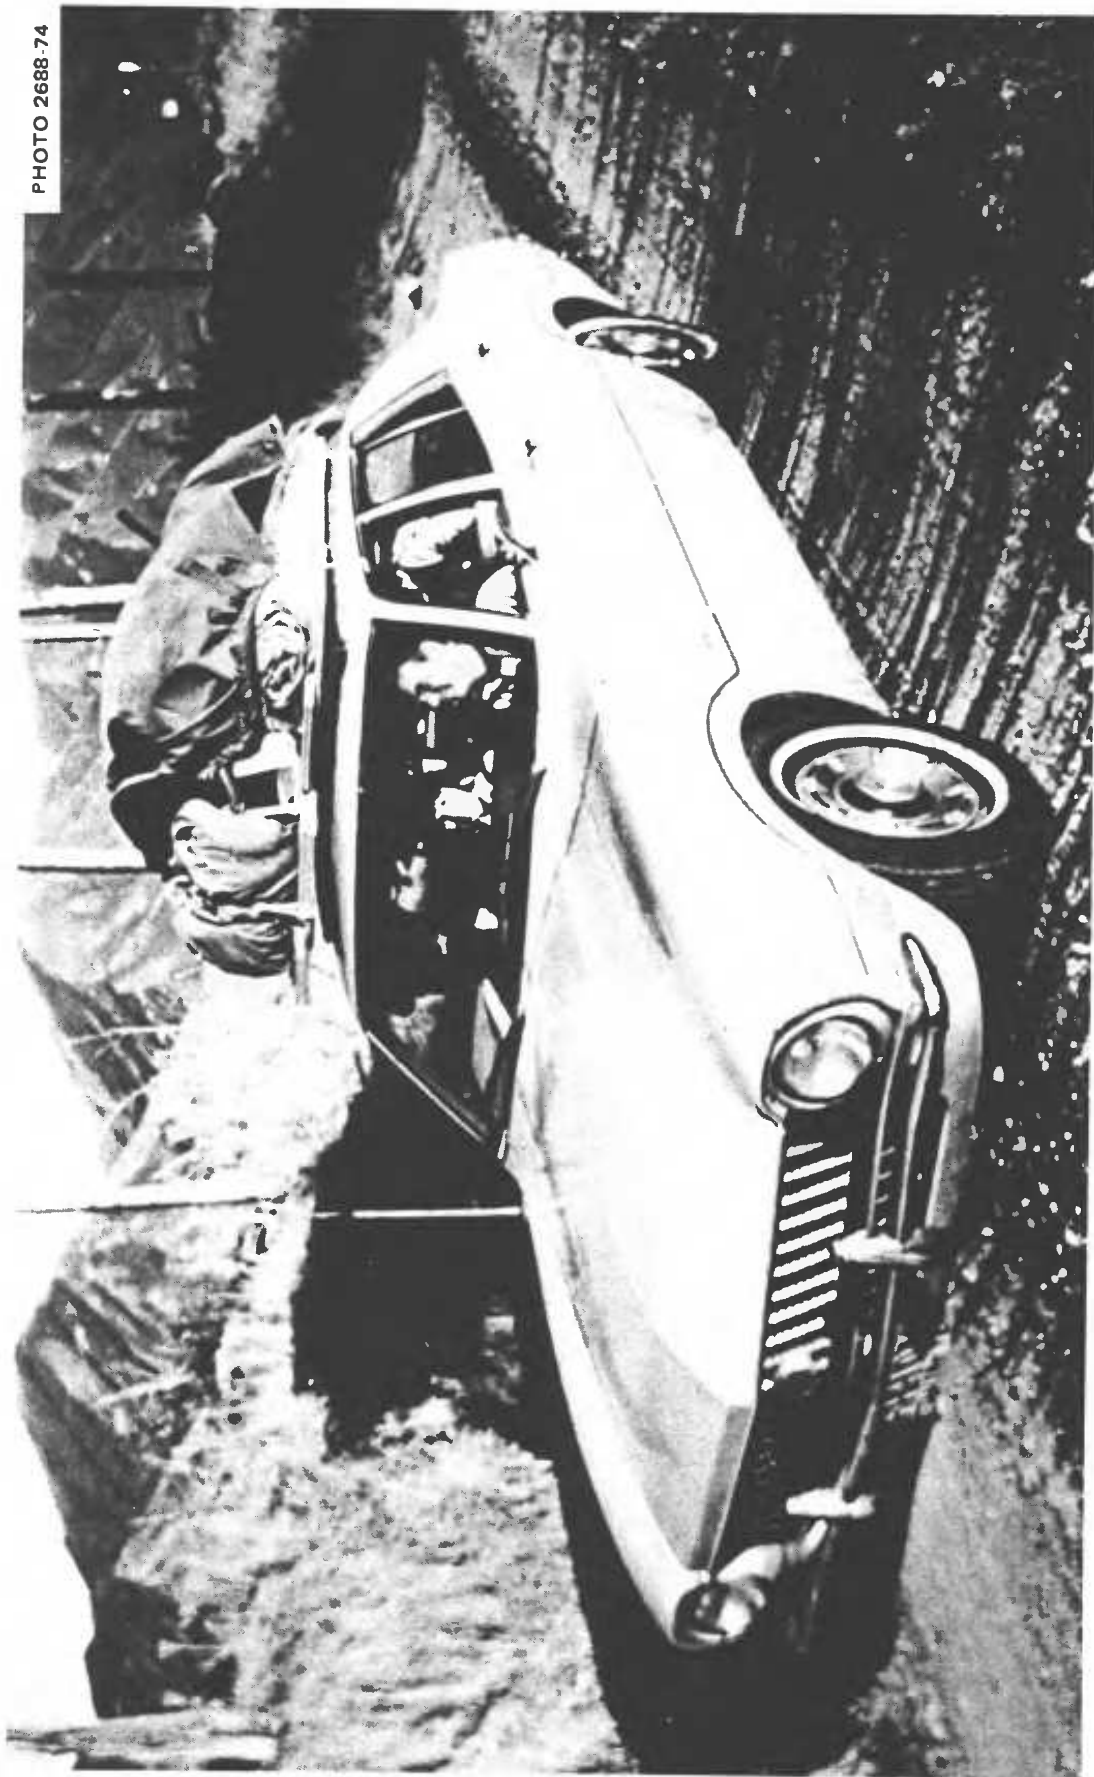
PHOTO 2688-74

Fig. 4.3. The 6-person family just before reaching the shelter-building site on a farm near Spanish Fork, Utah, at 7:48 PM. Most of the 64-mile drive (evacuation) was on an interstate, moving with the traffic at 55 to 60 mph. To provide space in their crowded car, they left the back seat at home.

Note that the load on top of the car was first tied together with cord. Then, after being covered with a small piece of canvas, it was tied to the top of the car with two pieces of light rope. These ropes encircled the top of the car, before the four doors were closed. The father made a loop on one end of each piece of rope, so that he was able to cinch each of these ropes tightly around the purposely resilient load. Obviously, many city people would need to read and follow instructions to enable them to tie bulky loads securely on their car roofs.

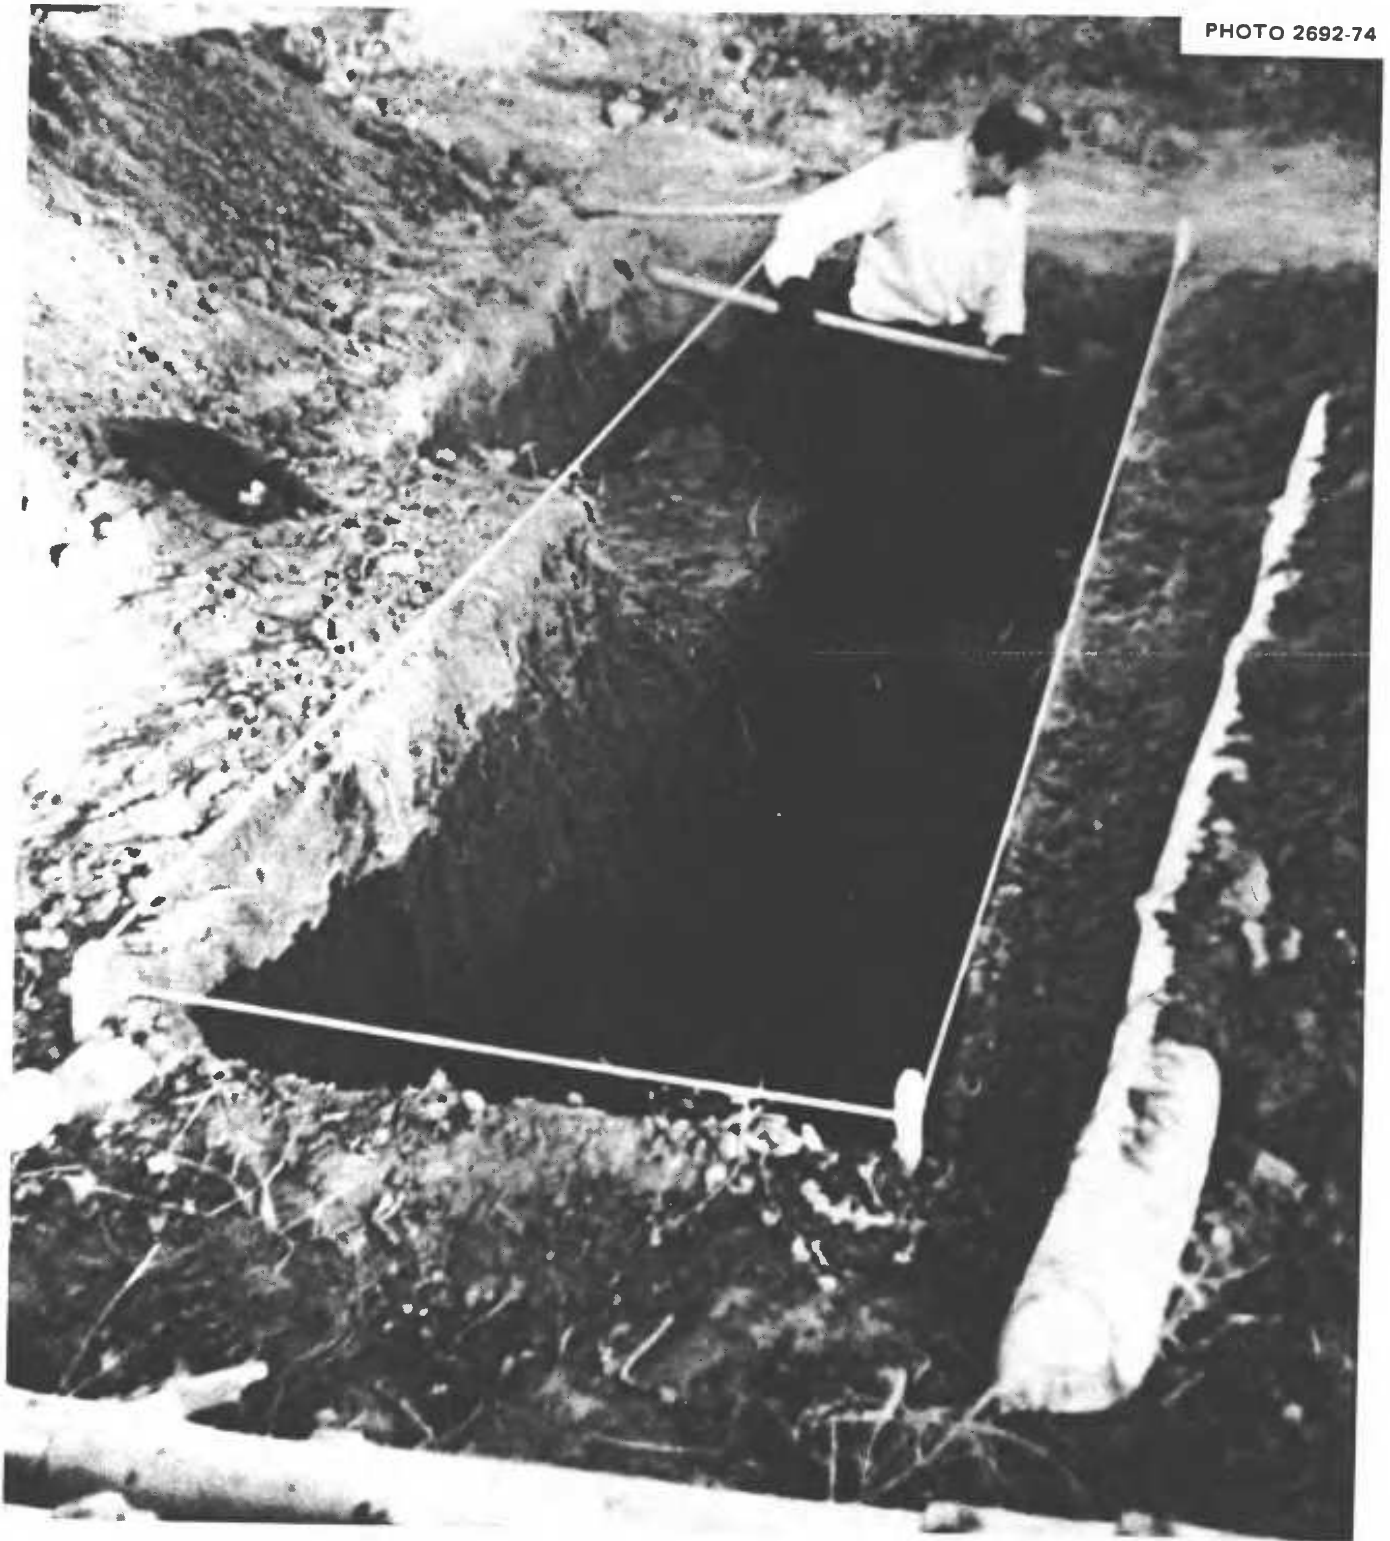
Fig. 4.4. Expanding the shelter room to its full specified width of  $3\frac{1}{2}$  feet, and to its  $4\frac{1}{2}$ -ft depth. This intelligent man made unnecessary work for himself by not following the instructions to cut a  $3\frac{1}{2}$ -ft stick, and then use it repeatedly to be sure the trench was being dug full width.

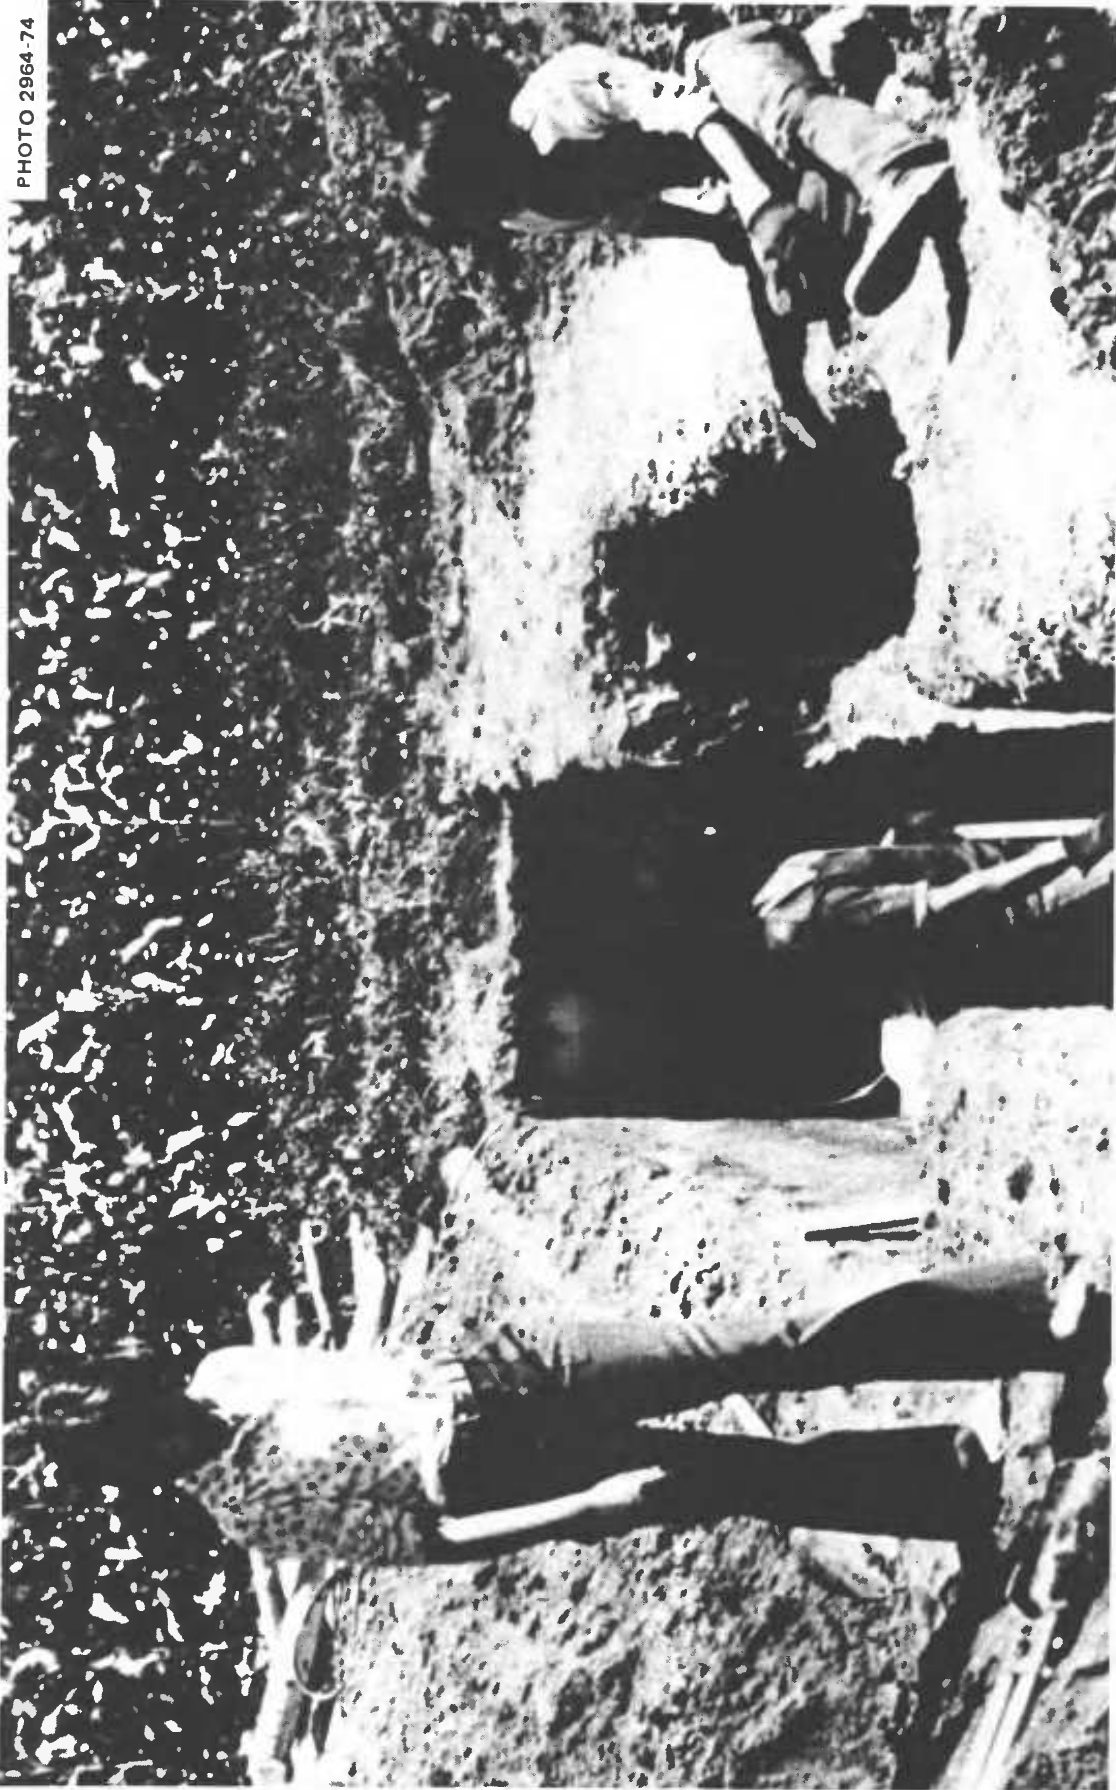
Fig. 4.5. The small ledge-like excavation on the side of the main trench was dug by Kearny to provide himself with a place to sleep and to observe the shelter-occupancy test. This sleeping ledge was 2 X 8 ft, providing a height to the log roof of only 2 ft. After Kearny got a sore neck from turning around periodically on this sleeping ledge, with only a 24-in. ceiling, during the 77 hours of shelter occupancy, he concluded that such sleeping ledges should be dug to provide a 30-in. ceiling.

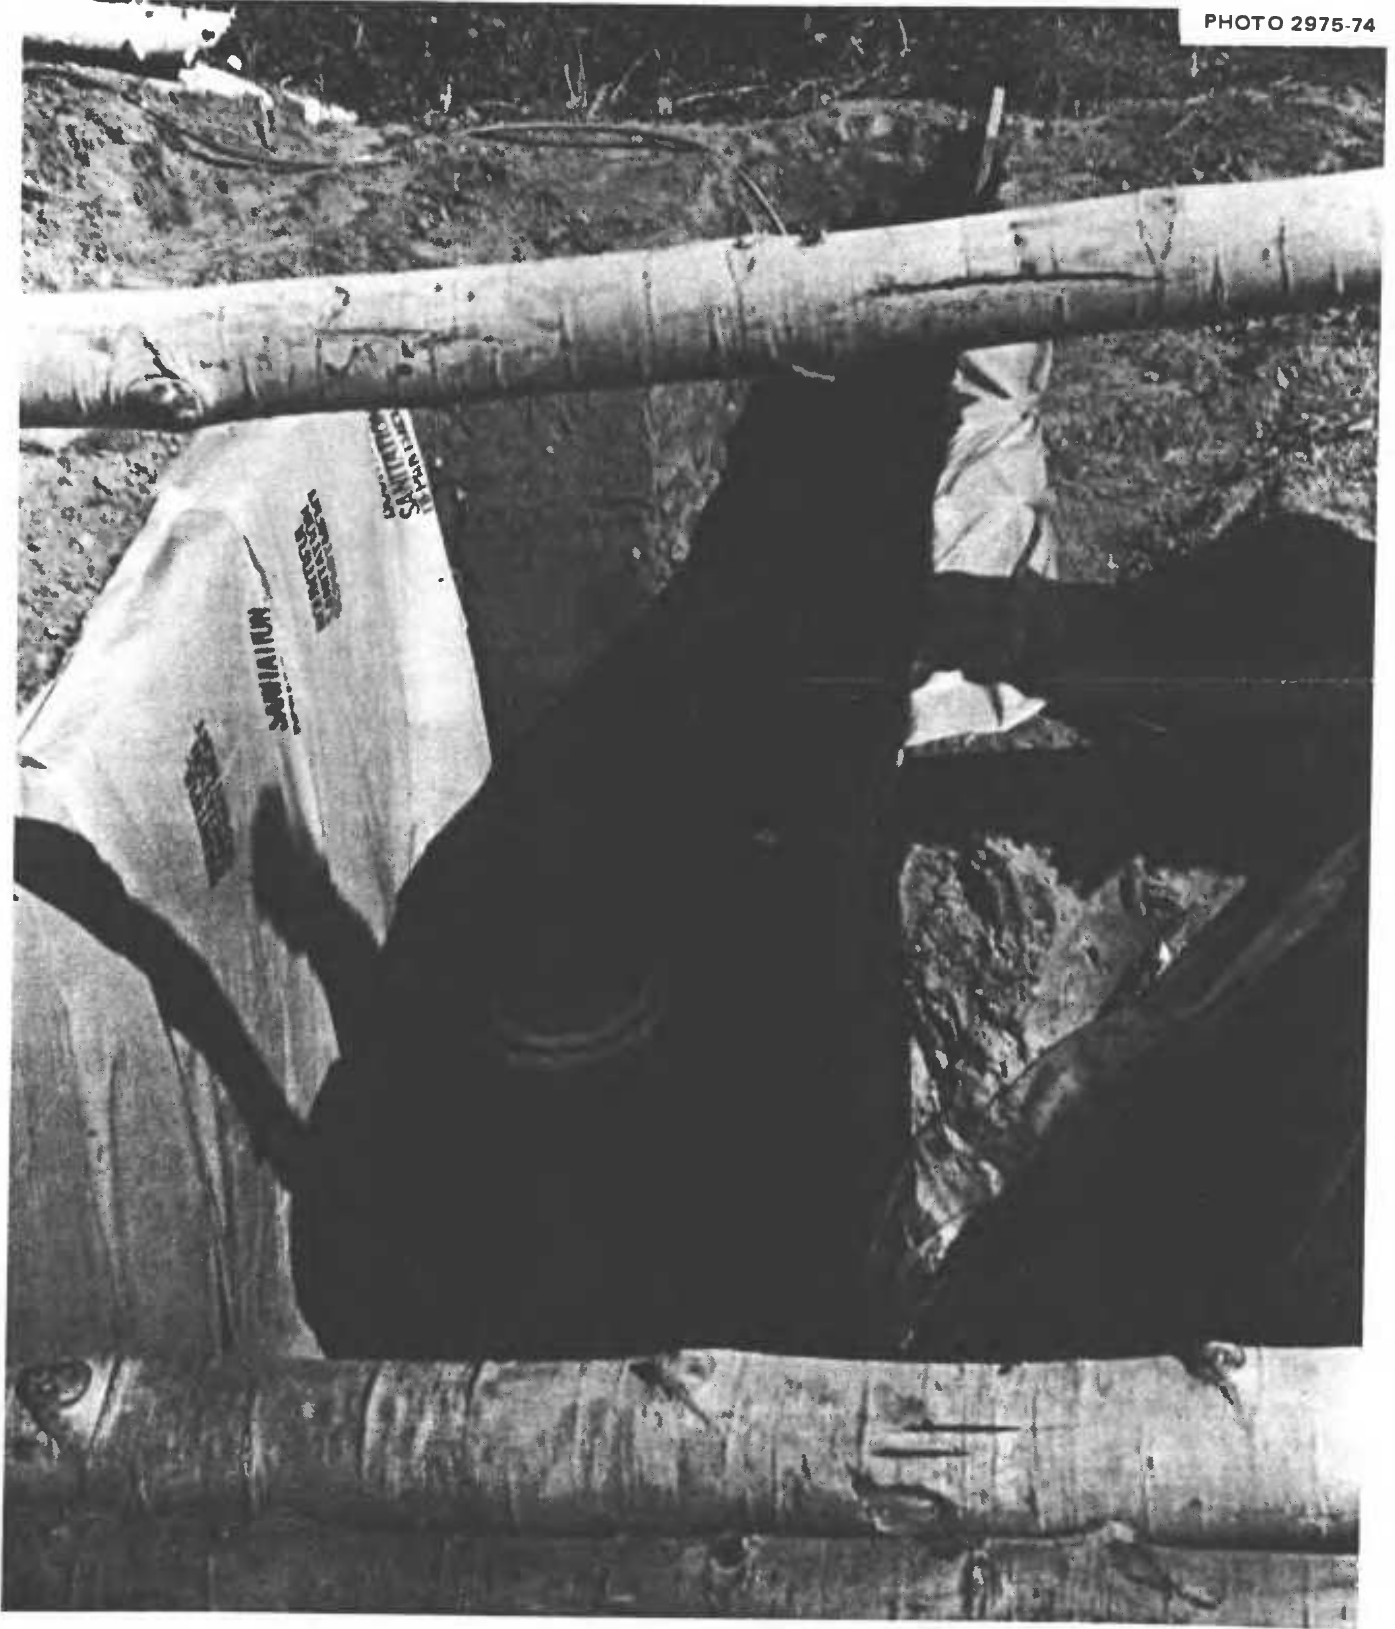
**Fig. 4.6.** Covering the main trench with 9-ft aspen logs. These logs were 4 to 6 in. in diameter at their small ends – thus being stronger than necessary to support the planned 3 ft of earth cover.

The uncovered narrow trench in the background is for the 22 × 24 × 60 in. ventilation duct-emergency exit. Note the plastic wall coverings, made of split-open garbage bags.

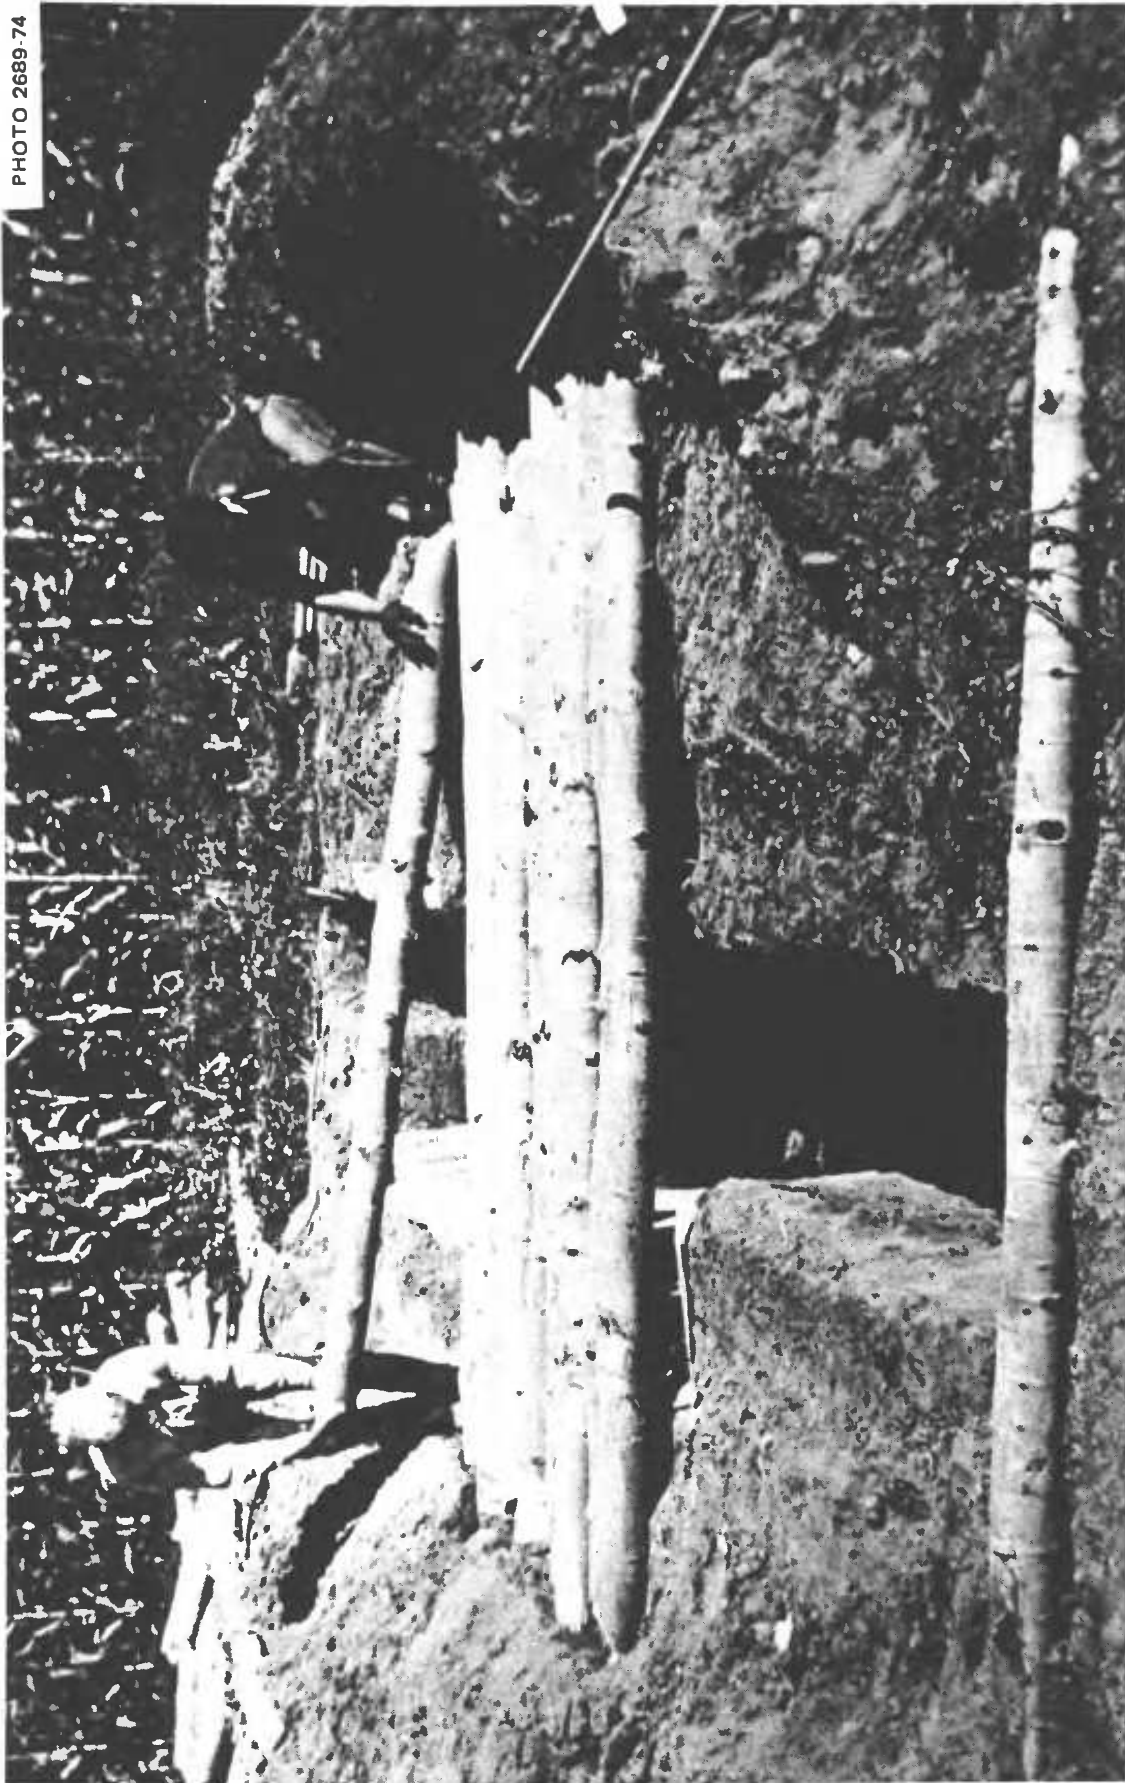
Fig. 4.7. Placing the 9-ft roof logs, all 2 ft off center, over the  $3\frac{1}{2}$ -ft-wide main trench. A shelter in firm earth such as this, with 9-ft roofing logs positioned 2 ft off center, would enable the builders to widen their shelter to a  $5\frac{1}{2}$ - or 6-ft width and to deepen it to standing height. If their home and community were destroyed, the family could live in such a rainproof dugout for months, if necessary, while minimizing their radiation doses and being more comfortable, in cold weather, than if living in a tent or shack.
