ORNL-5039  
UC-41-Health and Safety

EXPEDIENT SHELTER CONSTRUCTION AND  
OCCUPANCY EXPERIMENTS

Cresson H. Kearny

MARCH 1976

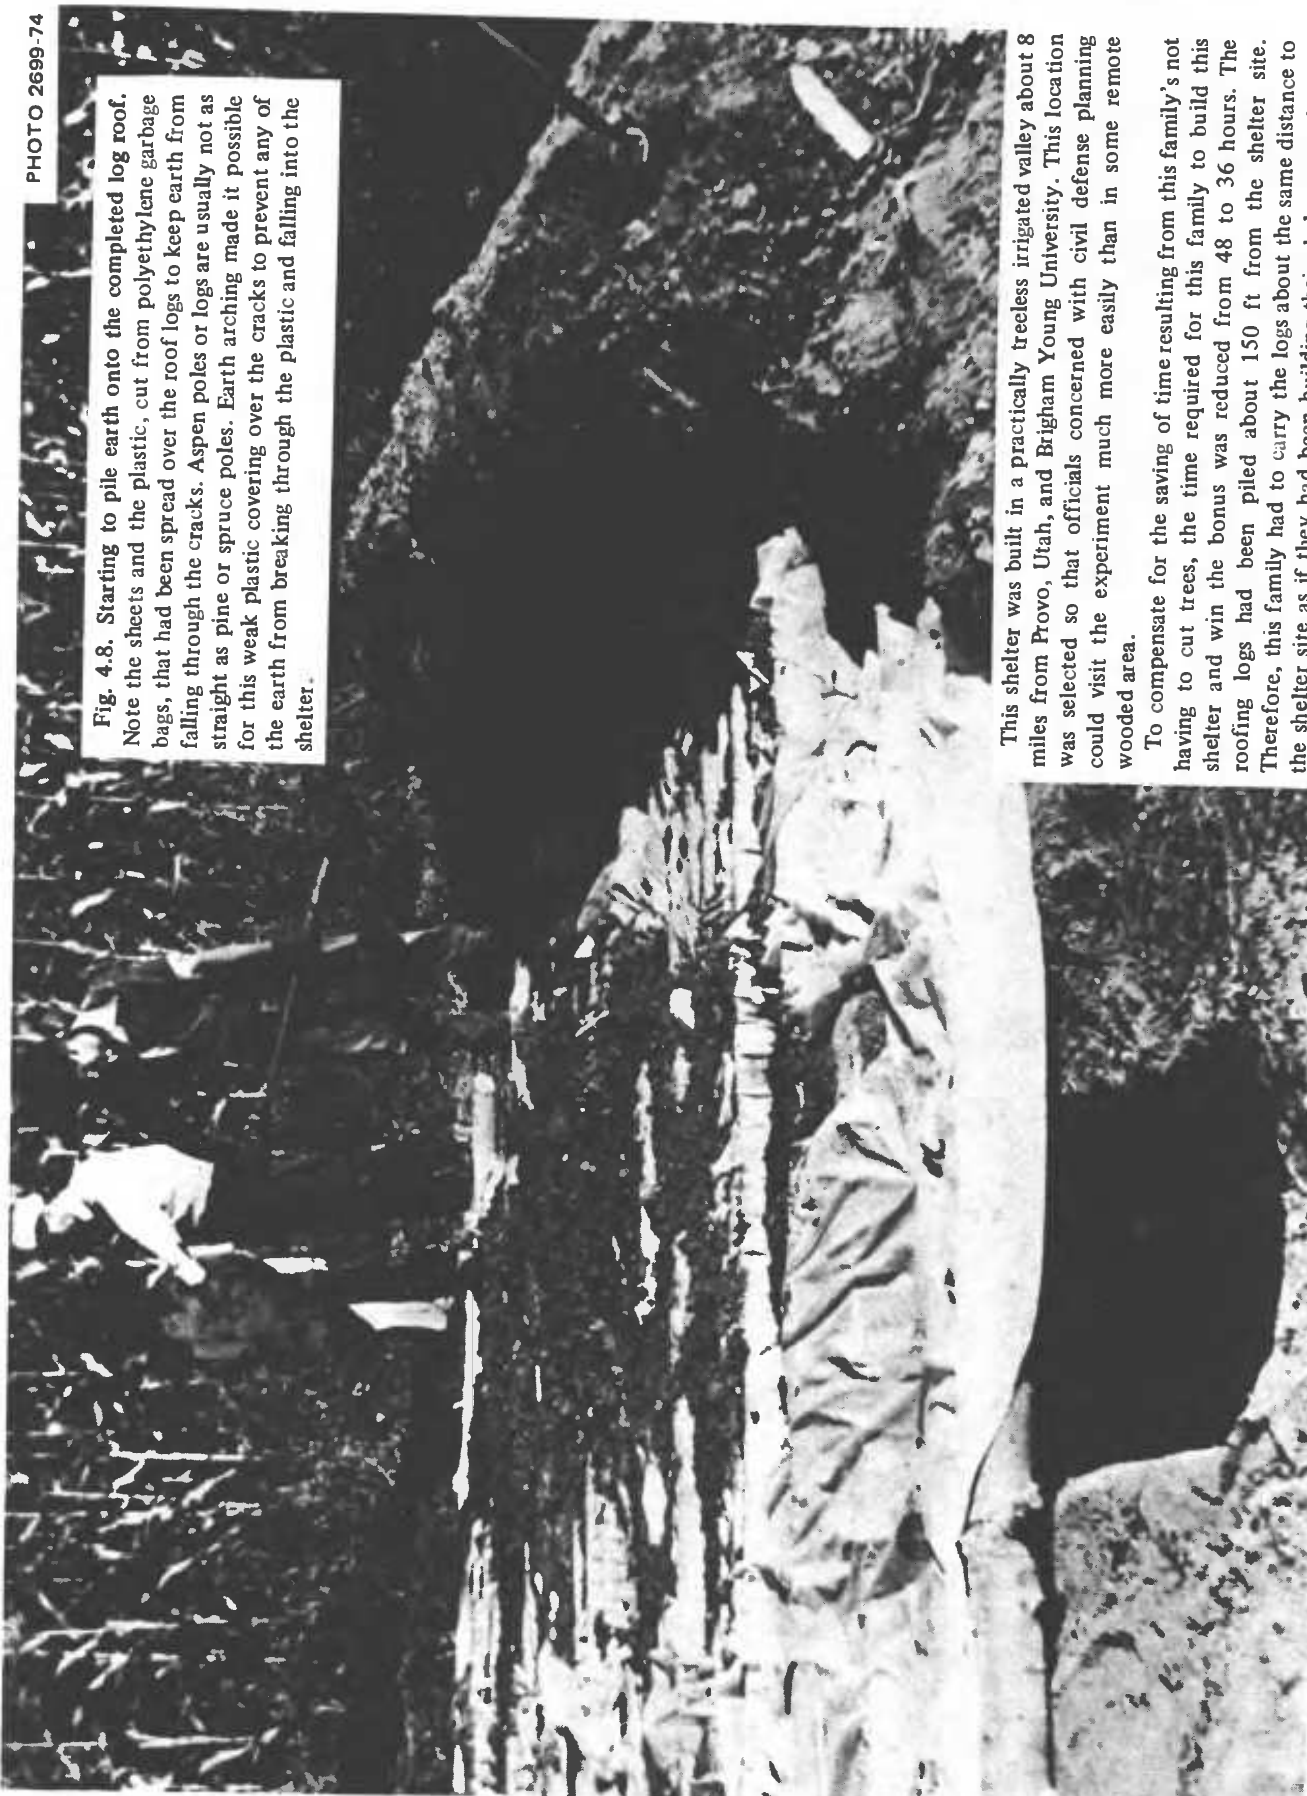
Fig. 4.8. Starting to pile earth onto the completed log roof. Note the sheets and the plastic, cut from polyethylene garbage bags, that had been spread over the roof logs to keep earth from falling through the cracks. Aspen poles or logs are usually not as straight as pine or spruce poles. Earth arching made it possible for this weak plastic covering over the cracks to prevent any of the earth from breaking through the plastic and falling into the shelter.

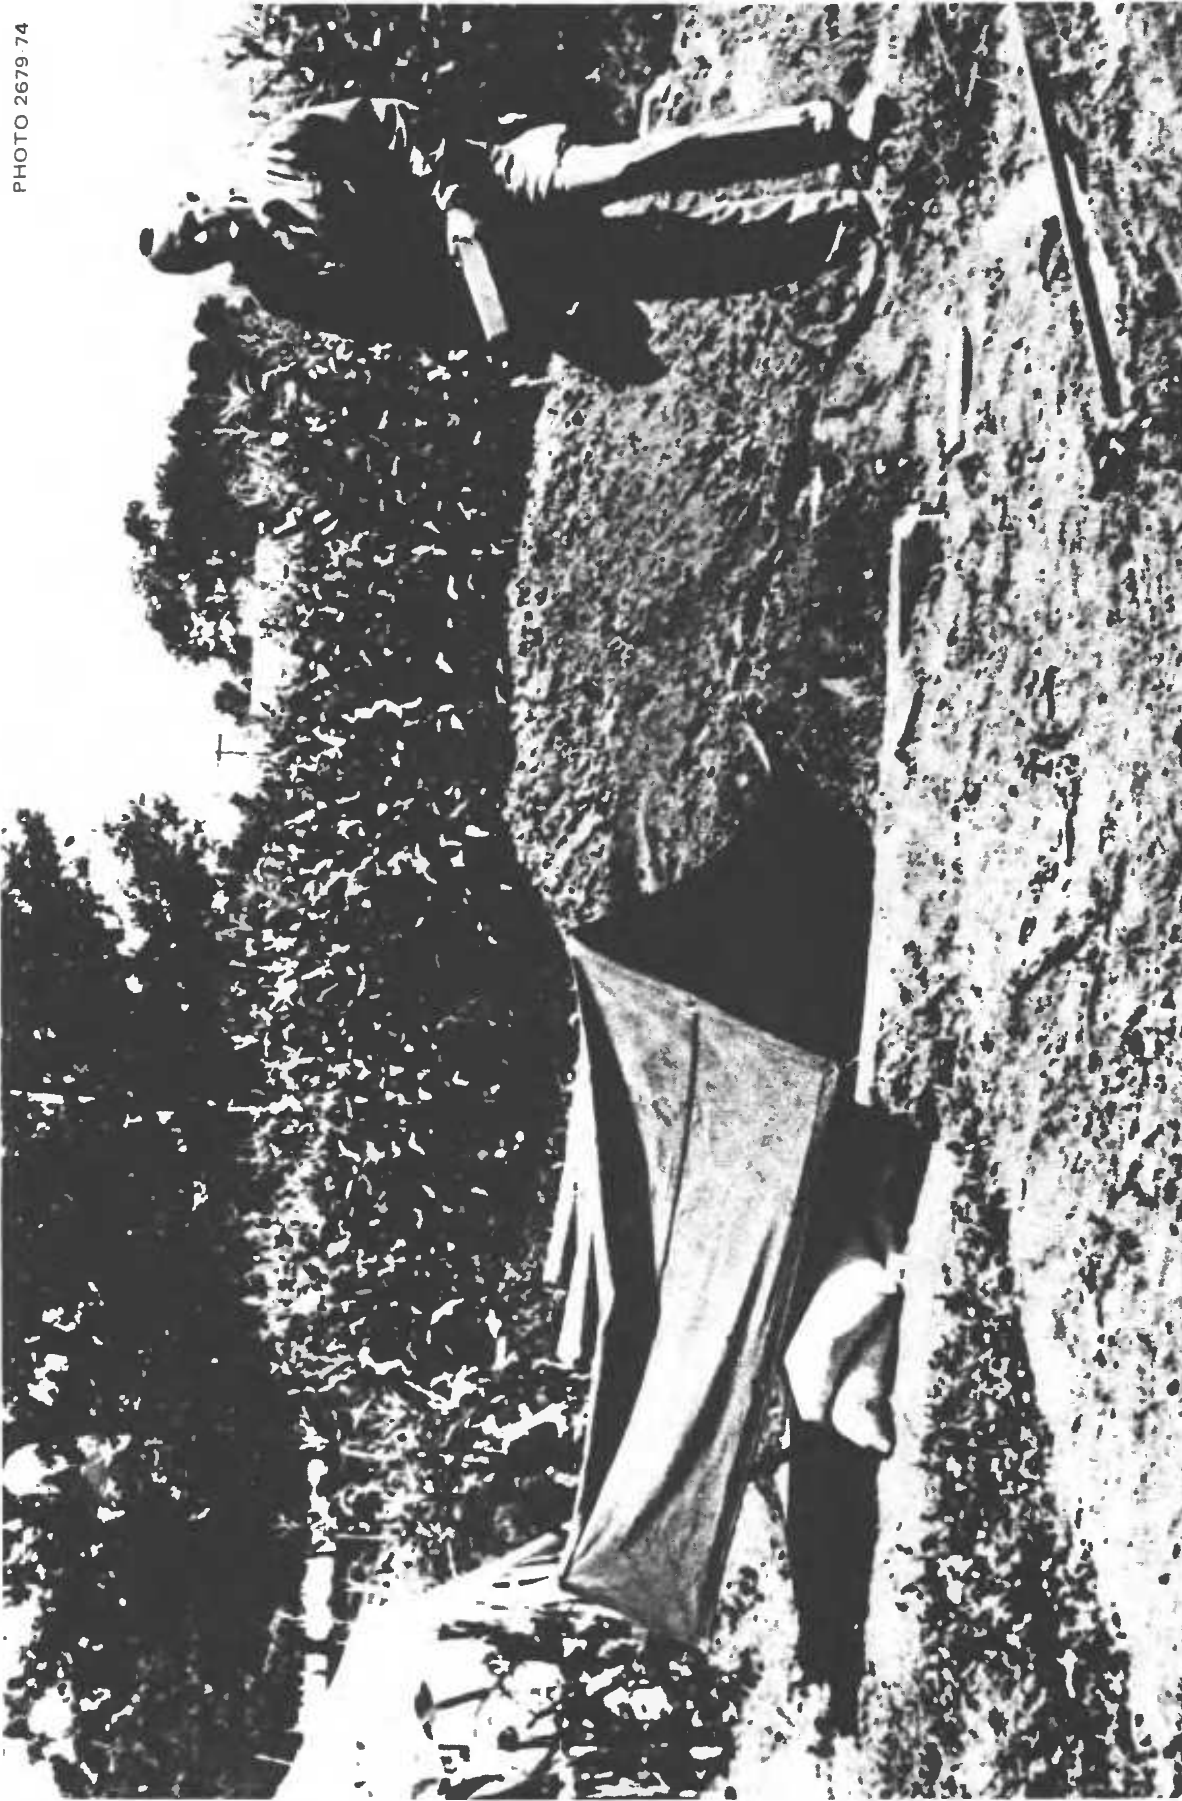
Fig. 4.11. Outside the completed shelter, with the family of six — and their dog — inside. Thirty-two and one-half hours elapsed from the time this family received an Evacuation Check List and the shelter-building instructions at their home in Bountiful, to the hour they completed their shelter near Spanish Fork and began the continuous occupancy test.

The small plastic canopy over the air-duct-emergency exit at the rear of the shelter is obscured by the mounded earth and the standing man. Window screens, one over each opening, kept out mosquitoes, numerous in this irrigated area.

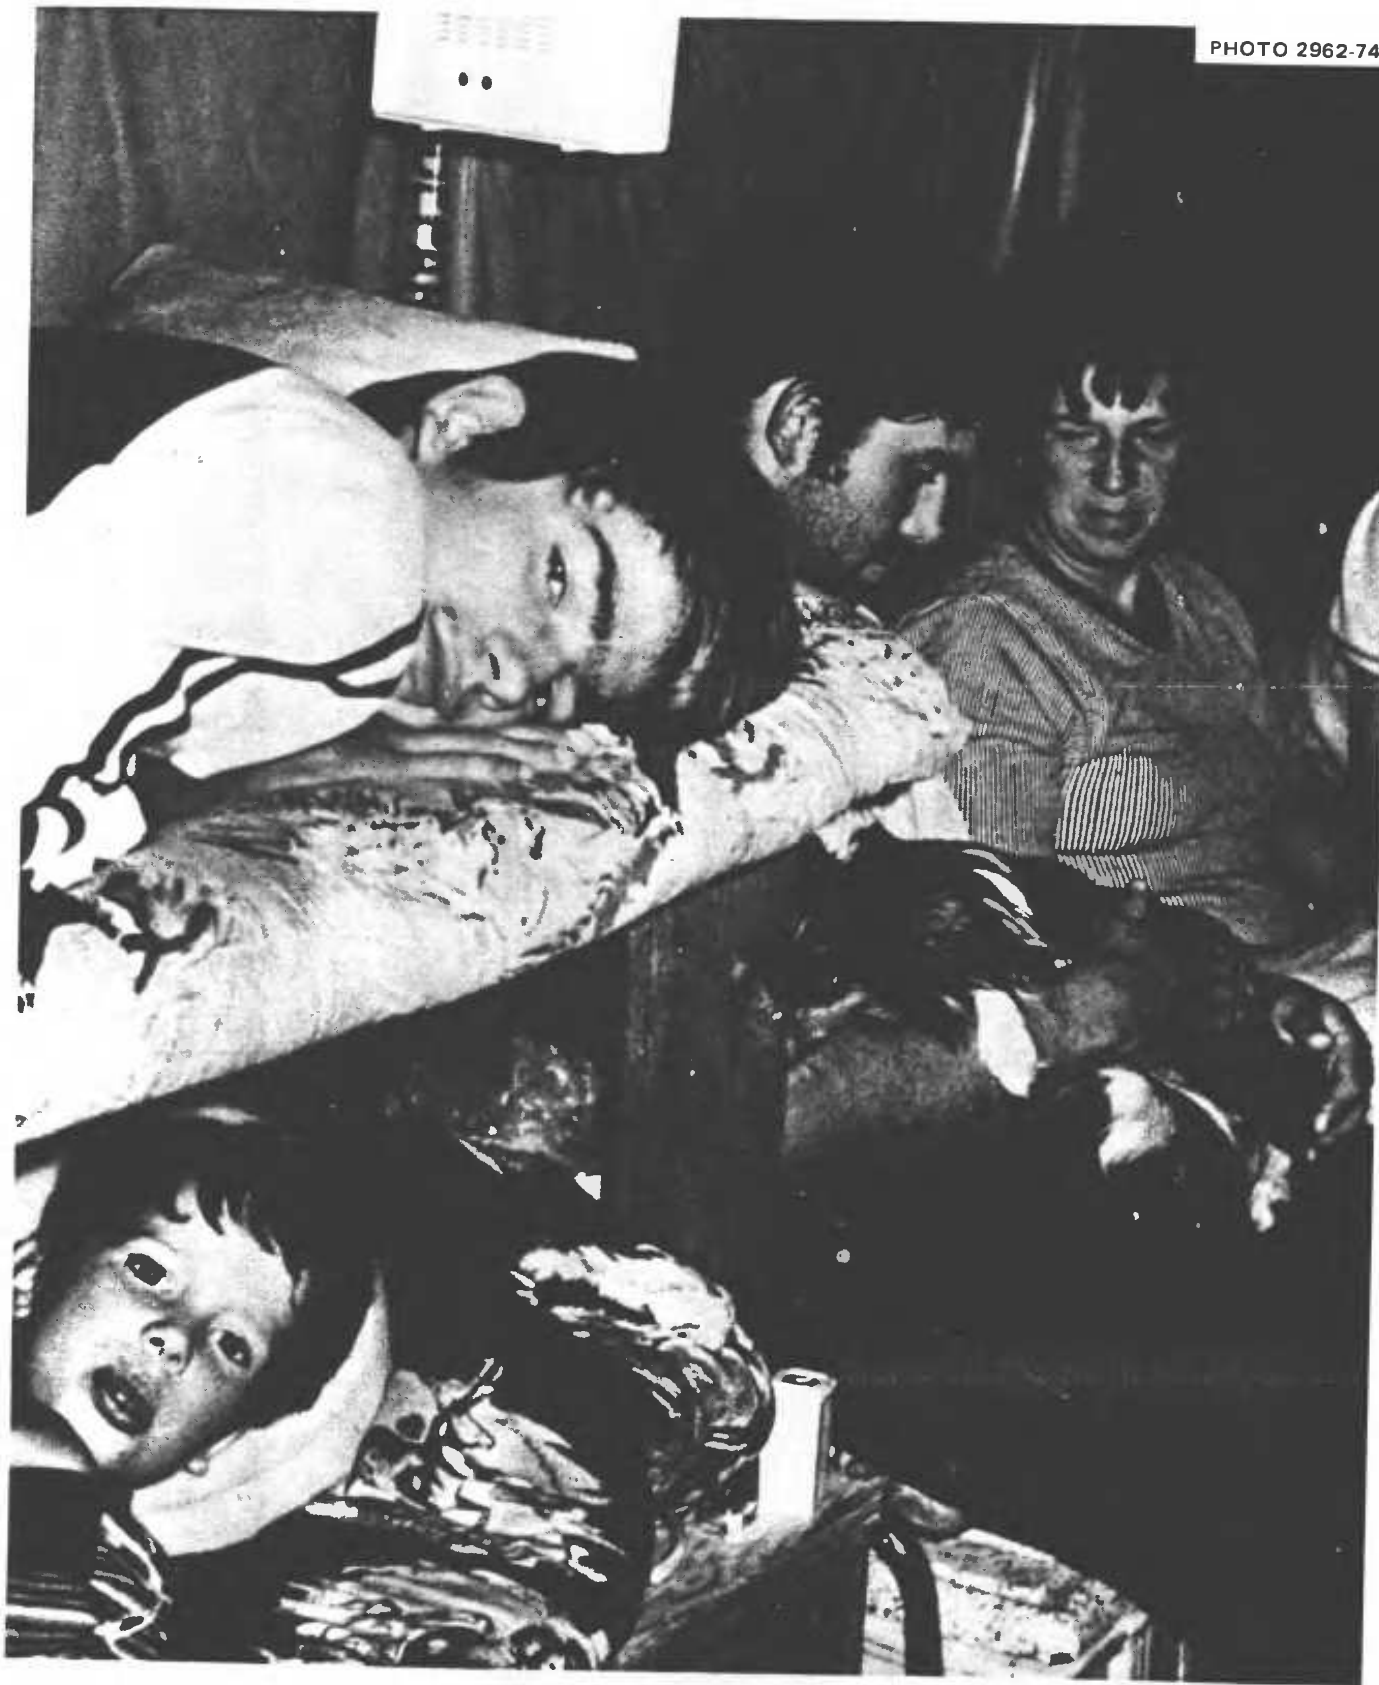
Fig. 4.12. Inside the completed shelter, showing the double-deck bunk, 21 in. wide and 6 ft long, in the 42-in.-wide shelter room. Most of the time two of the six shelter occupants slept or rested on the two bunks, while the remaining four sat in the four chairs along one wall. The walls were covered with 1-mil polyethylene sheets cut from garbage bags. This plastic was also placed under the shag rug on the floor, to keep the damp earth from dampening the rug.

Note the suspended transistor radio. Reception is good in all types of expedient shelters tested to date.

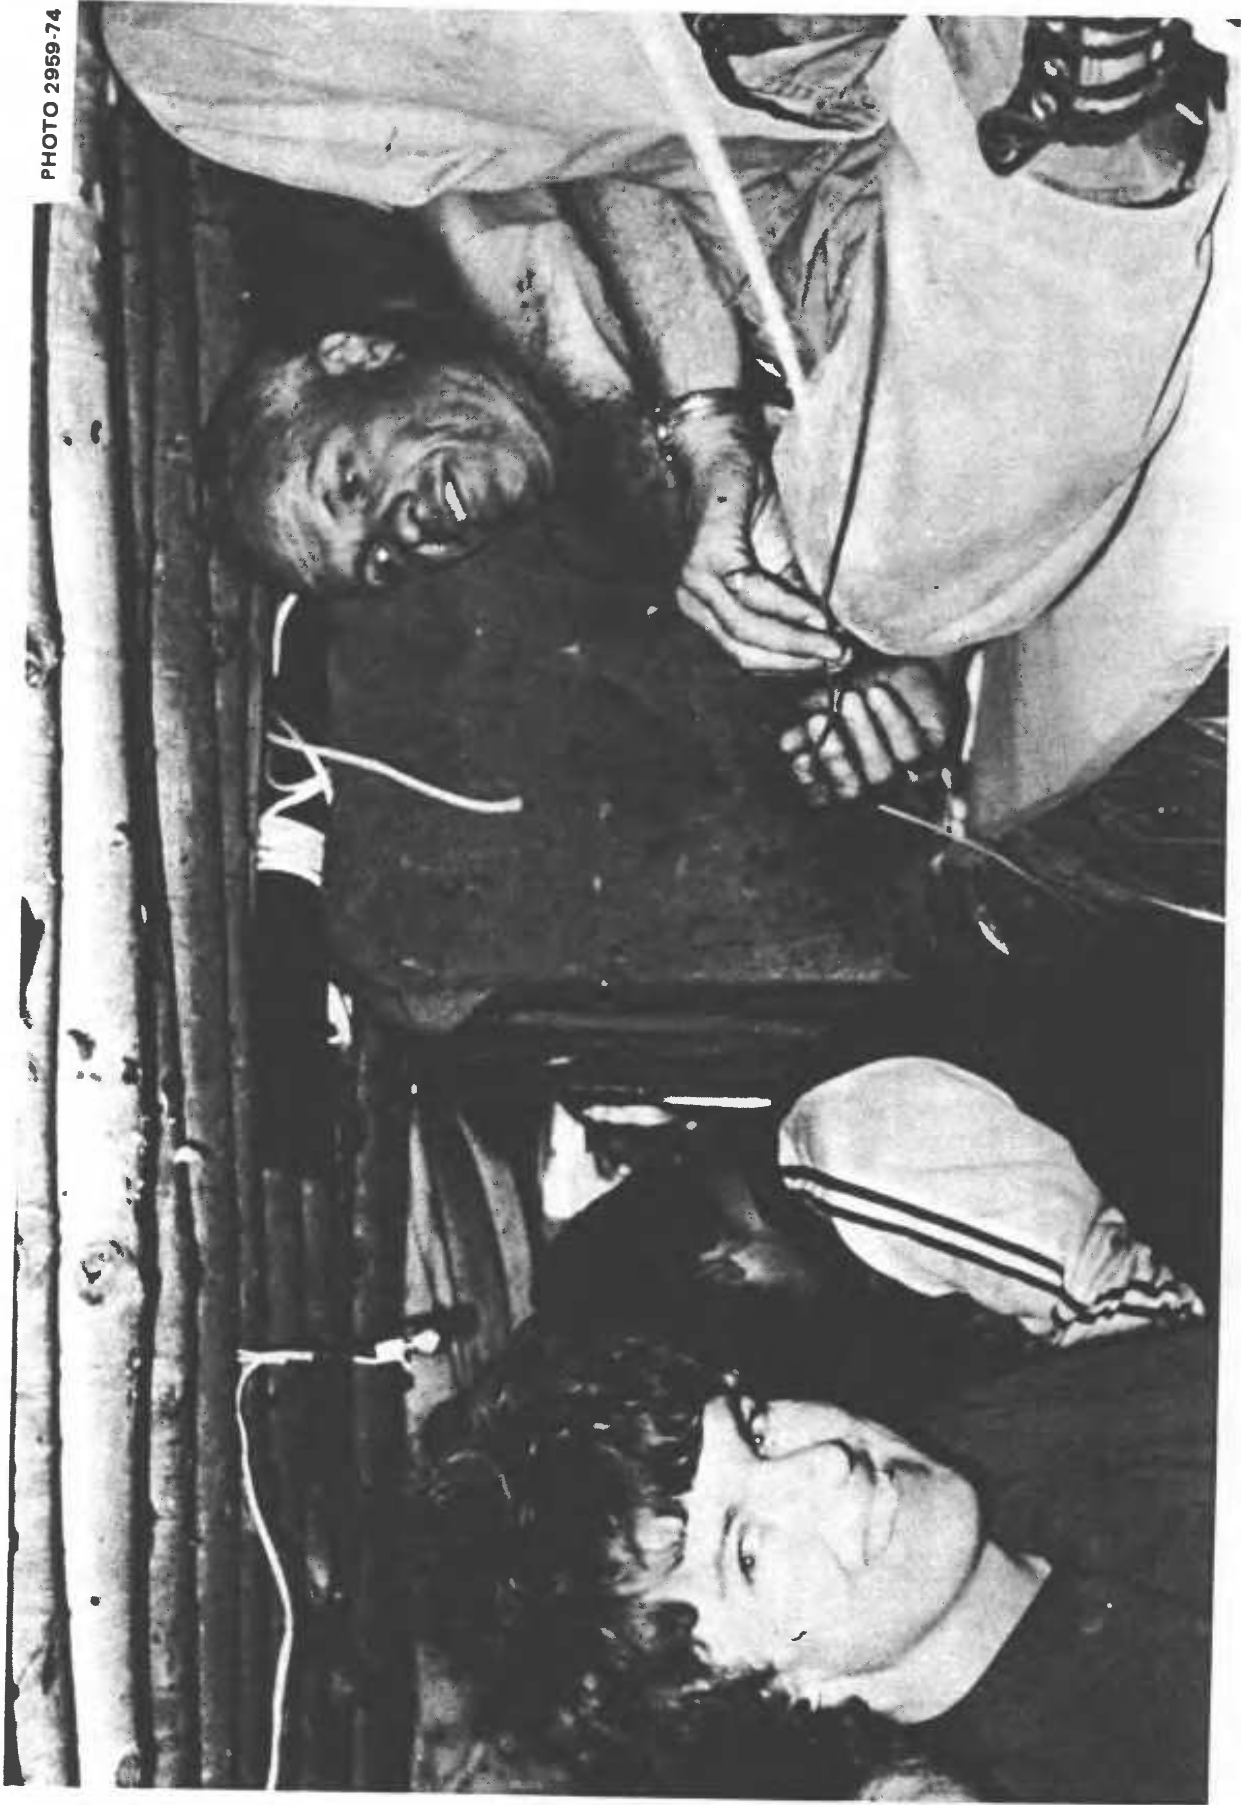
**Fig. 4.14.** Kearny, on his sleeping ledge, pulling the pull cord of the homemade KAP, to demonstrate to Dian Thomas, in the foreground, how a KAP forces an abundant flow of air through a crowded shelter.

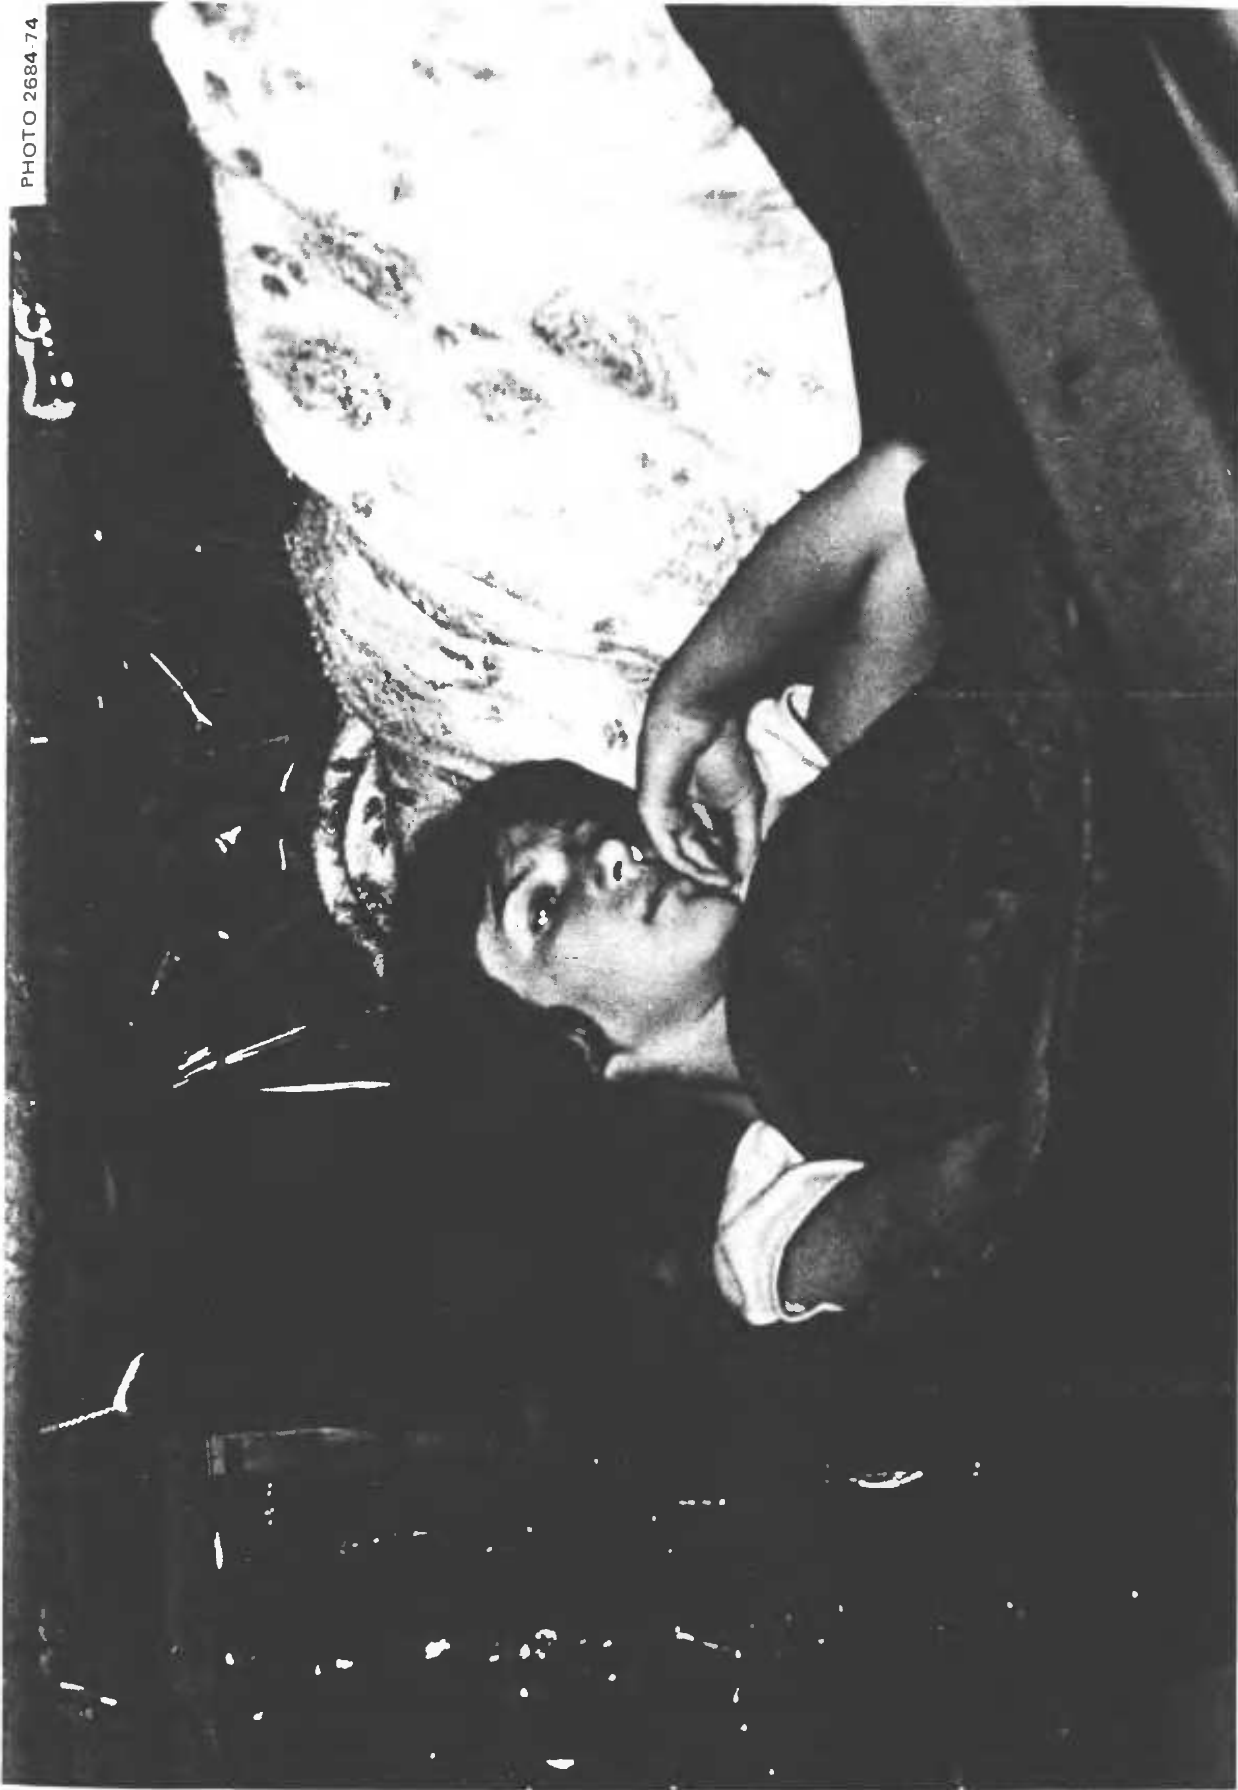
Fig. 4.17. Sleeping under a flowered blanket on a bunk, and resting in a hammock during the chill of a desert night. In the early morning hours, outside temperatures as low as 45° F were recorded, with effective temperatures as low as ET 66.5° F inside. The occupants wished they had brought more blankets, since they used their sleeping bags for mattresses.

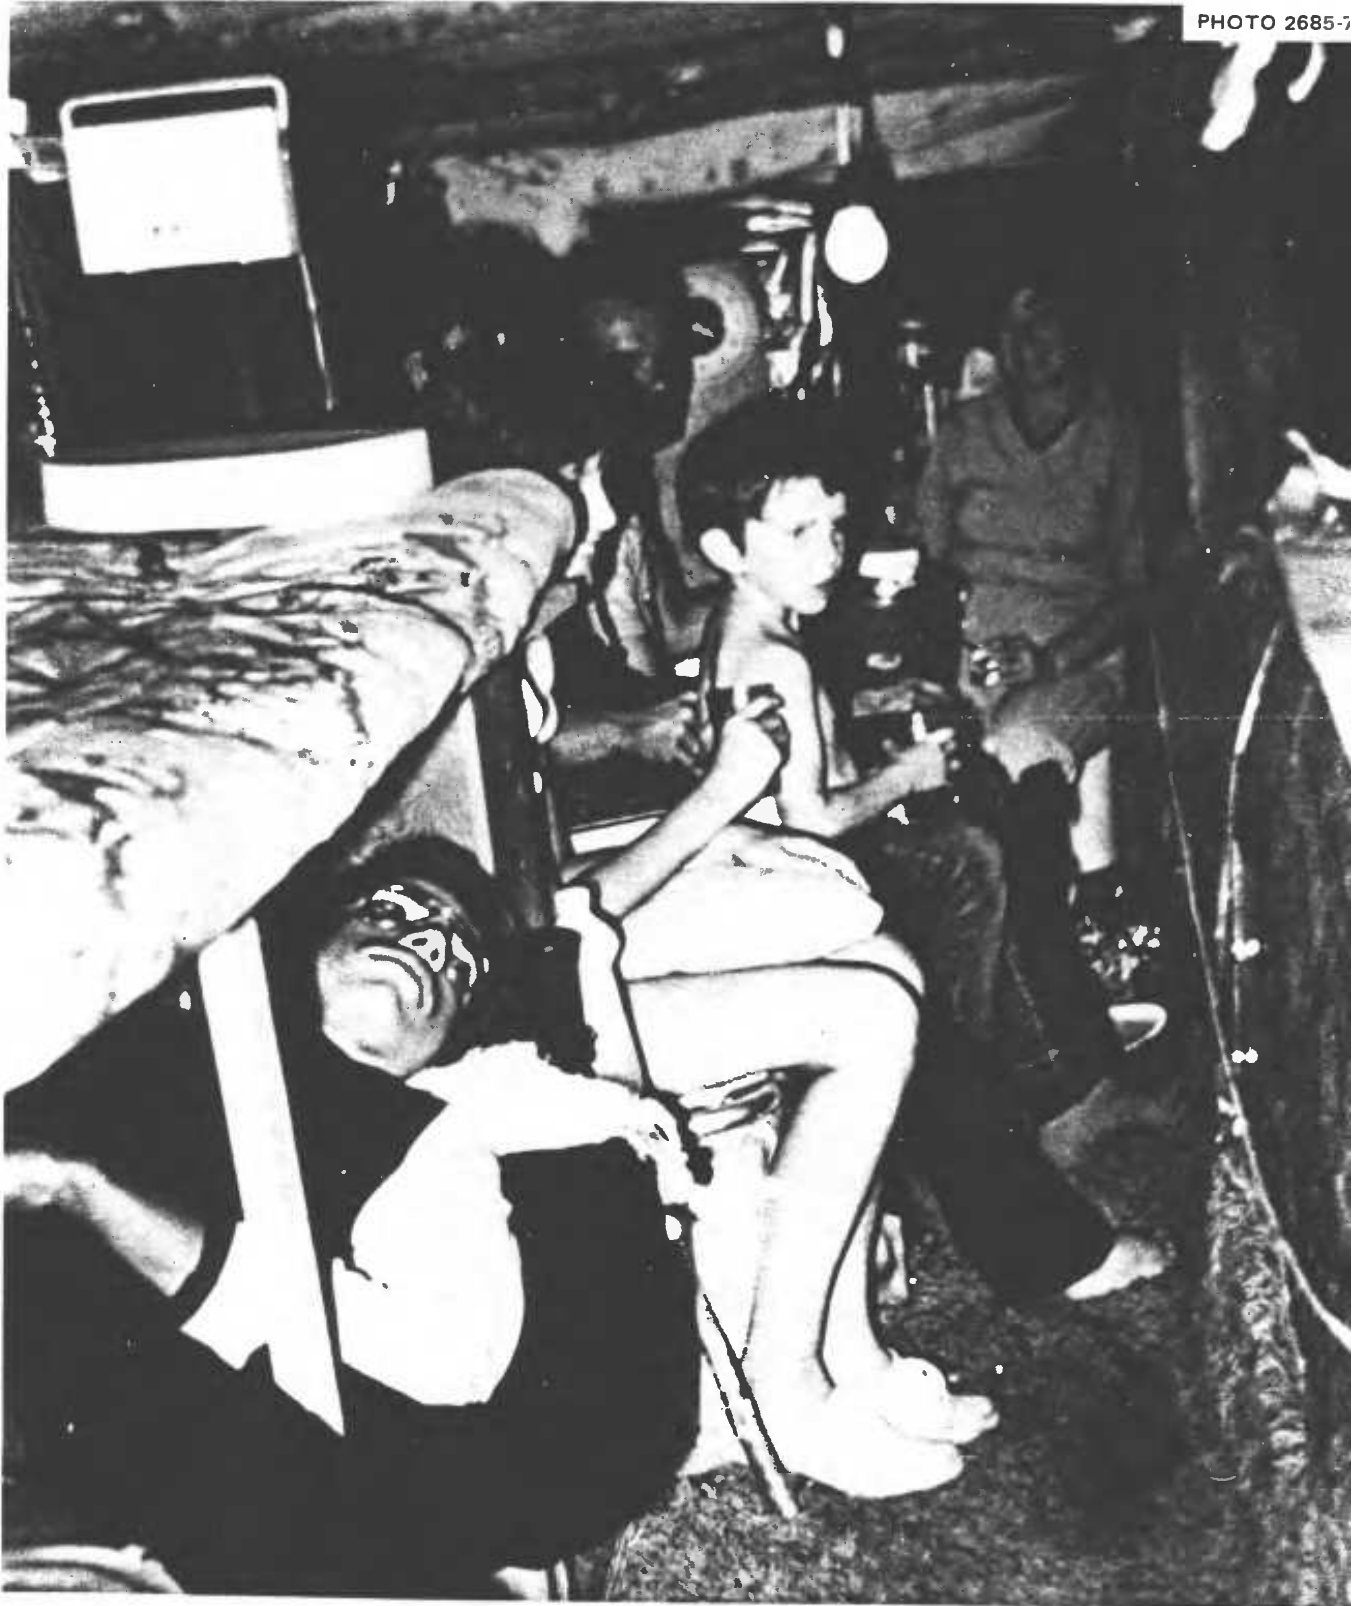
Fig. 4.18. Enjoying the occasional luxury of bright shelter illumination from a 25-watt bulb. A homemade manual generator and an extra car battery supplied electricity. The battery could have been recharged efficiently with this generator, if it had not had some faulty cells. Furthermore, both the original small 12-volt bulb and a spare bulb of this family's standard auto trouble light (operate off a 12-volt car battery) blew out while being used to provide light. Work progressed on most of two nights, before the shelter was completed at 1:30 AM on the second night. As a result, when the shelter-occupancy test started, this family was already using the spare flashlight batteries, and these batteries no longer gave a bright light.

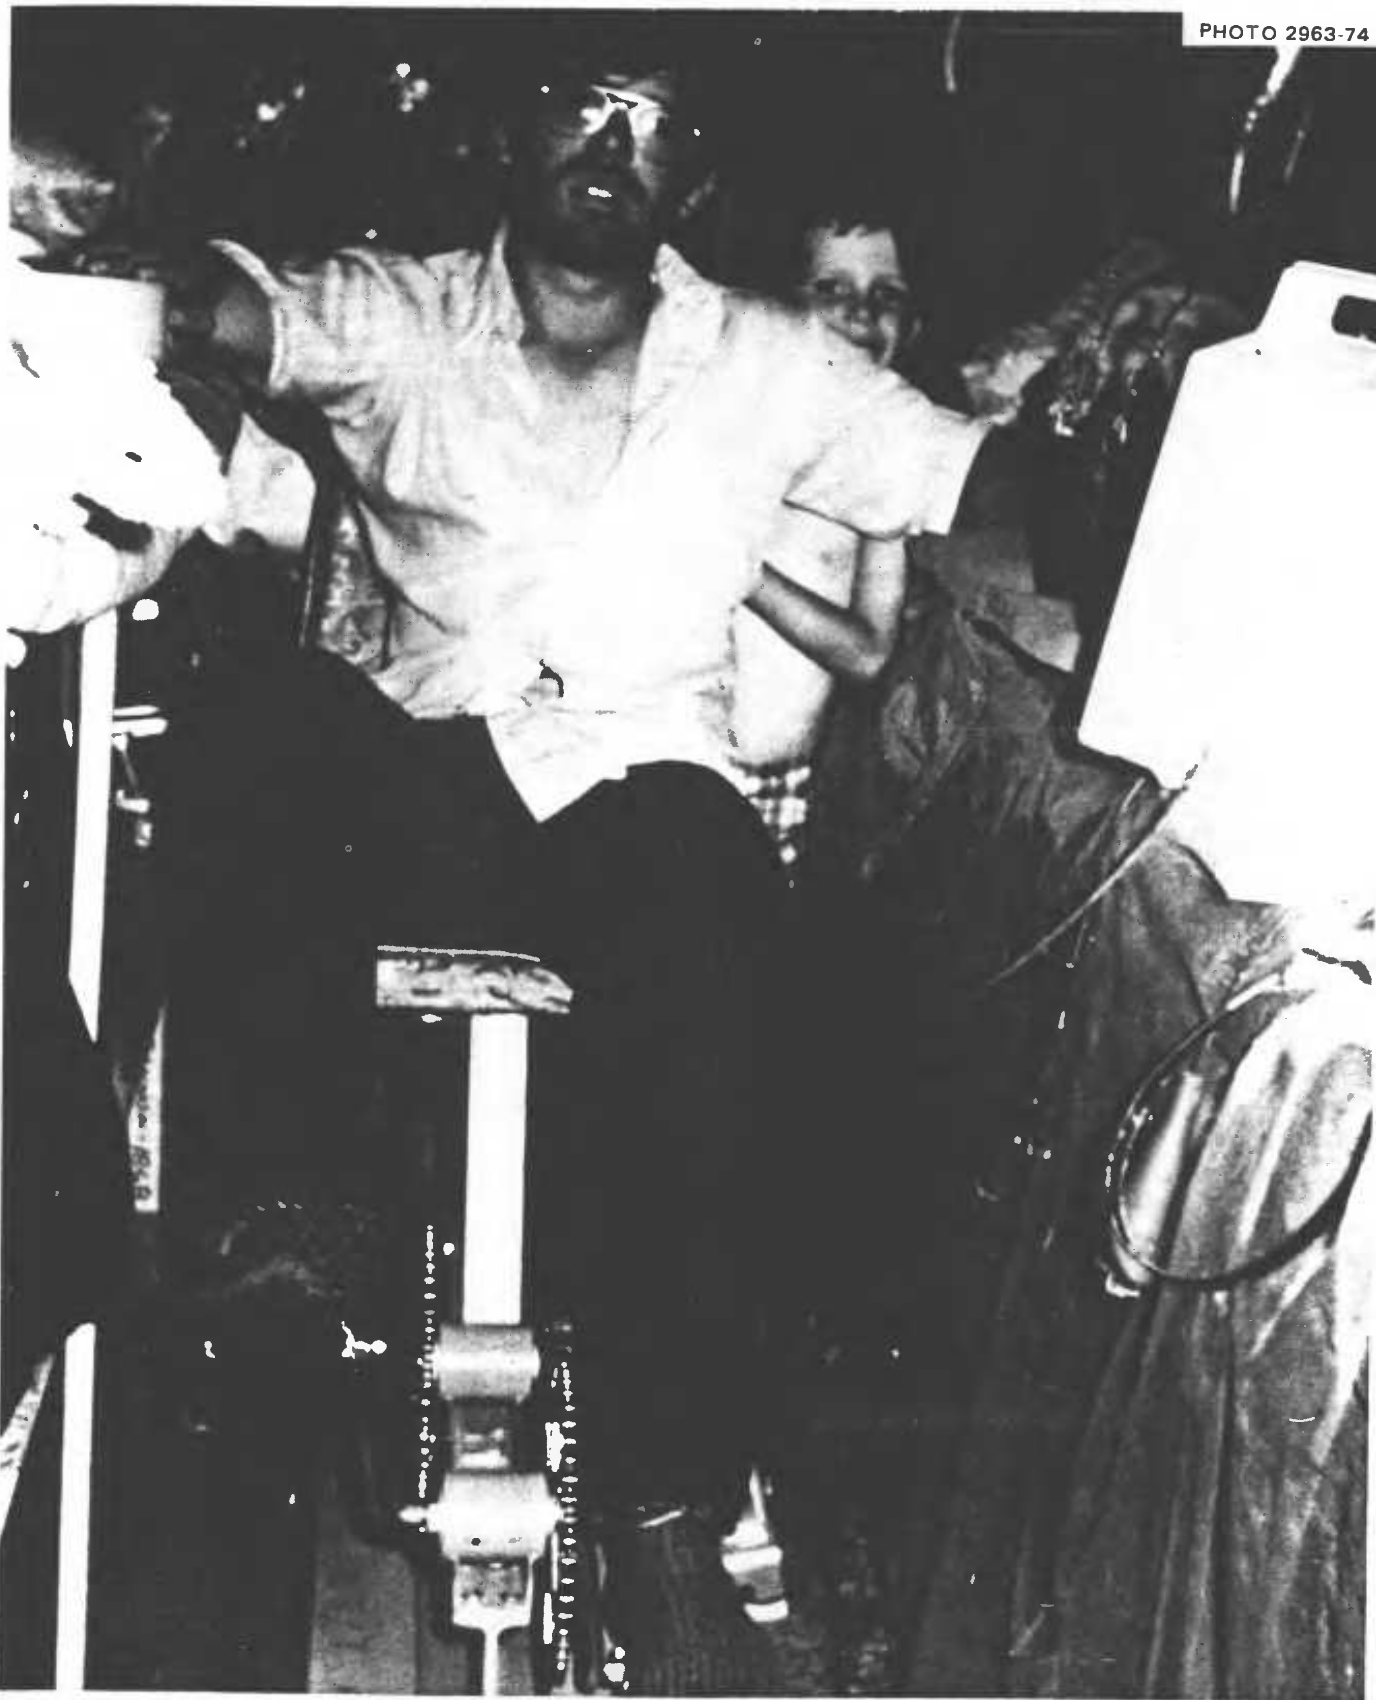
Fig. 4.20. The 18-year-old son getting good exercise by peddling his father's homemade generator to operate their portable TV set. Several years ago the father made this manually powered generator, which uses the sprockets and chains of two bicycles, mounted on a steel frame, to rotate the alternator from a car. The alternator is mounted on a bracket. Only a few minutes were required to remove the alternator and attach it securely to the bracket.

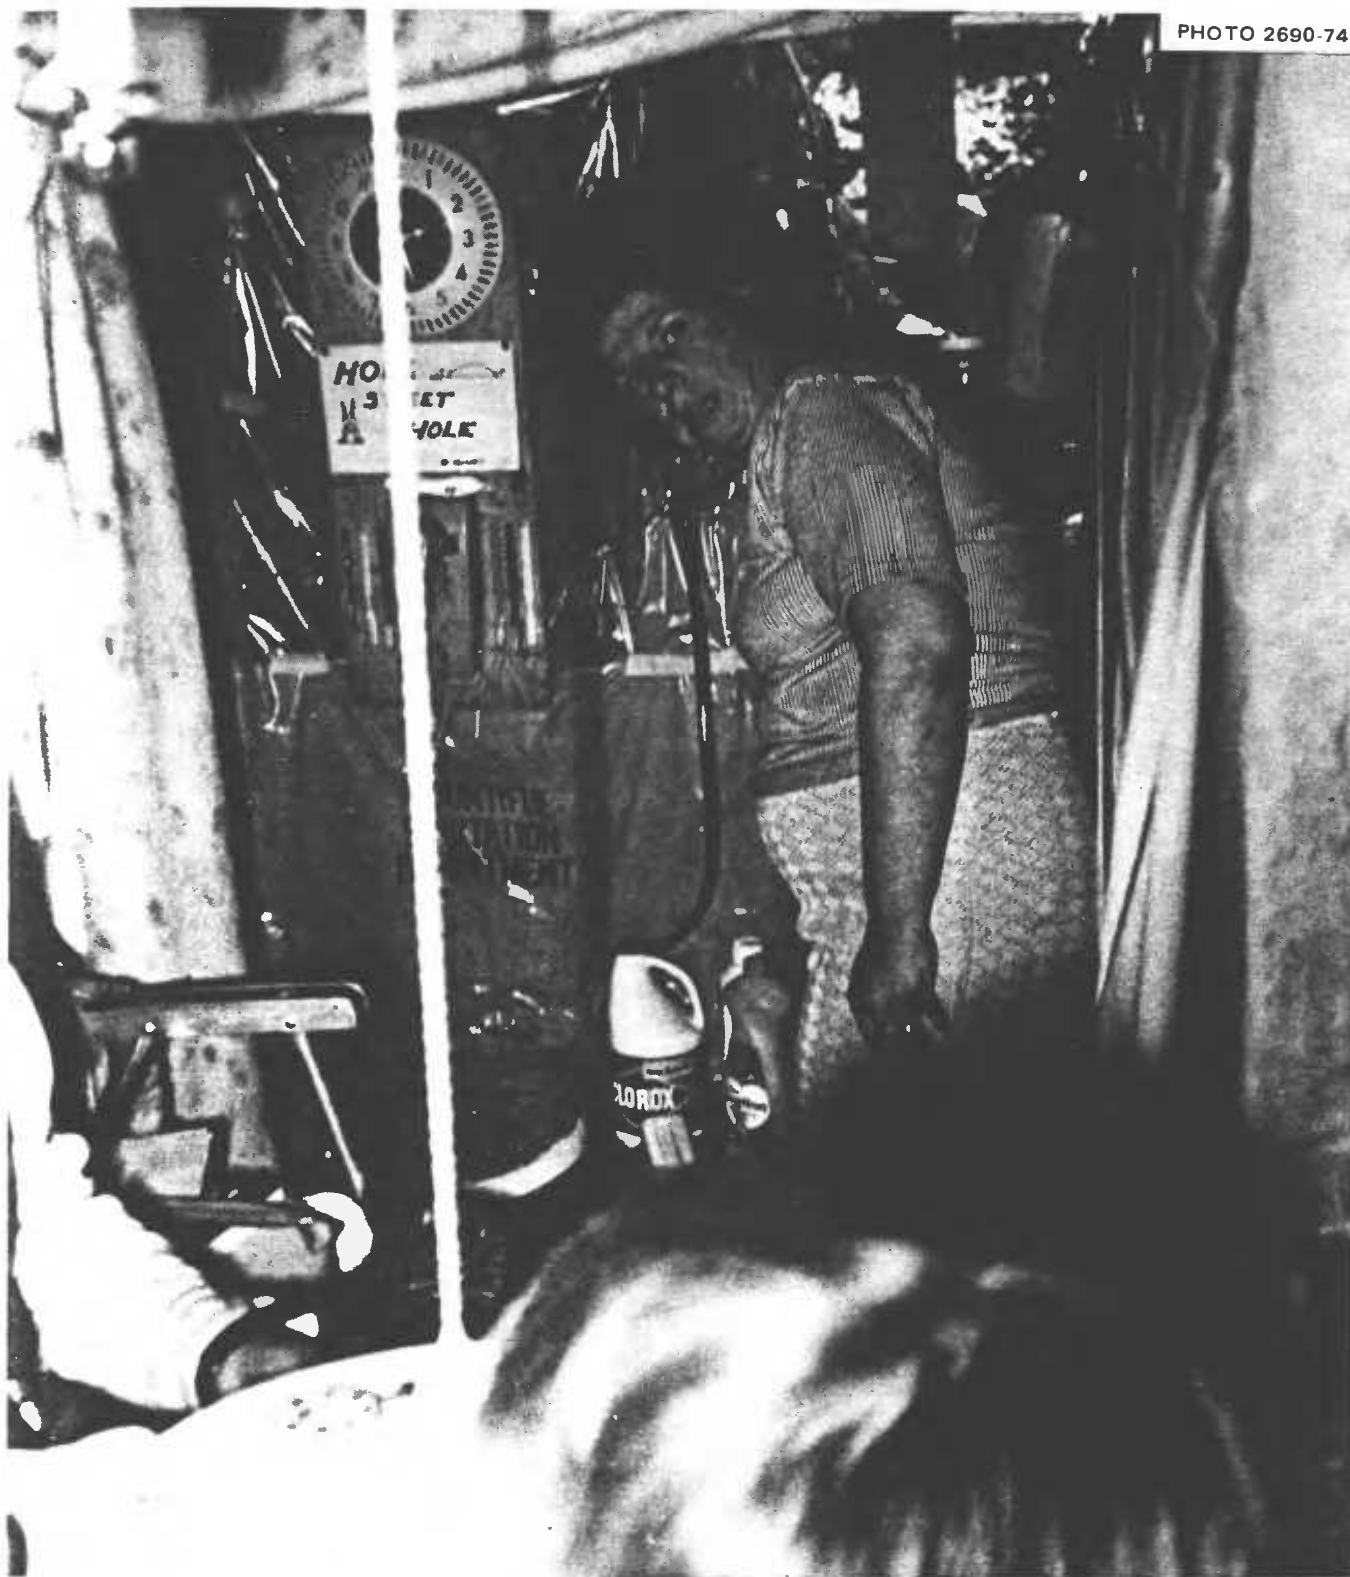
Fig. 4.23. The mother standing in the 18-in.-deep stand-up hole next to the toilet. Note the air-duct-emergency exit, shown above the mother's shoulders, with a piece of toilet paper hanging from its roof to indicate air movement.

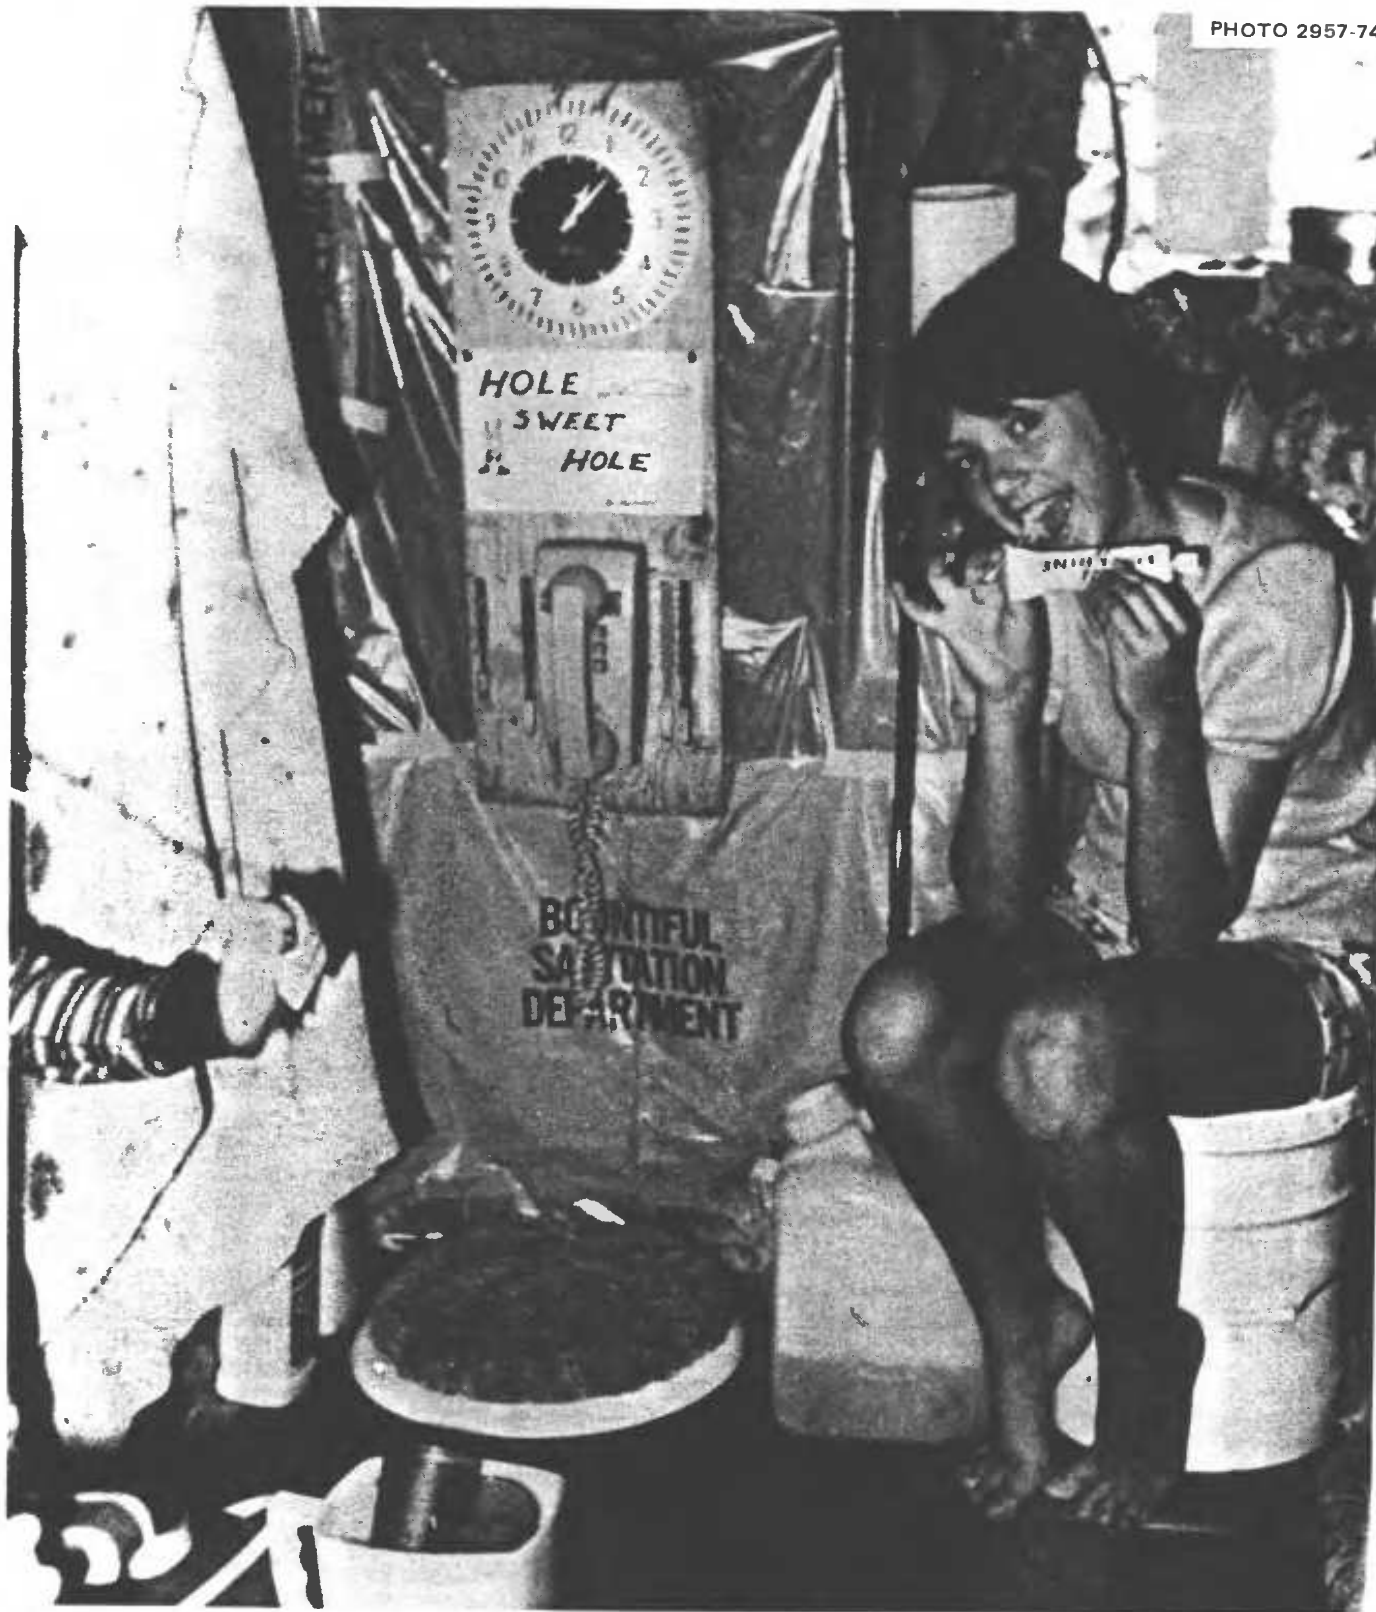
**Fig. 4.24.** The 13-year-old daughter brushing her teeth while sitting on a water container placed on the plywood threshold board. The stand-up hole, pictured just below the girl's toes on the edge of the threshold board, was also used by this family when taking their daily sponge bath.

The electric clock was powered by a flashlight battery. The telephone was brought along as a playful gag, to make nontechnical visitors think this family had all the conveniences of home in their 42-in.-wide shelter.
