ORNL-5039  
UC-41-Health and Safety

EXPEDIENT SHELTER CONSTRUCTION AND  
OCCUPANCY EXPERIMENTS

Cresson H. Kearny

MARCH 1976

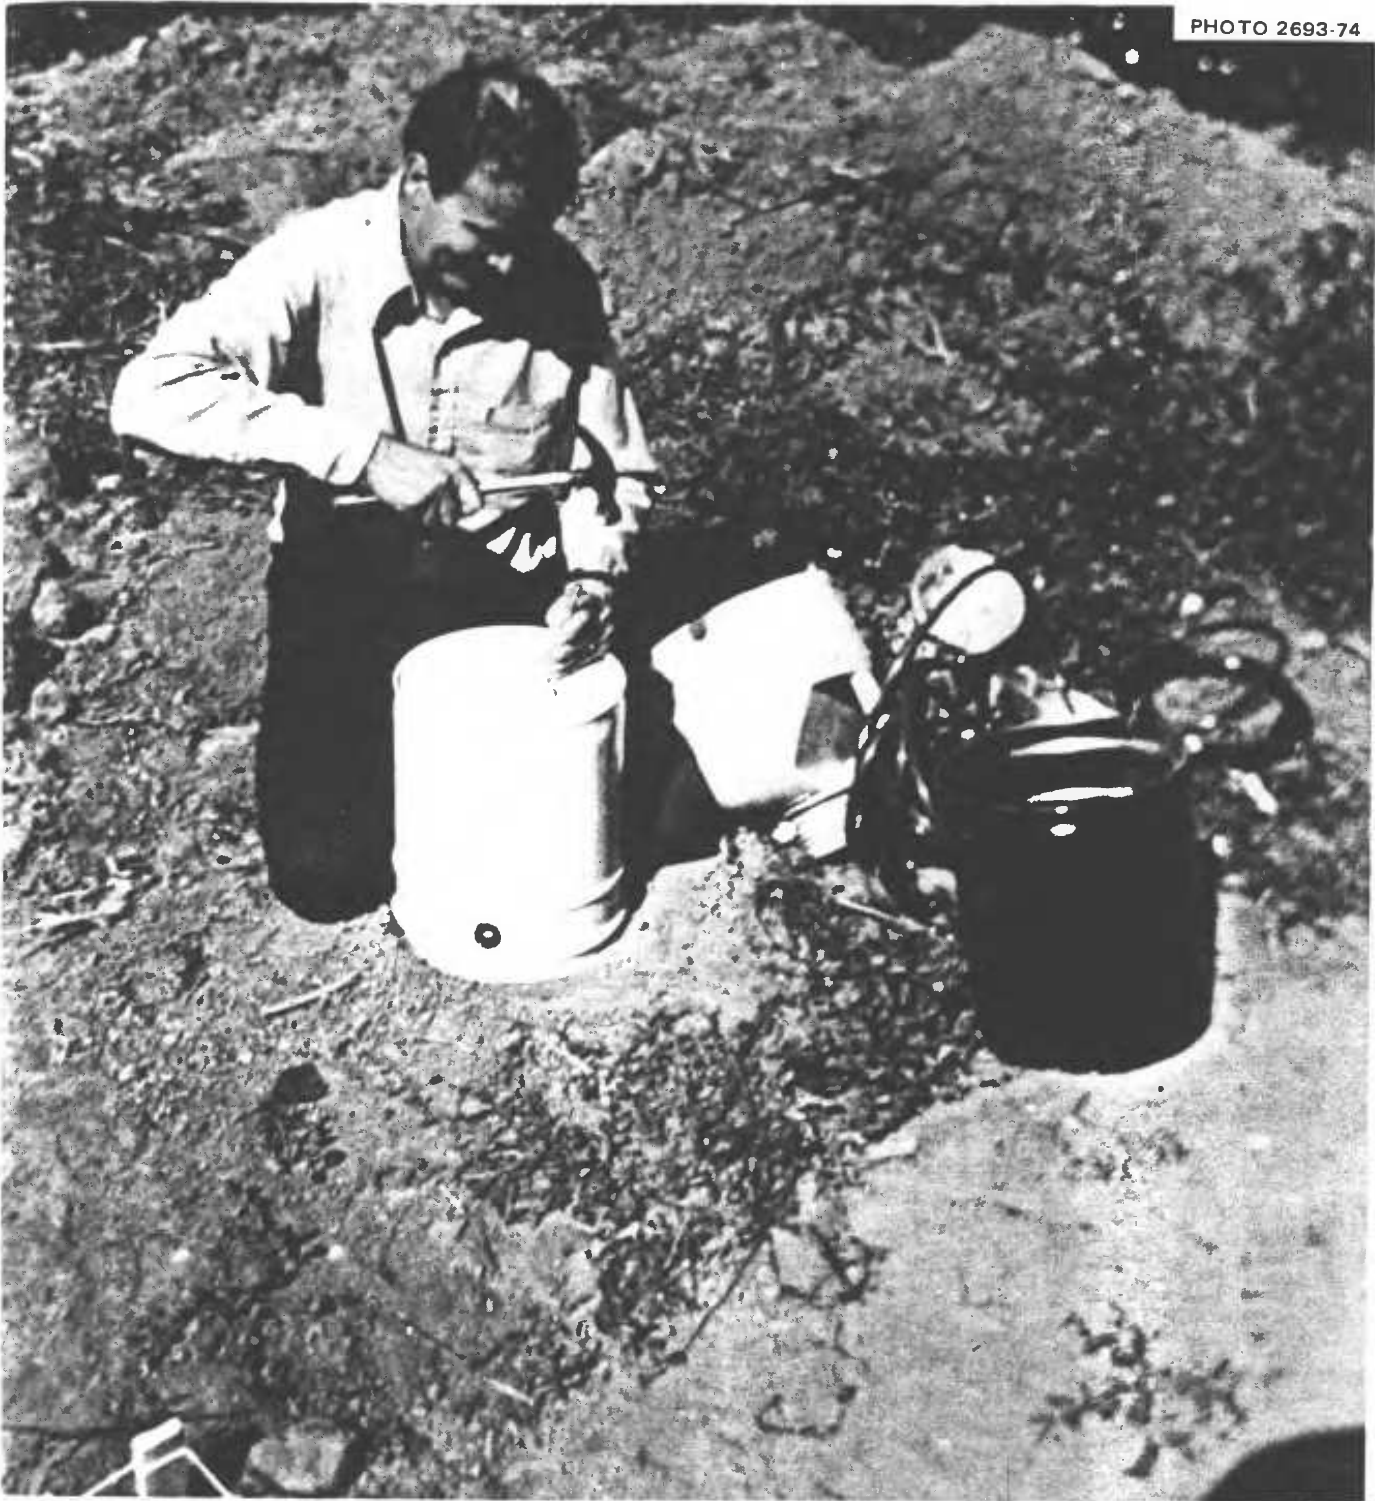
**Fig. 4.25.** The father starting work, with cold chisel and hammer, on his clever design of an odorless expedient toilet. In order to determine how long it would take to build and install this toilet under field conditions, he brought from his home the two 5-gallon cans, a 5-gallon plastic water jug (shown upside down), a garden hose, a complete toilet seat, an uncut piece of plywood, a tube, some cord, and freezer tape – all the materials needed to build this toilet.

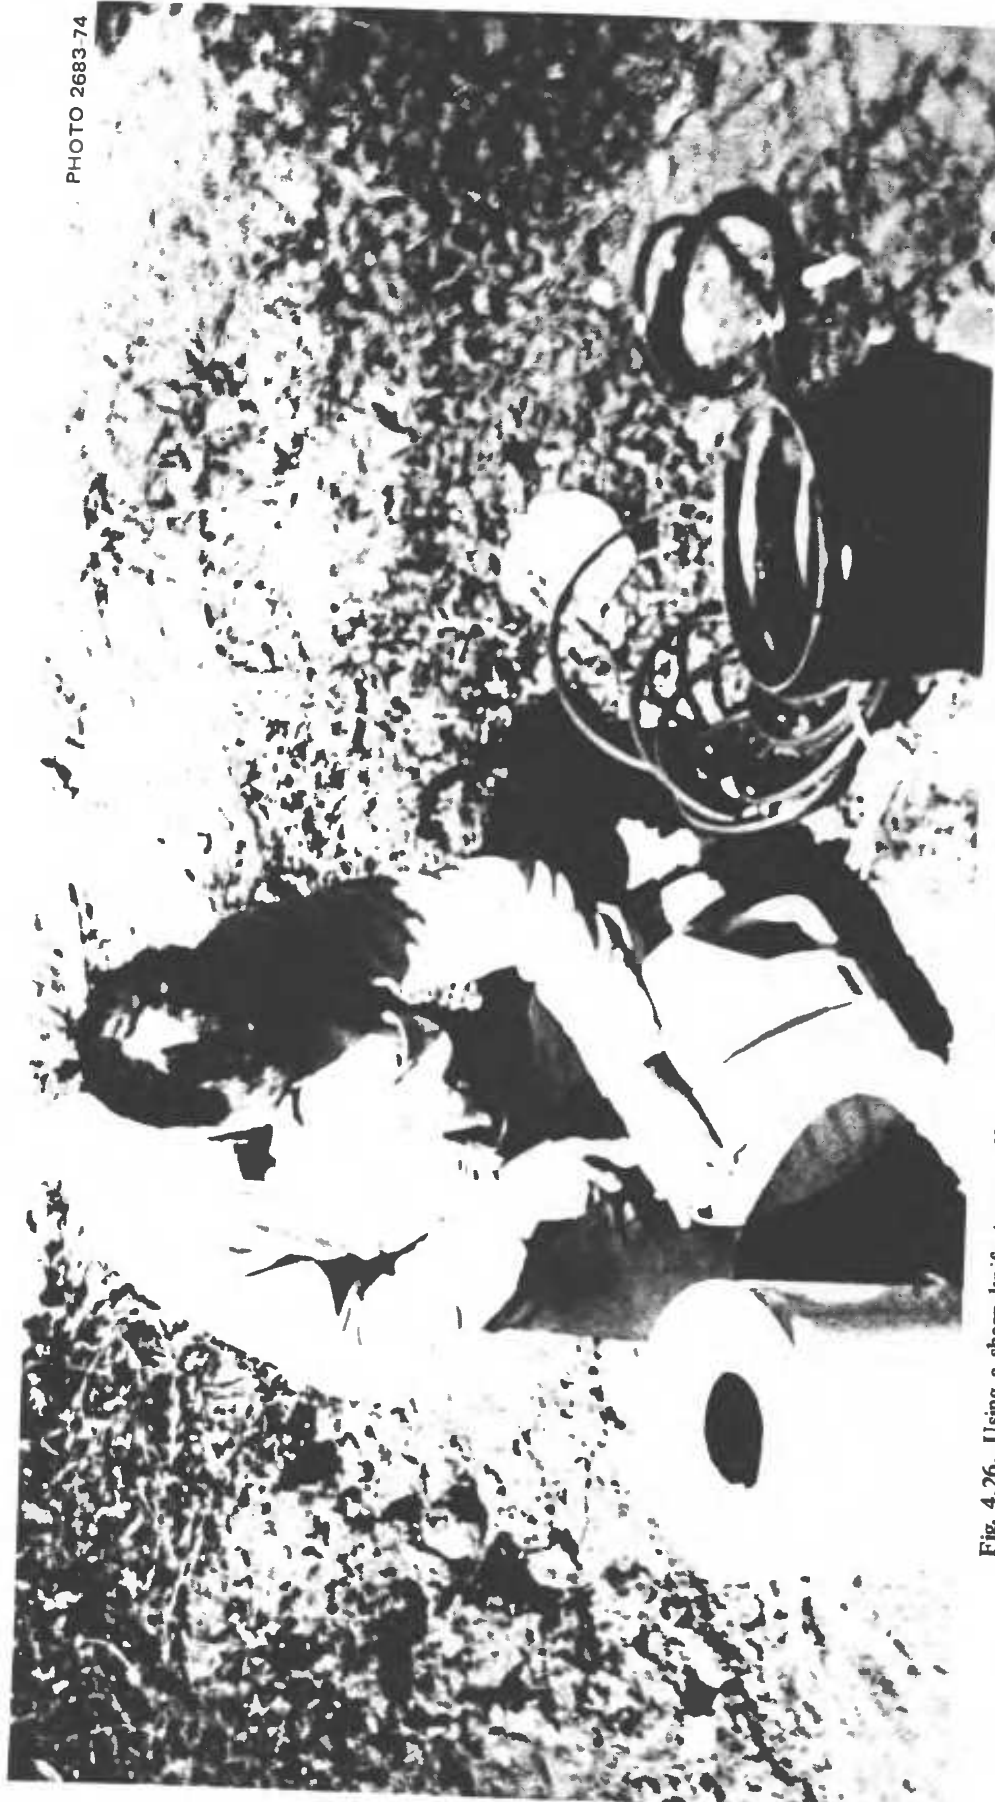
**Fig. 4.26.** Using a sharp knife to cut off the lower part of the 5-gallon plastic water jug, in order to make the bowl of the toilet. The bottom of the 5-gallon can shown on the right was cut out so that when this can was used to form the bottom of the 10-gallon vented space provided for the wastes, the liquid fraction could run into permeable earth or sand below.

Although this is an excellent expedient toilet, Kearny believes that most builders of expedient shelters should use simpler, less time-consuming means for disposing of human wastes.

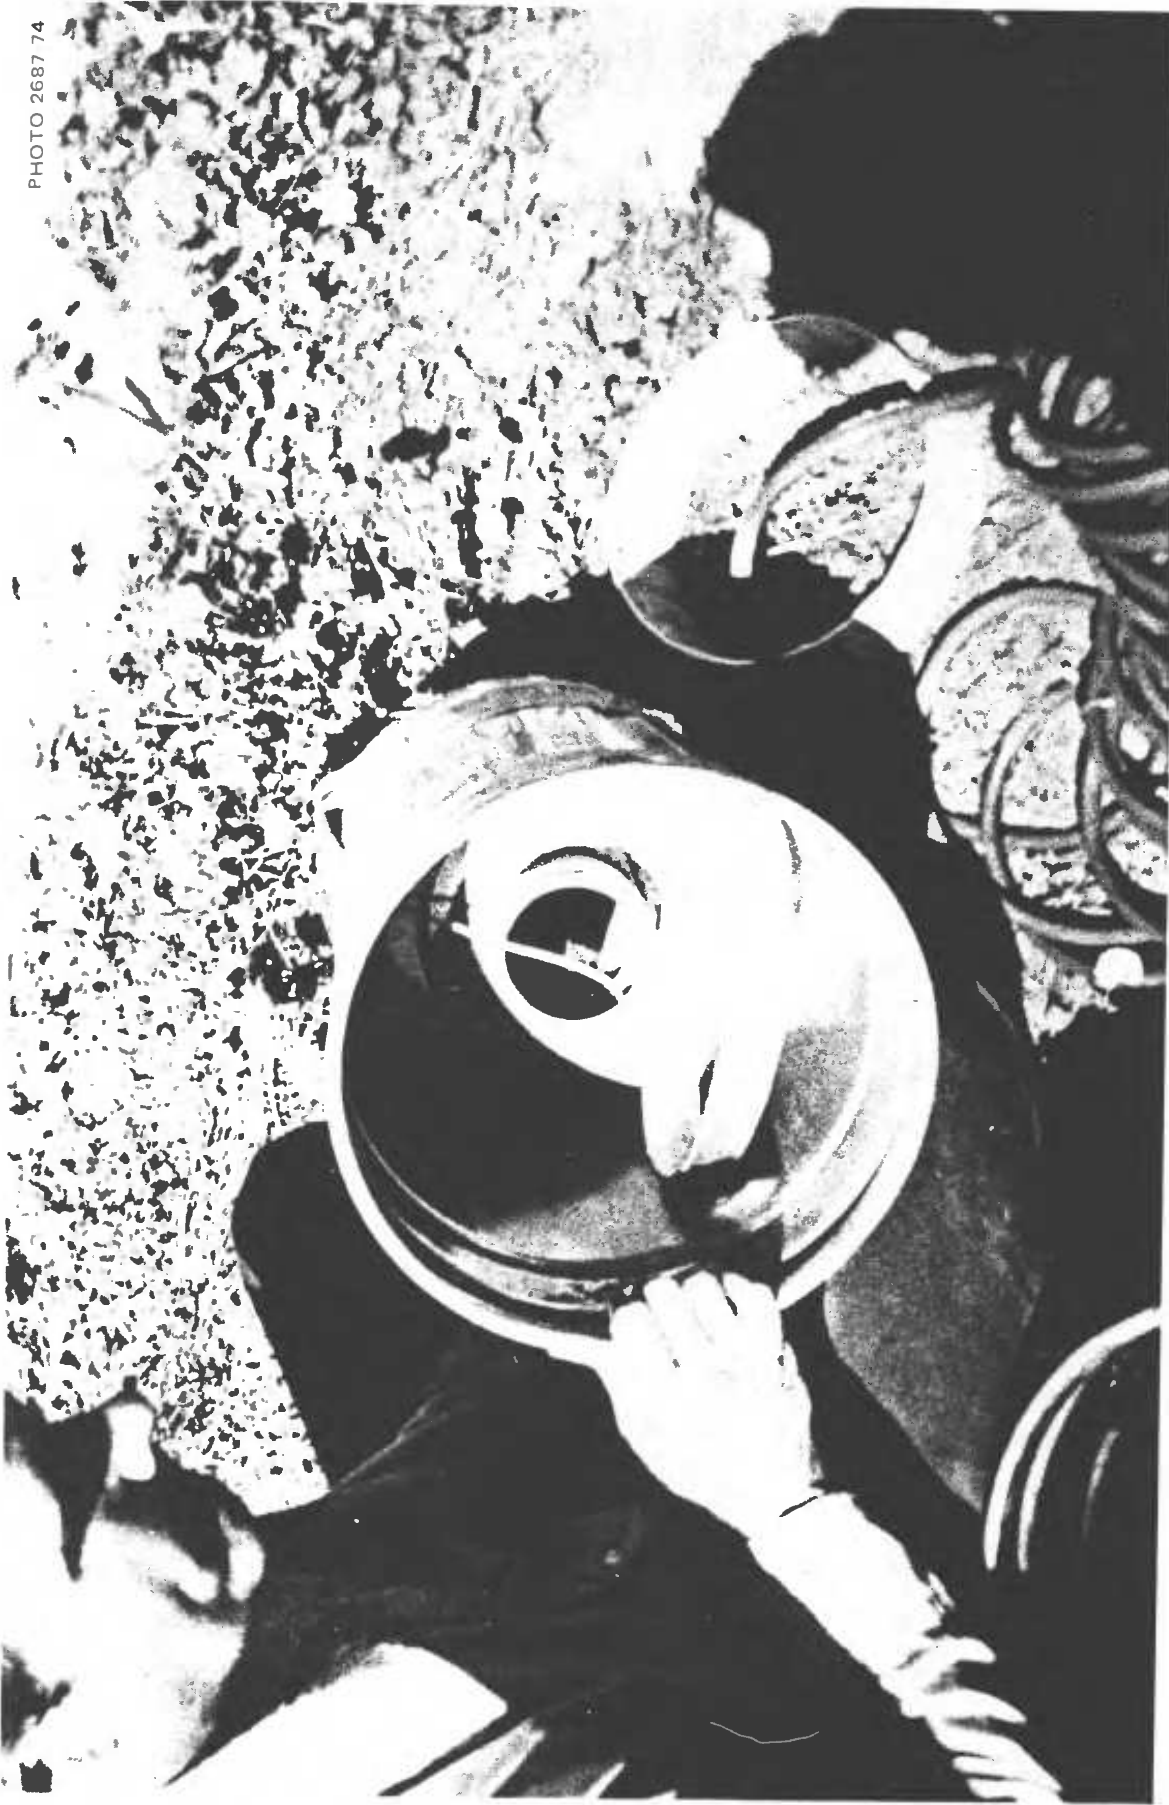
Fig. 4-27. View looking into what was to become the uppermost 5-gallon can of the 10-gallon vented space. The toilet bowl is on the ground, below this can and attached to it. The mouth of the shortened, plastic water-jug bowl is shown extending through the hole cut into the bottom of this can. Freezer tape had been used to seal the cracks between these parts.

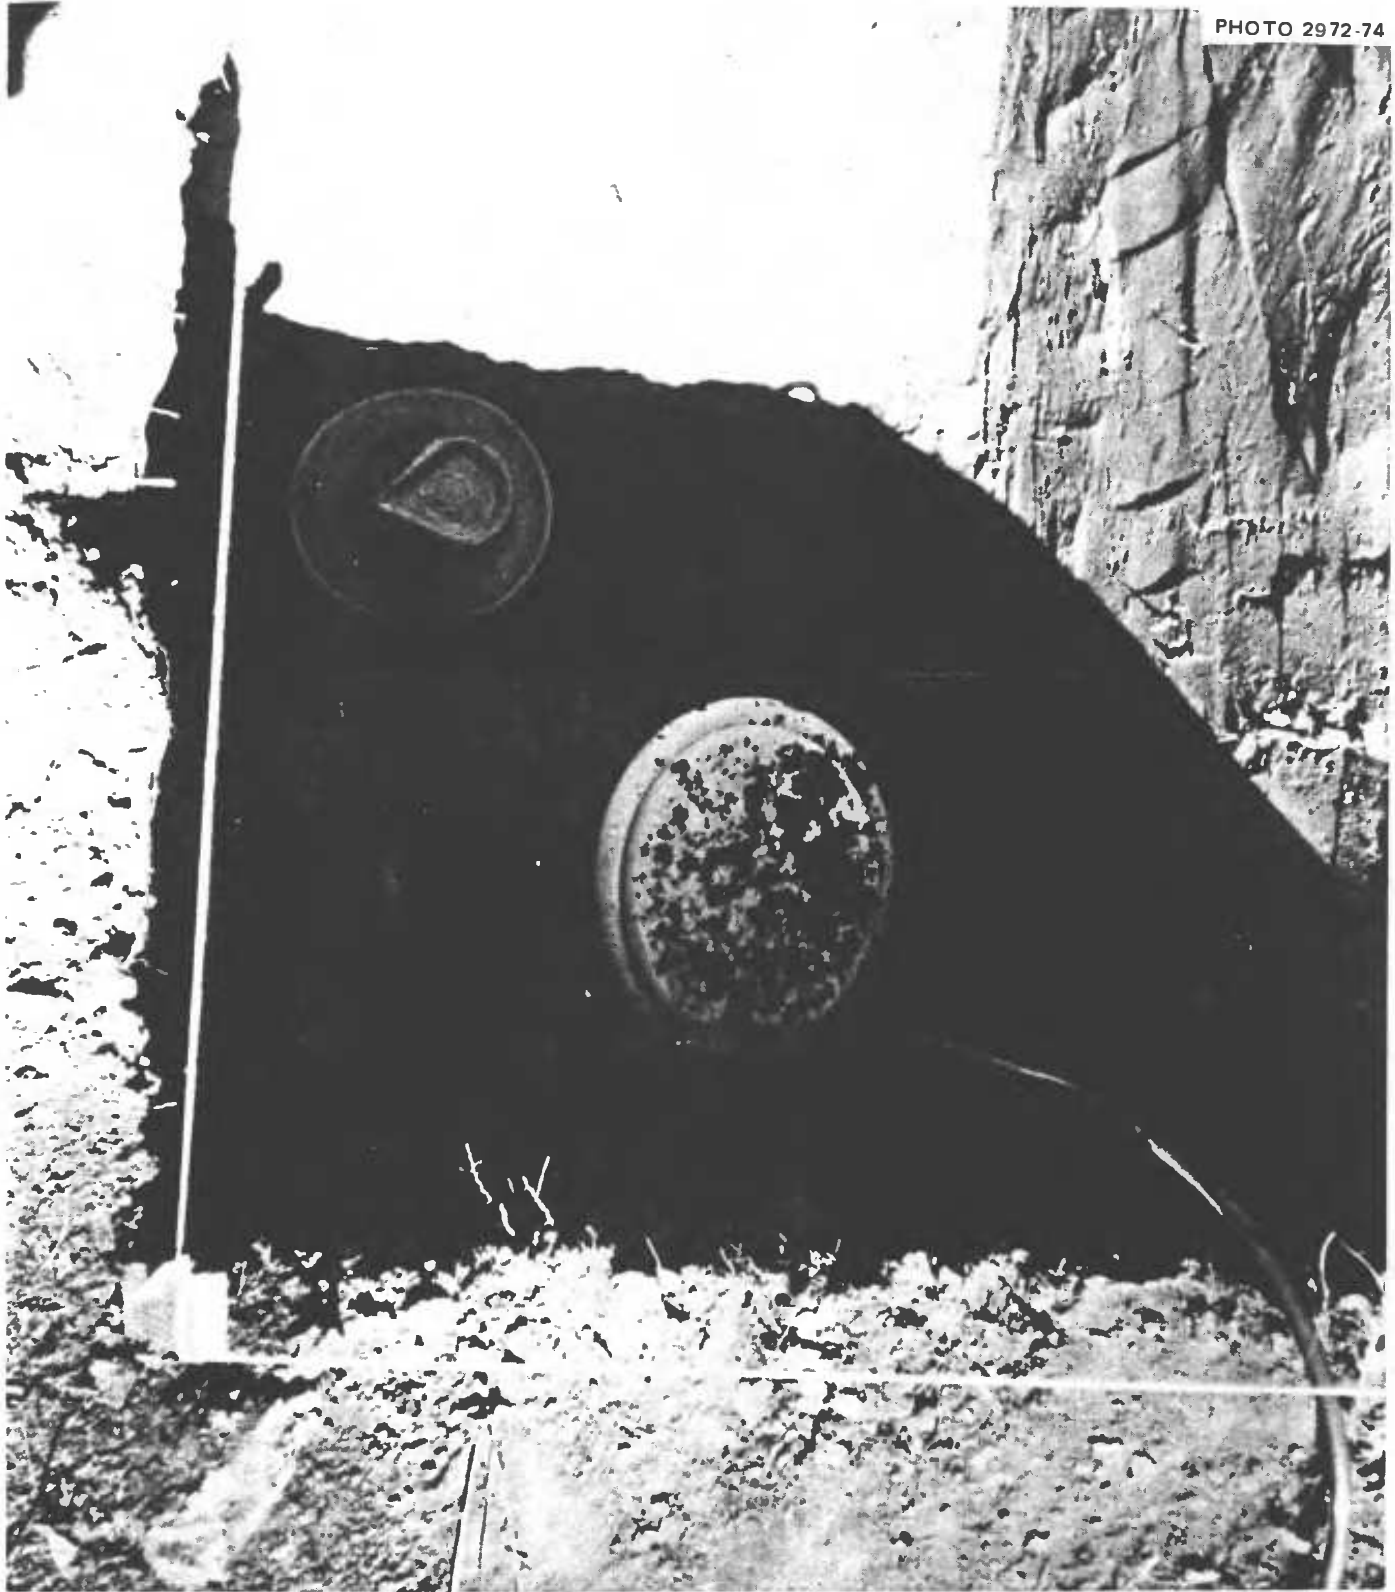
Fig. 4.29. View looking straight down on the installed toilet and its seat. The two assembled 5-gallon cans and the toilet bowl had been placed in a hole dug in the bottom of the shelter. A piece of  $\frac{1}{2}$ -in. plywood, in length equal to the 42-in. width of the shelter room and about 20 in. wide, served as the horizontal surface to which the toilet seat was attached. An appropriately sized, roughly elliptical hole had been cut in this plywood with a brace and bit and a cold chisel. The plywood base of the toilet was at floor level. Note the vent hose.

The 42-in.-wide threshold board is seen on the far edge of the stand-up hole. This and other threshold boards were installed on the edges of earth steps, and prevented the earth edges from being broken off, even after having been used for days.

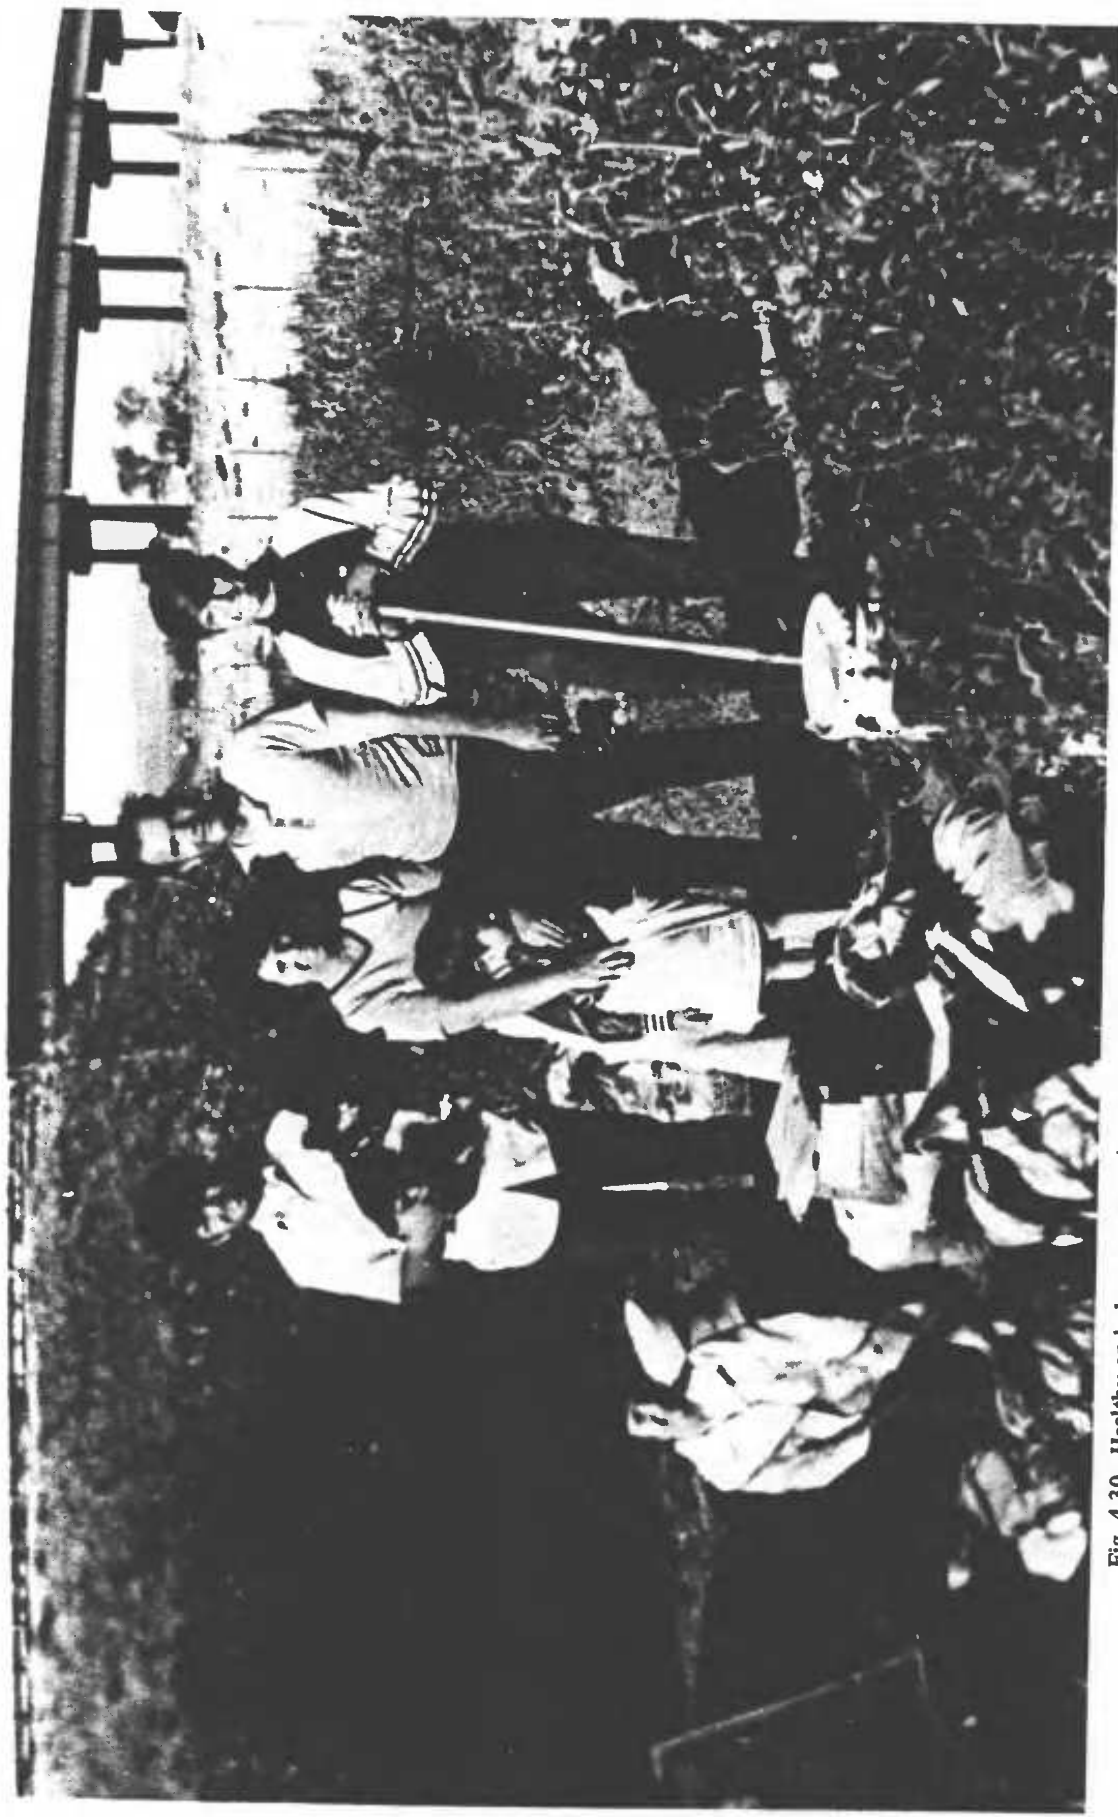
PHOTO 2969 74

**Fig. 4.30. Healthy and clean, on emerging at sunup after the fourth night of continuous shelter occupancy. The only member of this family that suffered during this test was the family dog, who, remarkably, held in everything for the 77 hours of shelter occupancy.**

One of the two metal-framed window screens (that this family had carried from their home) is pictured on the left. These screens had been placed over the entrance hole and served well. Only a few of the many mosquitoes outside got into the shelter. The garbage bags, shown in the foreground, contained empty cans, waste paper, and other refuse accumulated during the shelter occupancy. These bags had been thrown outside from day to day. Behind the family are the...

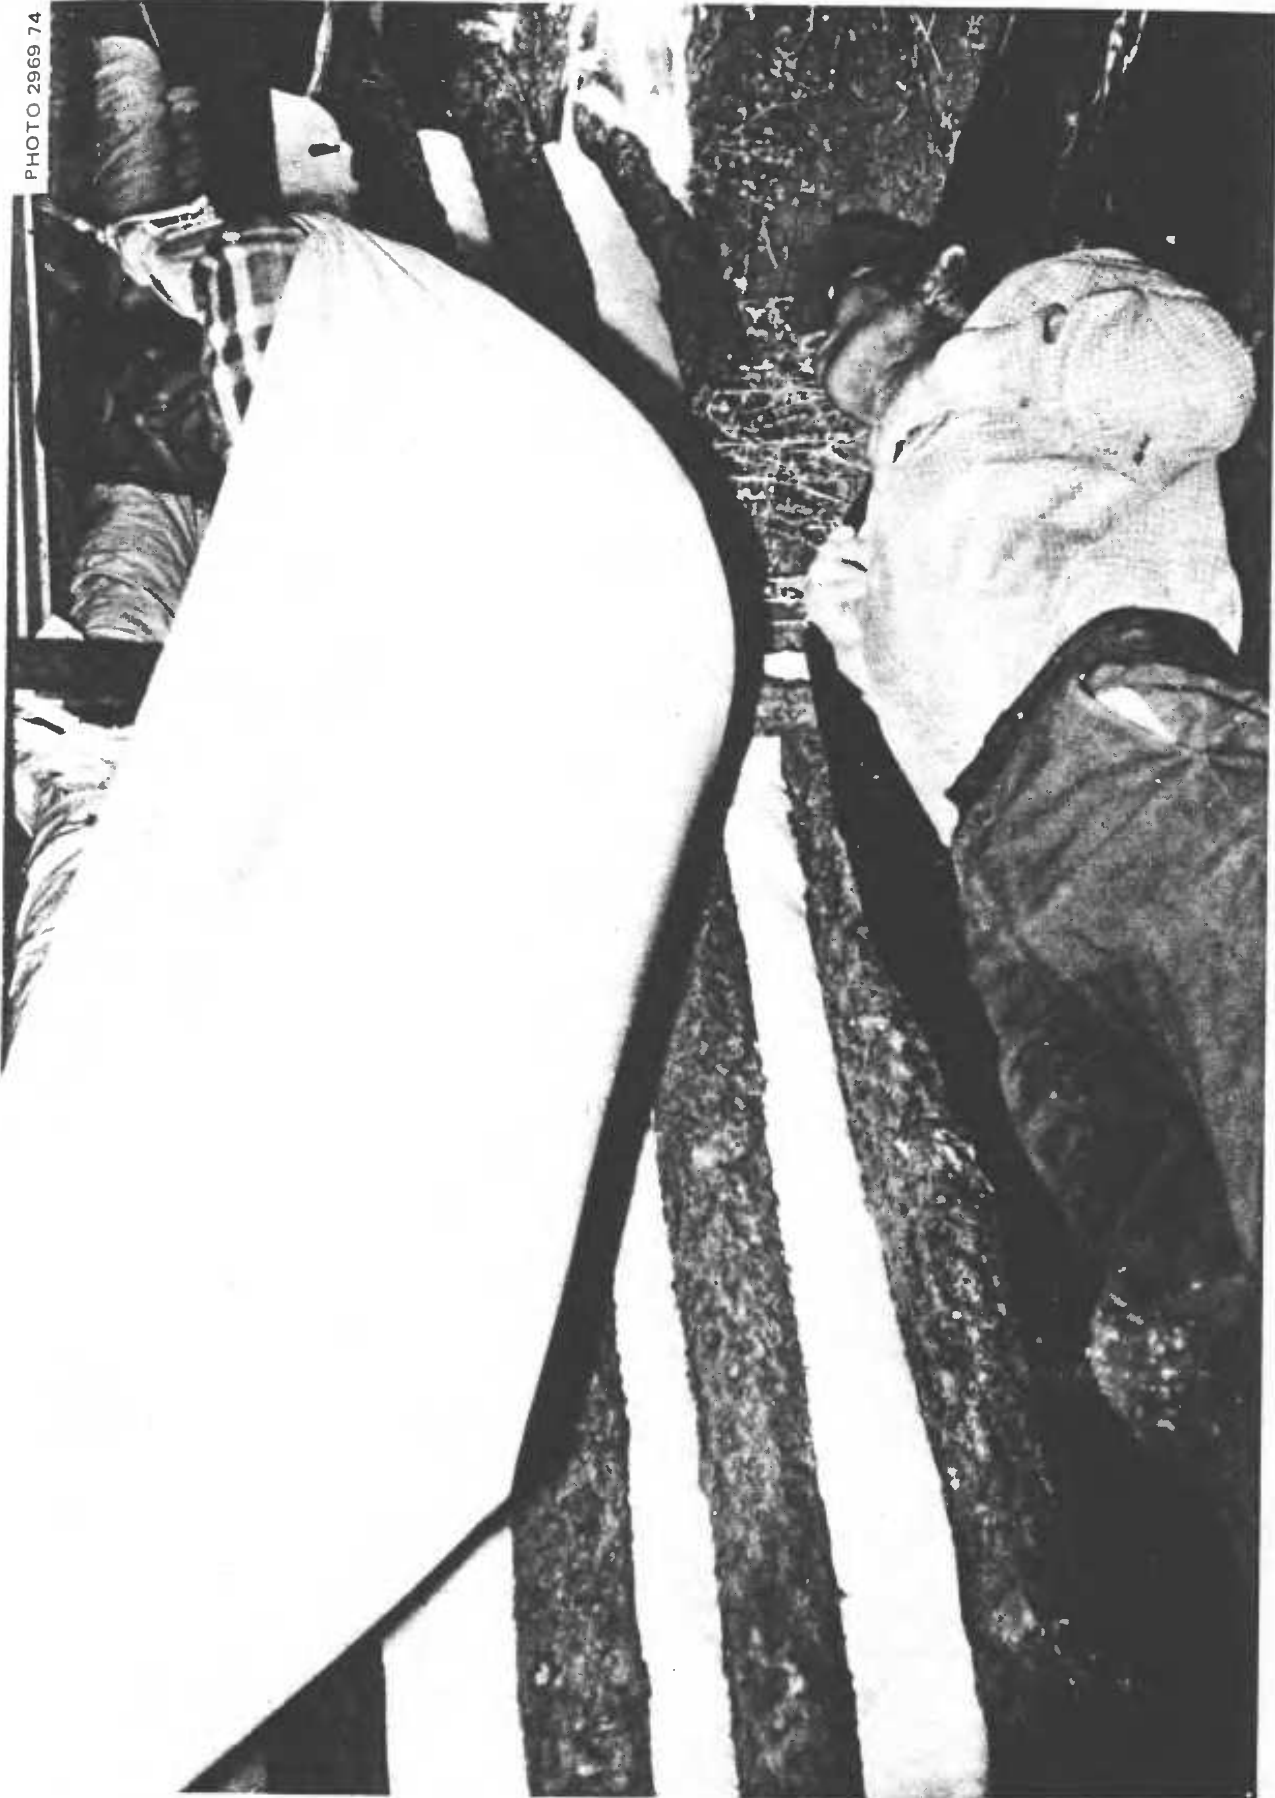
Fig. 4.31. Using an expedient Bedsheet-Hammock, to enable two persons to sleep over the same floor space. Otherwise, only one person could sleep in this space in an Above-Ground Crib-Walled Shelter. The ceiling was only 40 in. above the floor.

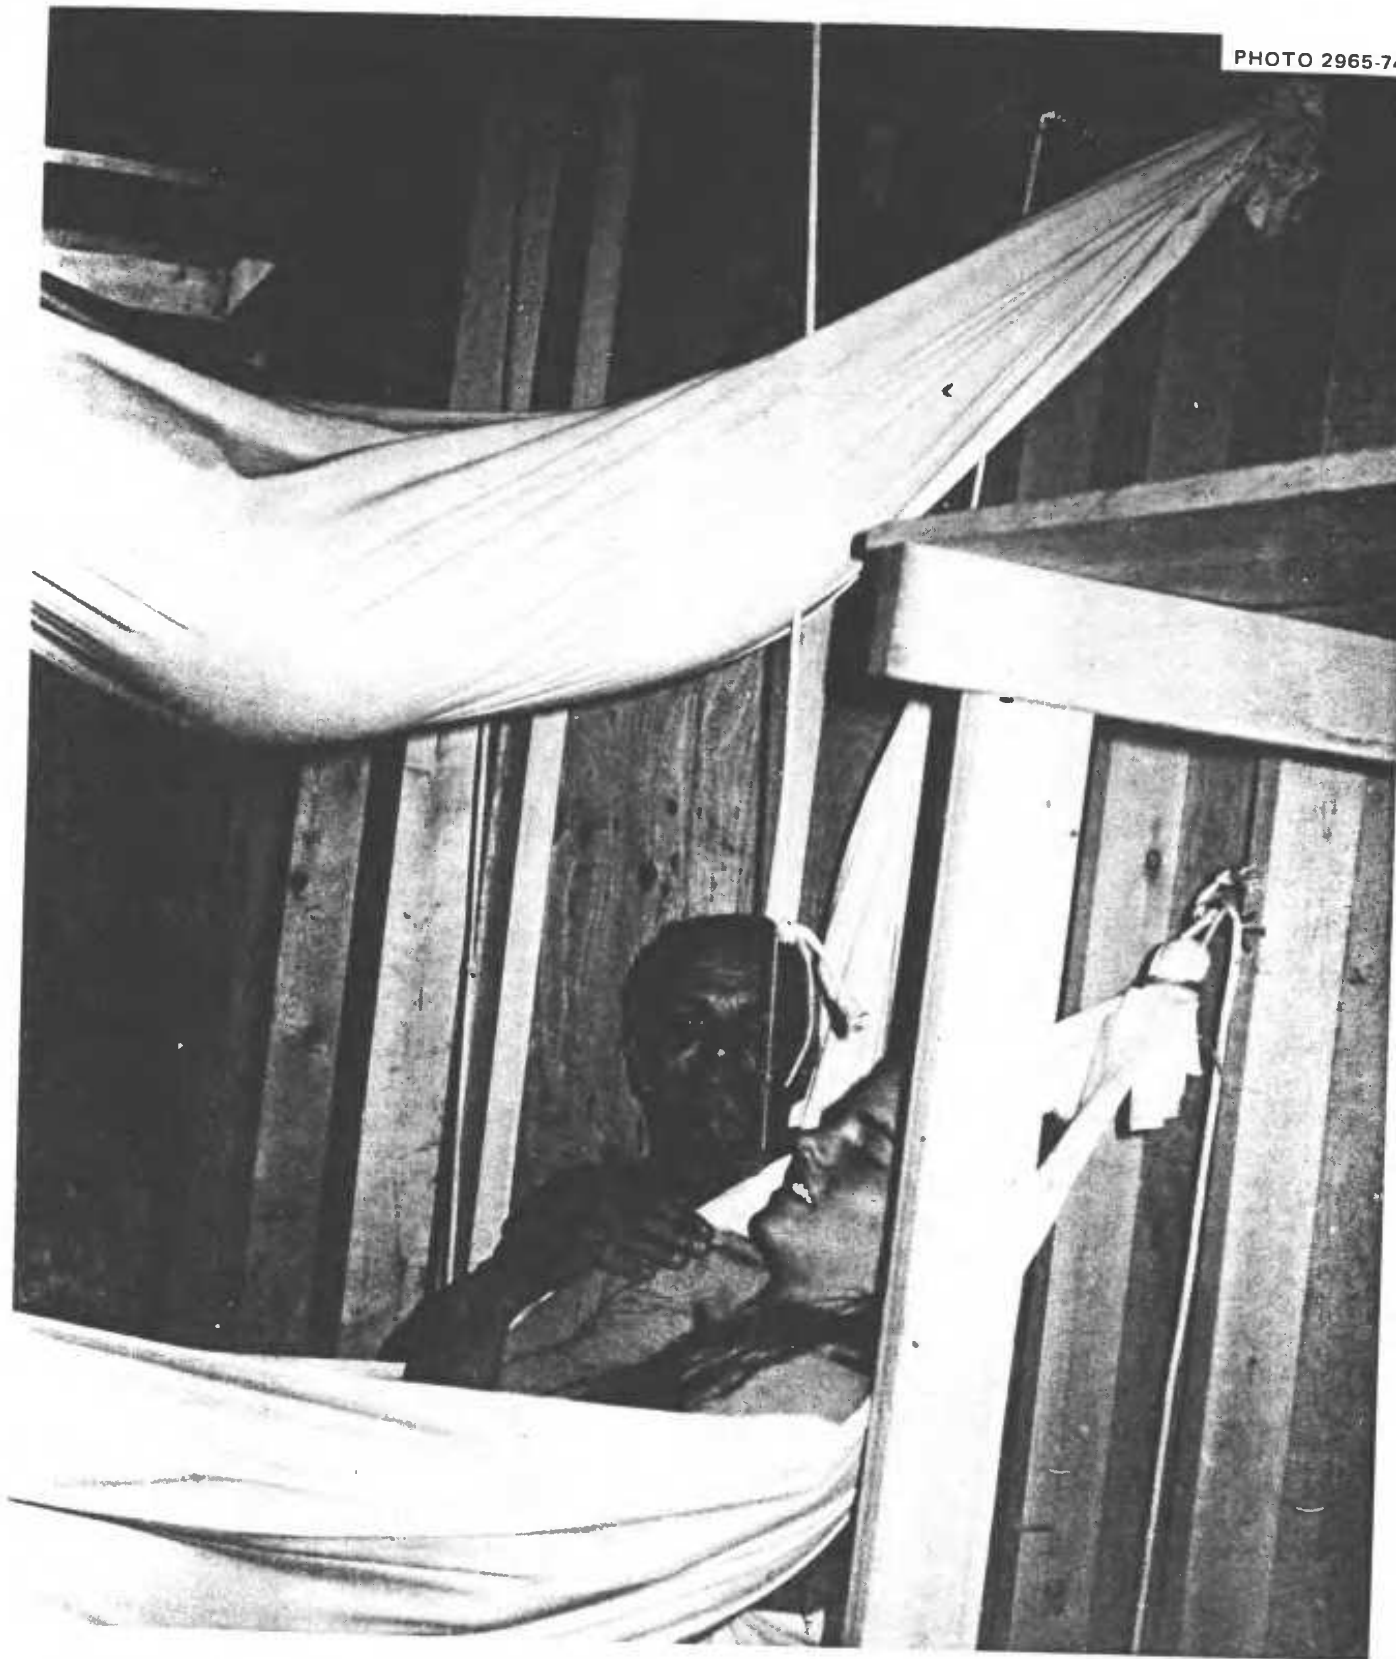
**Fig. 4.32. Two Bedsheet Hammocks, one above the other, slung in the entrance end of a lumber version of a Russian-type Small-Pole Shelter. On the right is seen the end of one side of the typical Russian-style benches with overhead boardbunks. The Russian sitting-sleeping system is a "hot-bunk" system that enables only one-third of the occupants to lie down at the same time.**

By using this new design of short, space-saving hammocks, all occupants can lie down and sleep at the same time — even in the austere stoop-in Log-Covered Trench Shelter. Furthermore, all occupants can sit comfortably together in suspended Bedsheet-Chairs, that they can quickly make from their Bedsheet Hammocks.

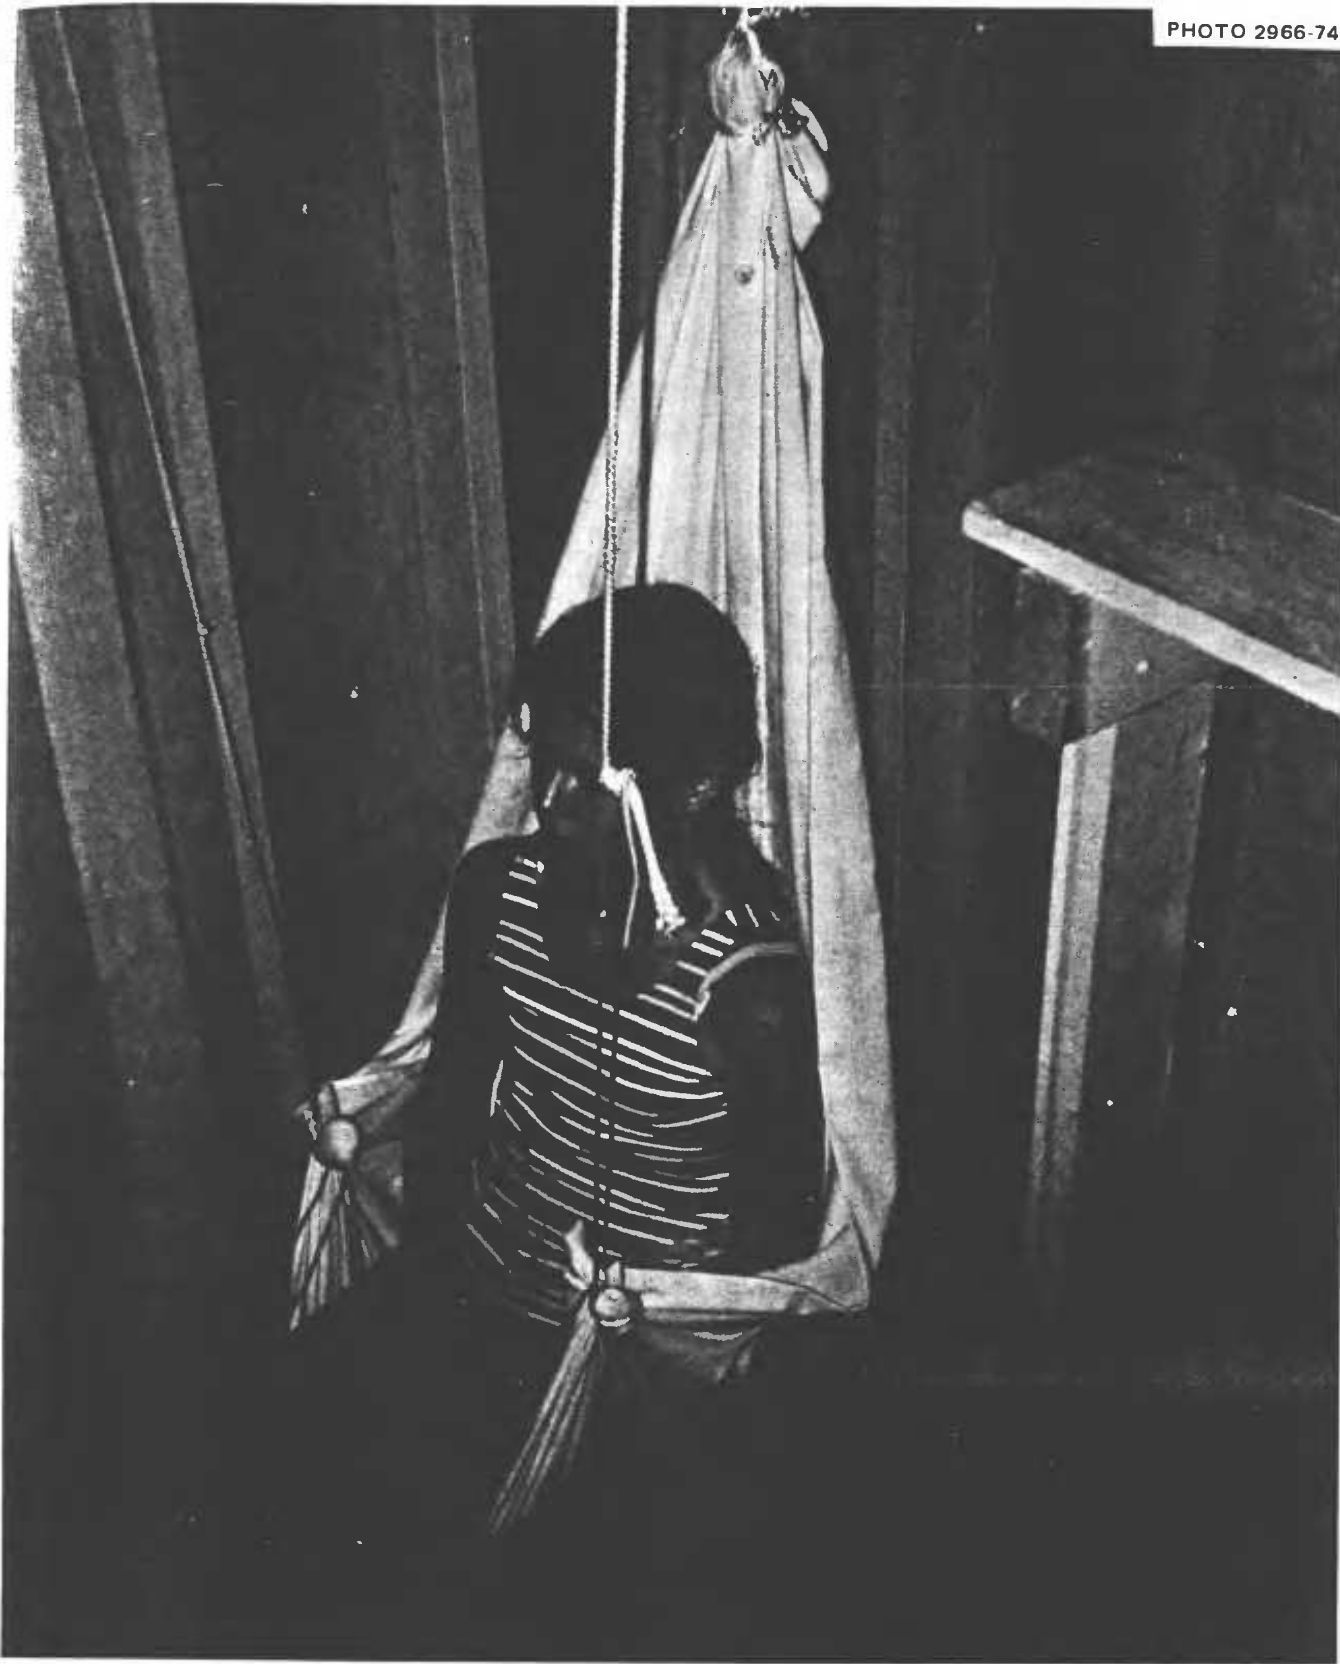
**Fig. 4.33.** Sitting comfortably in an expedient suspended Bedsheet-Chair, easily made by converting a Bedsheet-Hammock. This design was developed after the August 1974 shelter occupancy test.

Two stones, or lumps of earth, each about  $1\frac{1}{2}$  in. in diameter, are tied in the edges of a Bedsheet-Hammock, so that two cords (or strips of sheet serving as cords) can be securely connected as supports.

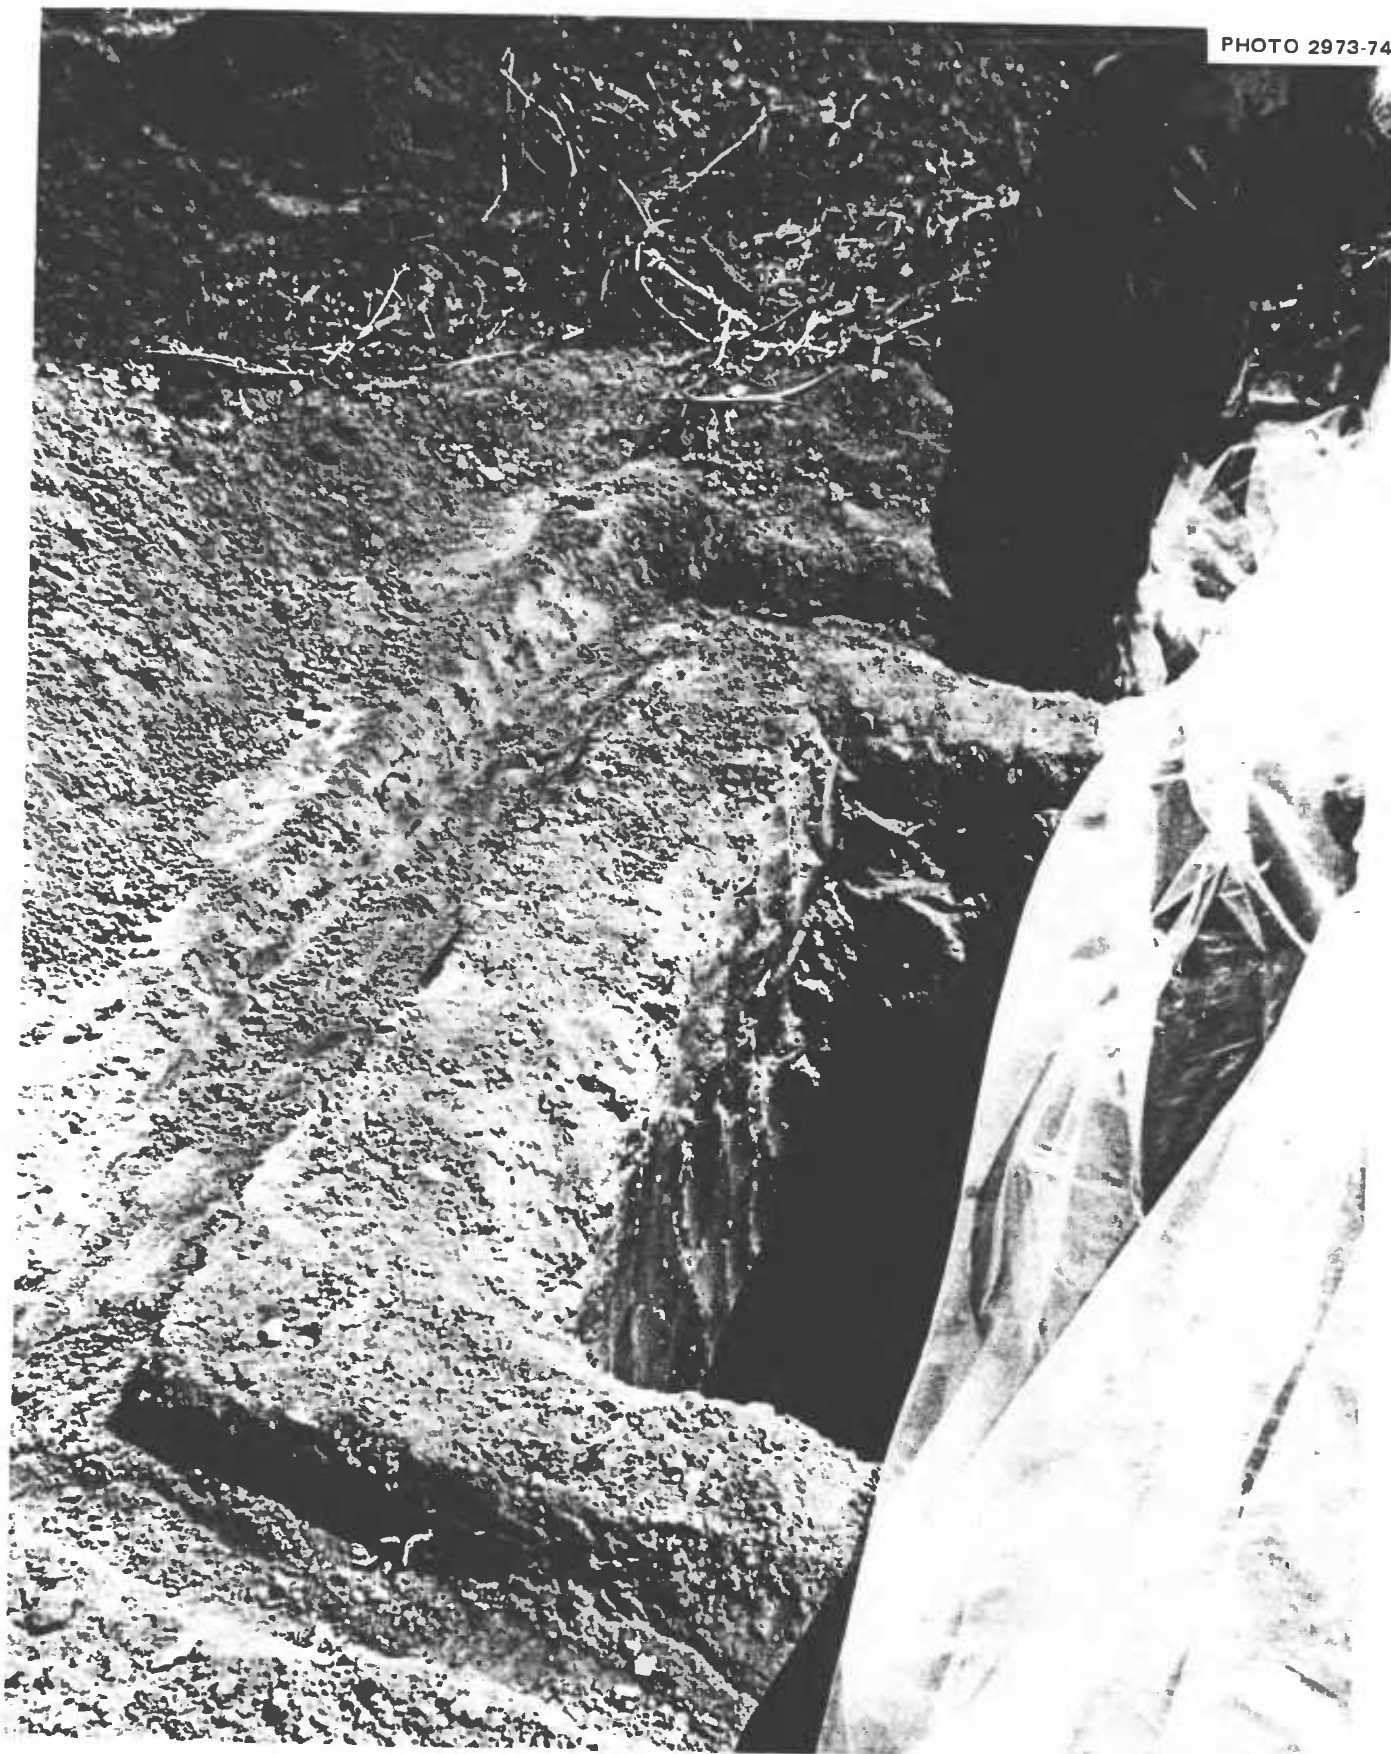
Fig. 4.34. Placing a sheet of 4-mil polyethylene in a 120-gallon water-storage pit. Unlike previous water-storage pits dug and tested by Kearny, this pit was not first lined with cloth or other material to keep sharp roots, etc., from puncturing the waterproofing plastic. All root ends were merely cut off with a knife. The edges of the plastic were folded into the small side trenches, and then held by packed earth. Six days after being filled, no leaks had developed.

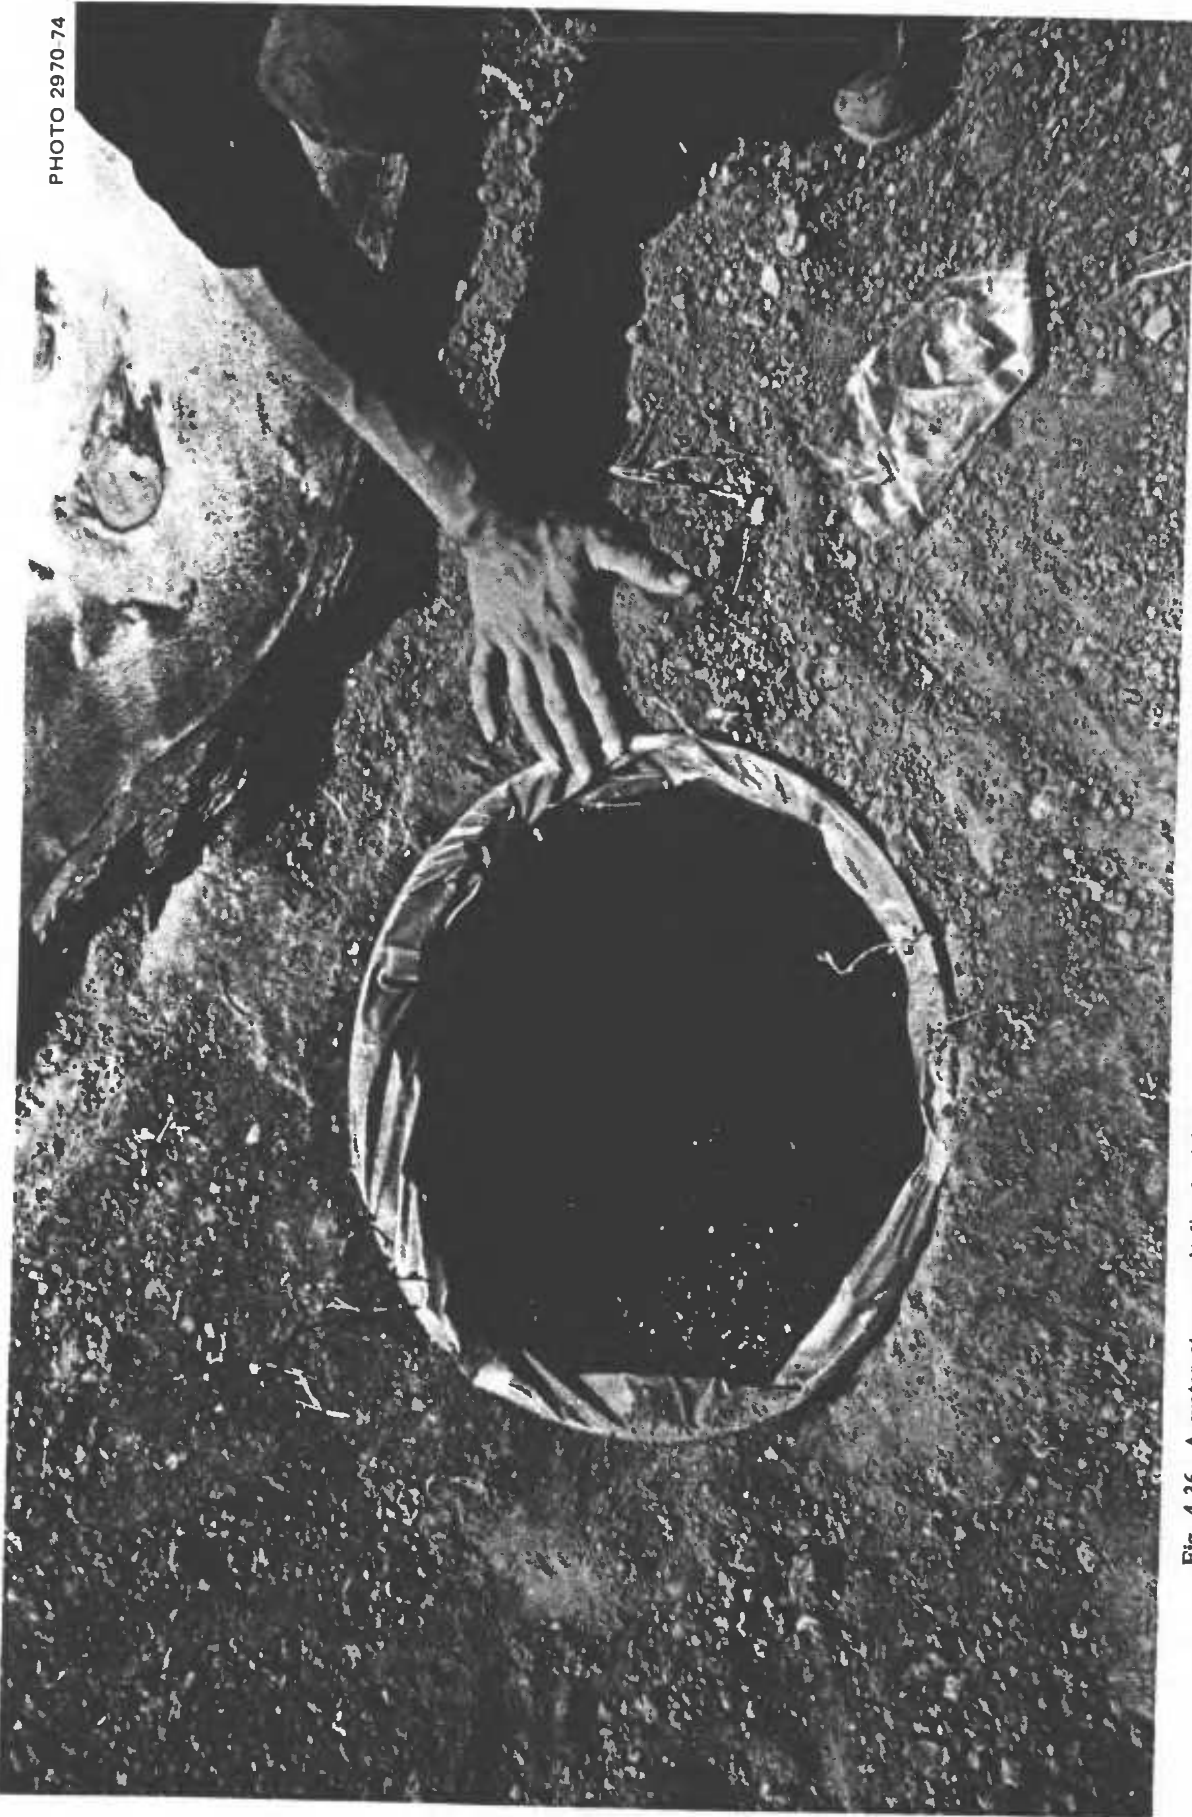
**Fig. 4.36. A water storage pit lined with plastic bags, photographed 6 days after having been filled and covered. None of the approximately 25 gallons of water in this pit had leaked through the two 30-gallon trash bags (each about 1 1/4 mils thick) placed one inside the other for a pit lining.**
