ORNL-5039  
UC-41-Health and Safety

EXPEDIENT SHELTER CONSTRUCTION AND  
OCCUPANCY EXPERIMENTS

Cresson H. Kearny

MARCH 1976

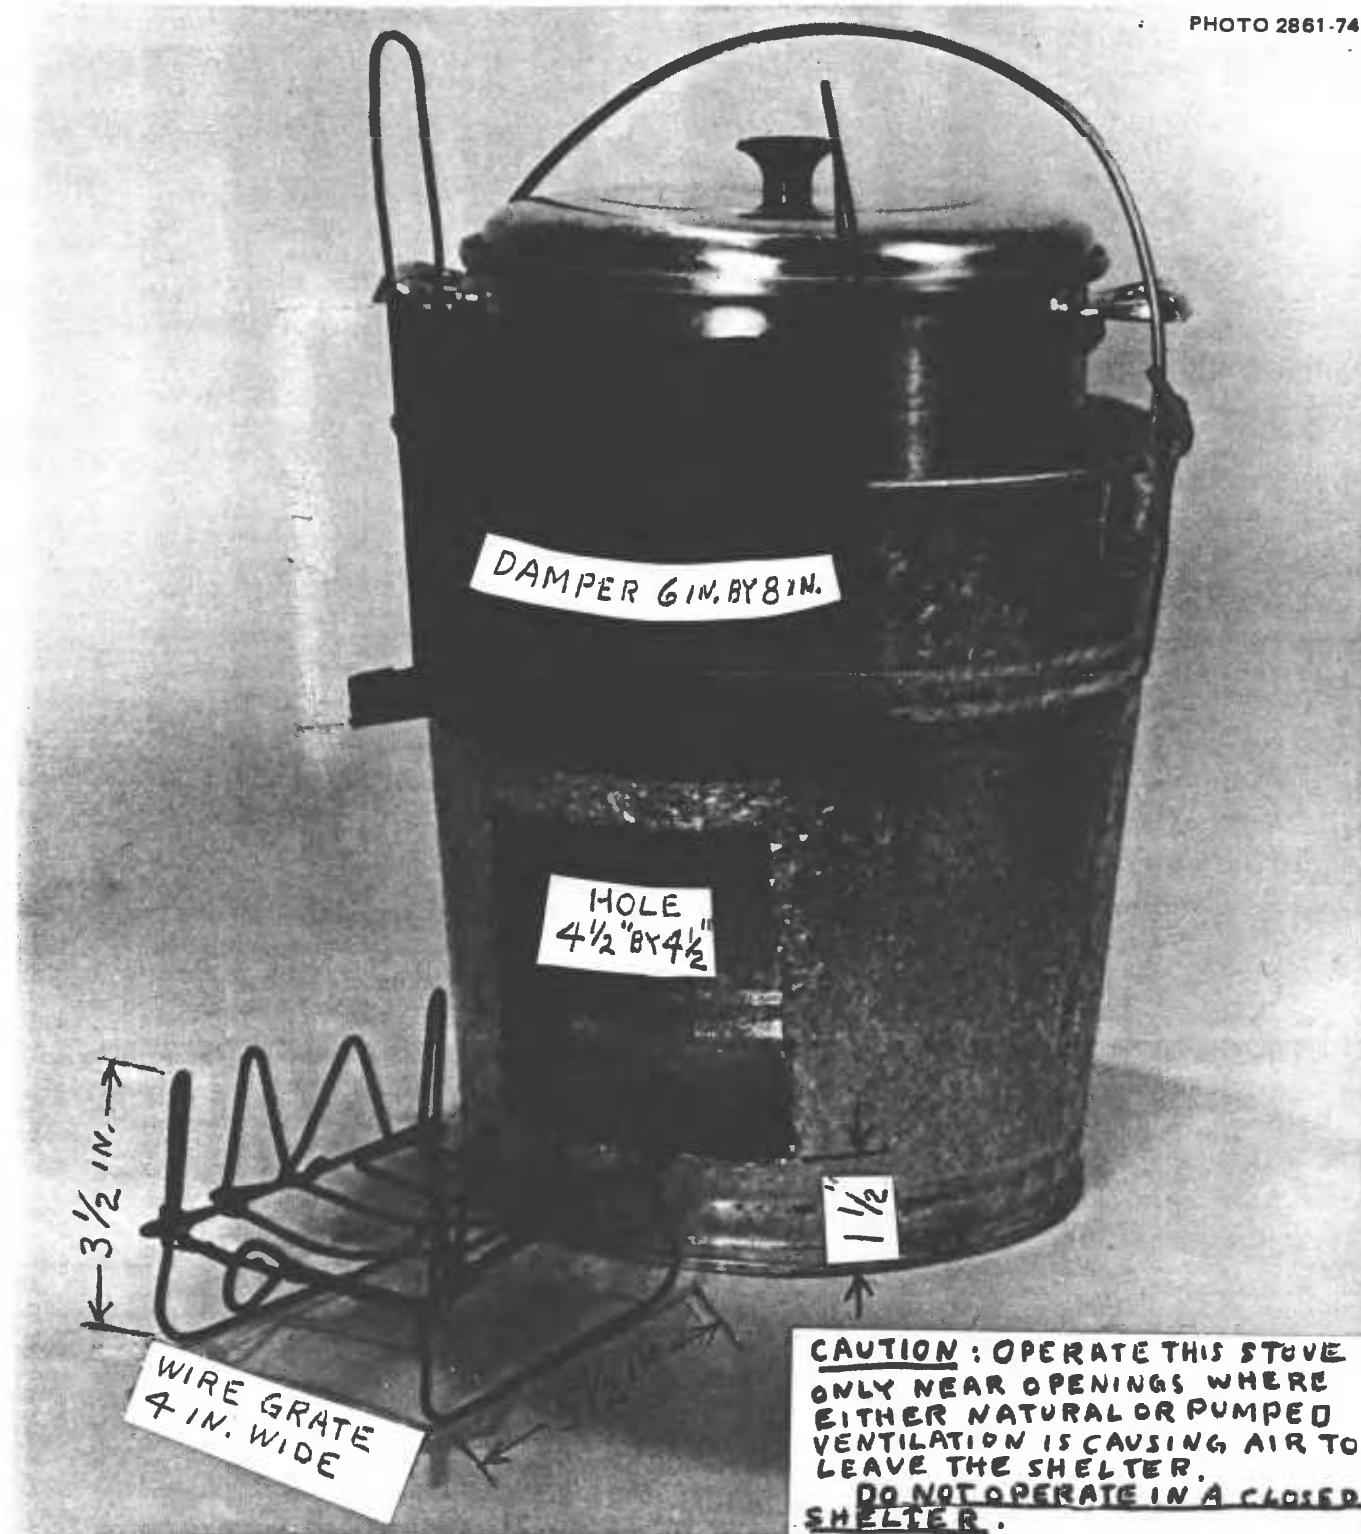
Fig. 4.37a. Expedient Bucket-Stove, made of a bucket, coat-hanger wire, about 2 ft of finer wire, and metal from an ordinary juice can. This is the most efficient expedient stove tested to date.

No chimney is required; a Bucket-Stove is used in the shelter opening that is serving as the air-exhaust outlet at that time.

When this stove is used with a covered-lid pot having a diameter about 2 in. less than the diameter of the bucket (or large can) at the height of the bottom of the pot, 3 quarts of water can be raised from 60°F to boiling by burning only about 7 ounces of dry wood or paper.

If an expedient fireless cooker is also available, then 3 quarts of soaked beans, wheat, or tough meat can be cooked by burning only about half a pound of dry wood or paper.

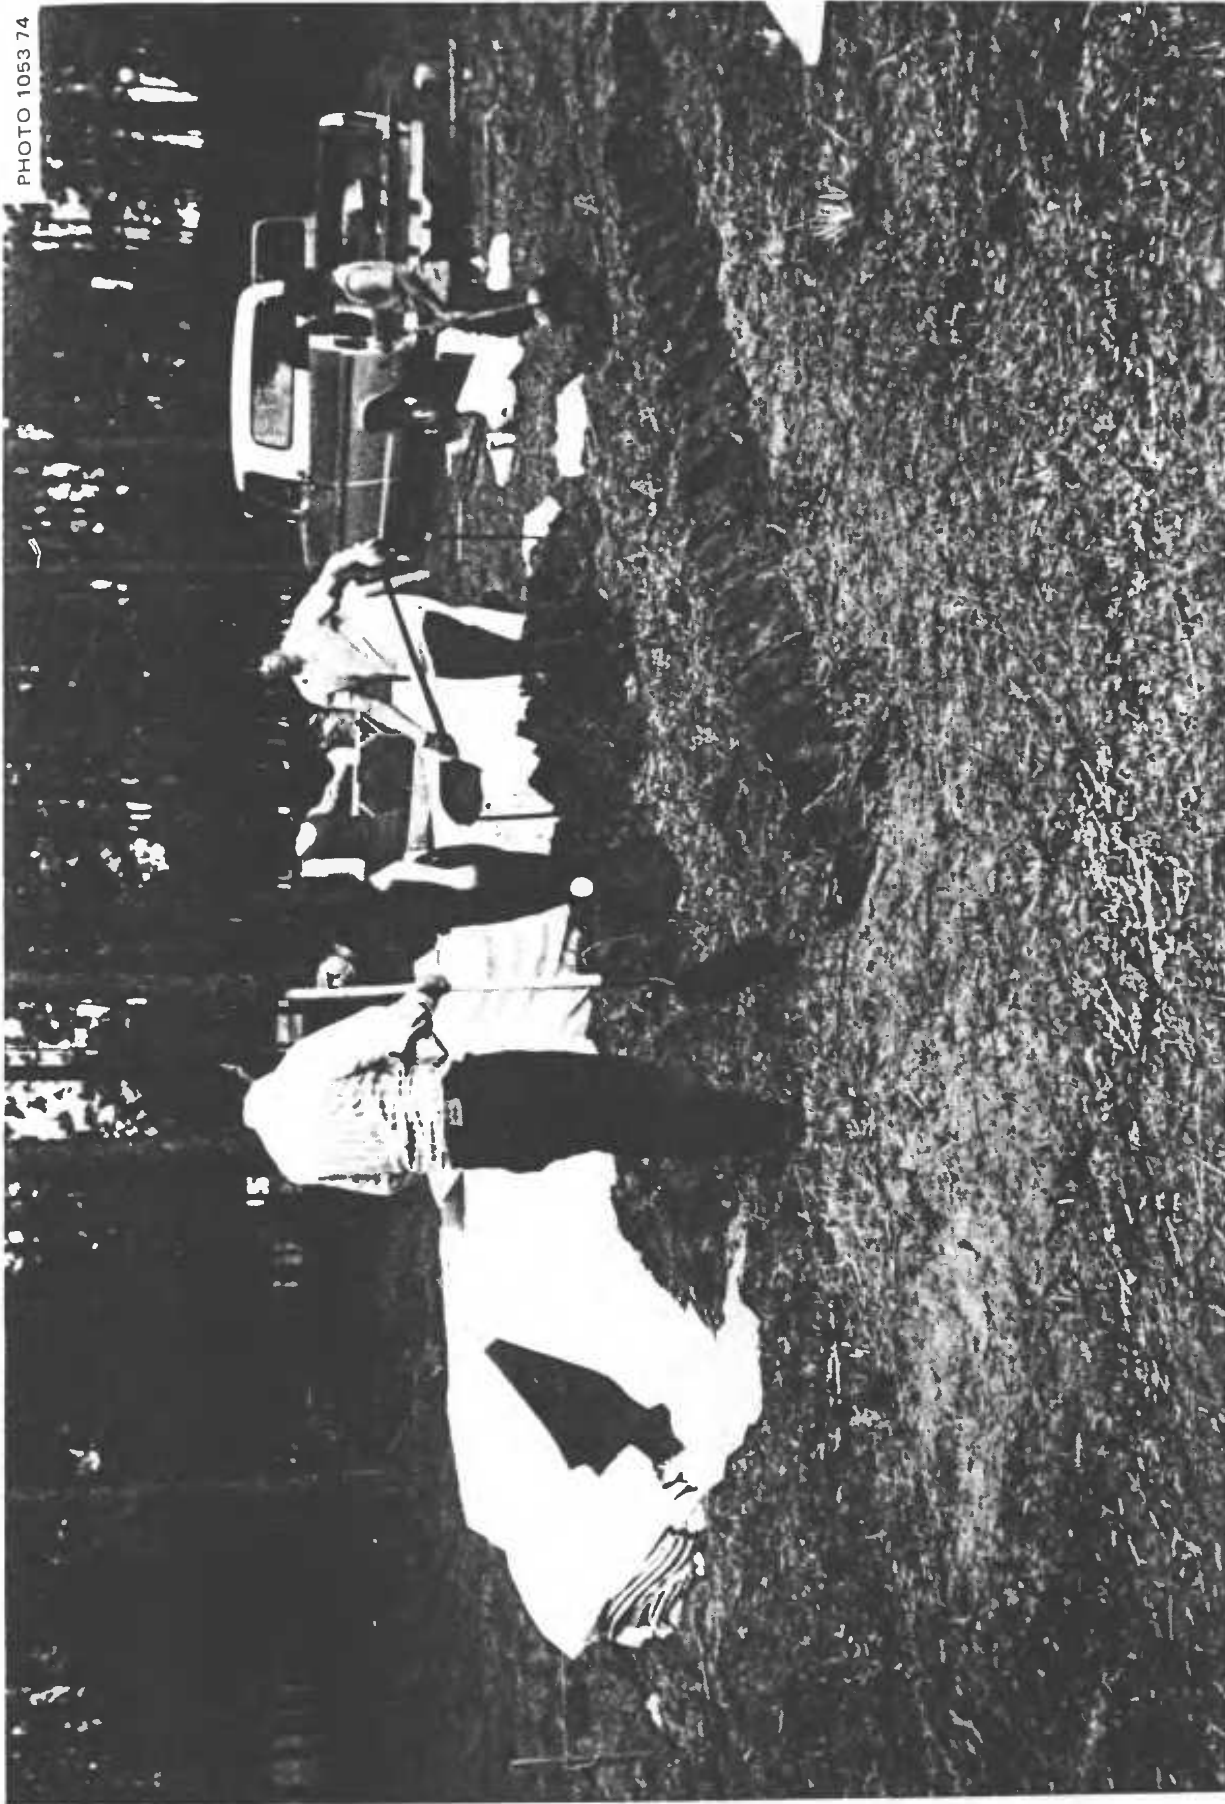
PHOTO 0931 74

Fig. 5.4. Starting to make the first roll by shoveling earth onto bed sheets that had been placed with 2 ft of their long sides on the ground, with the rest of the sheets temporarily draped over the doors used as forms. This sandy earth could be dug quite easily with shovels.

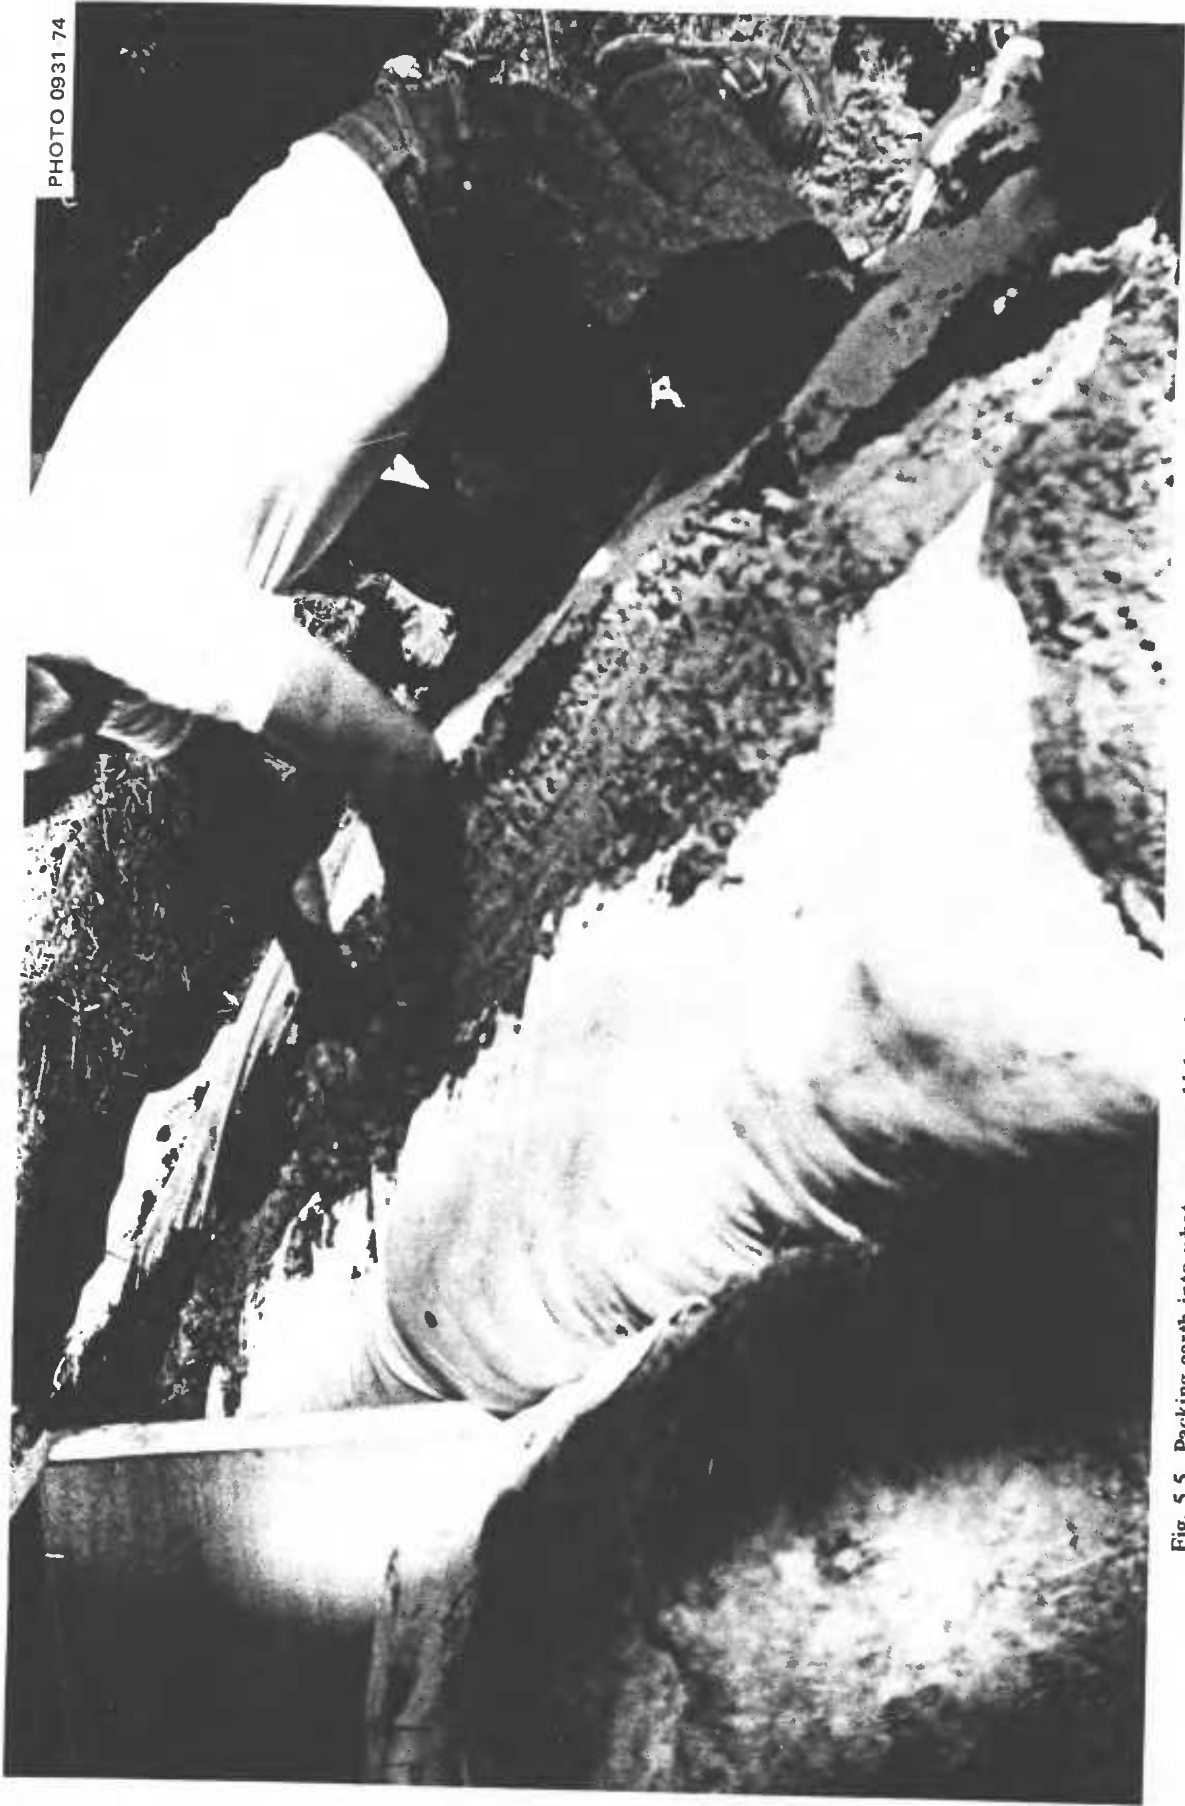
PHOTO 1055 74

**Fig. 5.5. Packing earth into what soon would be the hook of a roll. This photo was taken after the upper, free part of the sheet had been pulled down and over the earth that had been piled on part of the sheet while part of it was supported by the form made of an interior door. A part of this sheet had been folded down into a shallow ditch dug in the mounded earth; this ditch was below the line of packed-in earth on which the father's hands are pressed.**

To complete the hook, the upper, outer edge of the sheet was folded over this earth packed into the shallow ditch. One layer of a wall made of rolls was then completed by placing earth both on top of the hook and on the rest of the sheet-covered roll of earth, until the surface of the earth was as high as the rest of the earth.

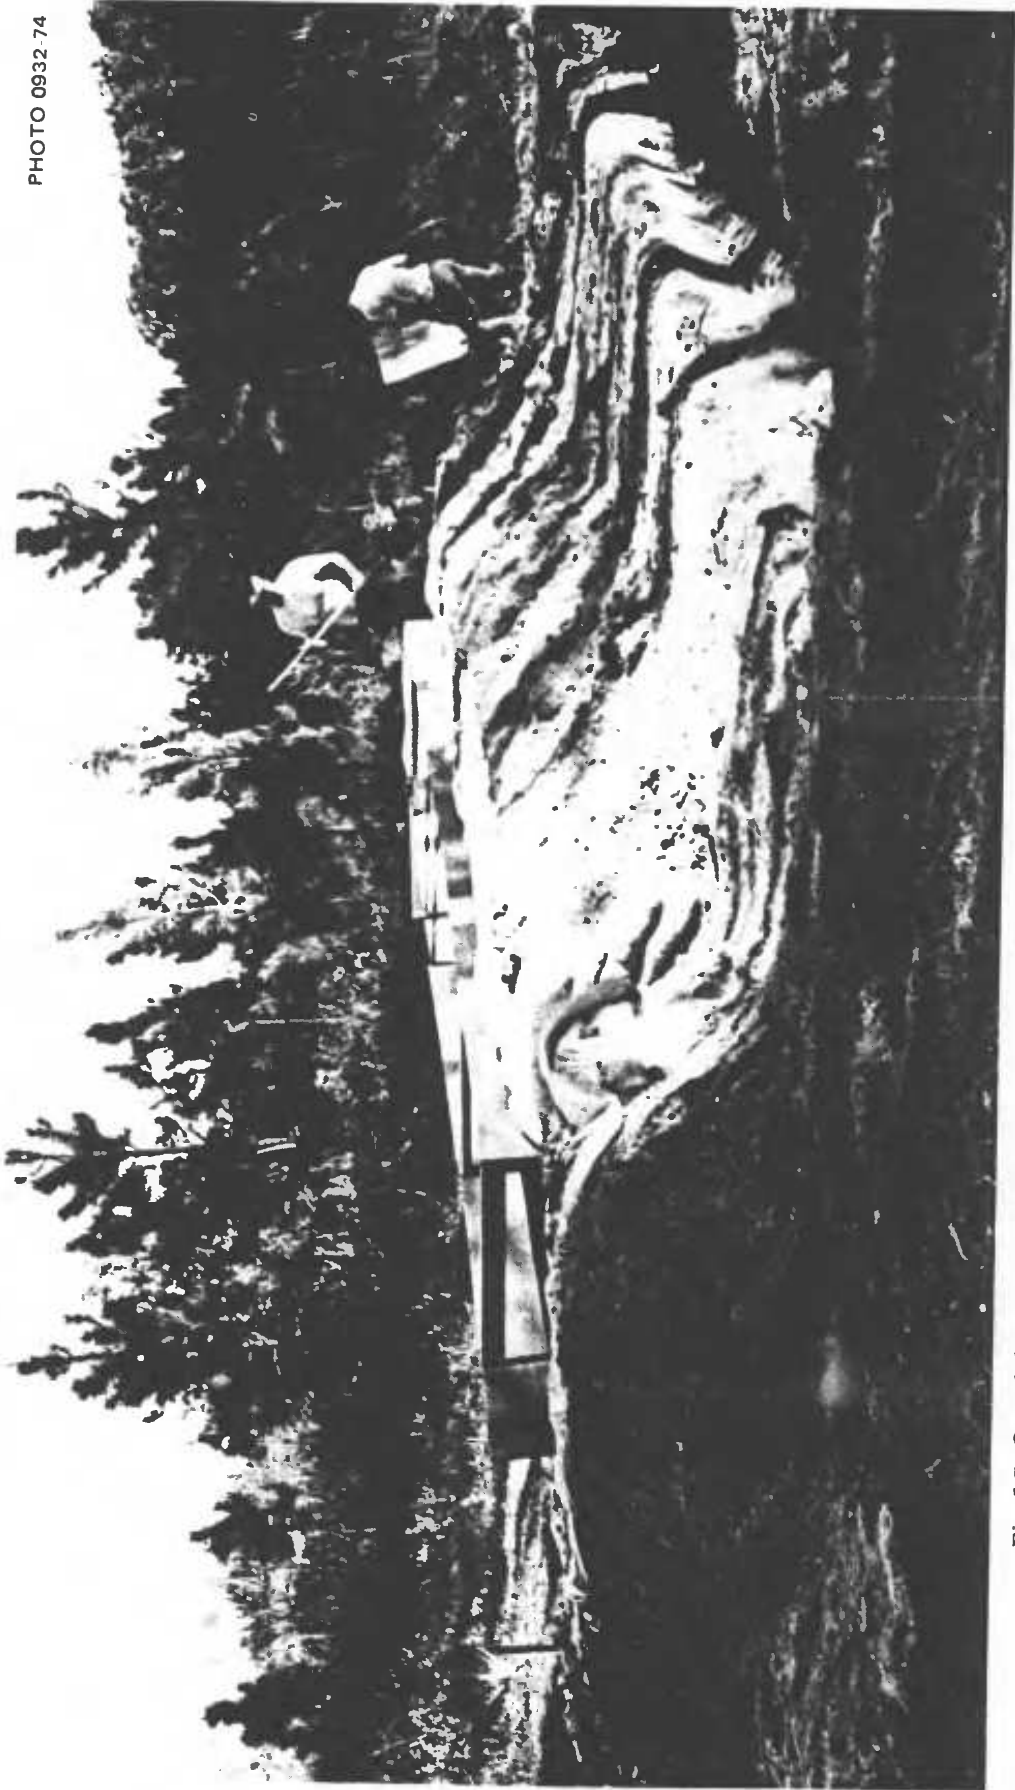
**Fig. 5.7.** One of the side walls, made of three rolls placed one on top of the other, pictured shortly before the door forms were removed.

Note the pits from which earth was excavated. Due to the high water table and underlying wet clay, these workers removed earth from only the uppermost 12 to 15 in.

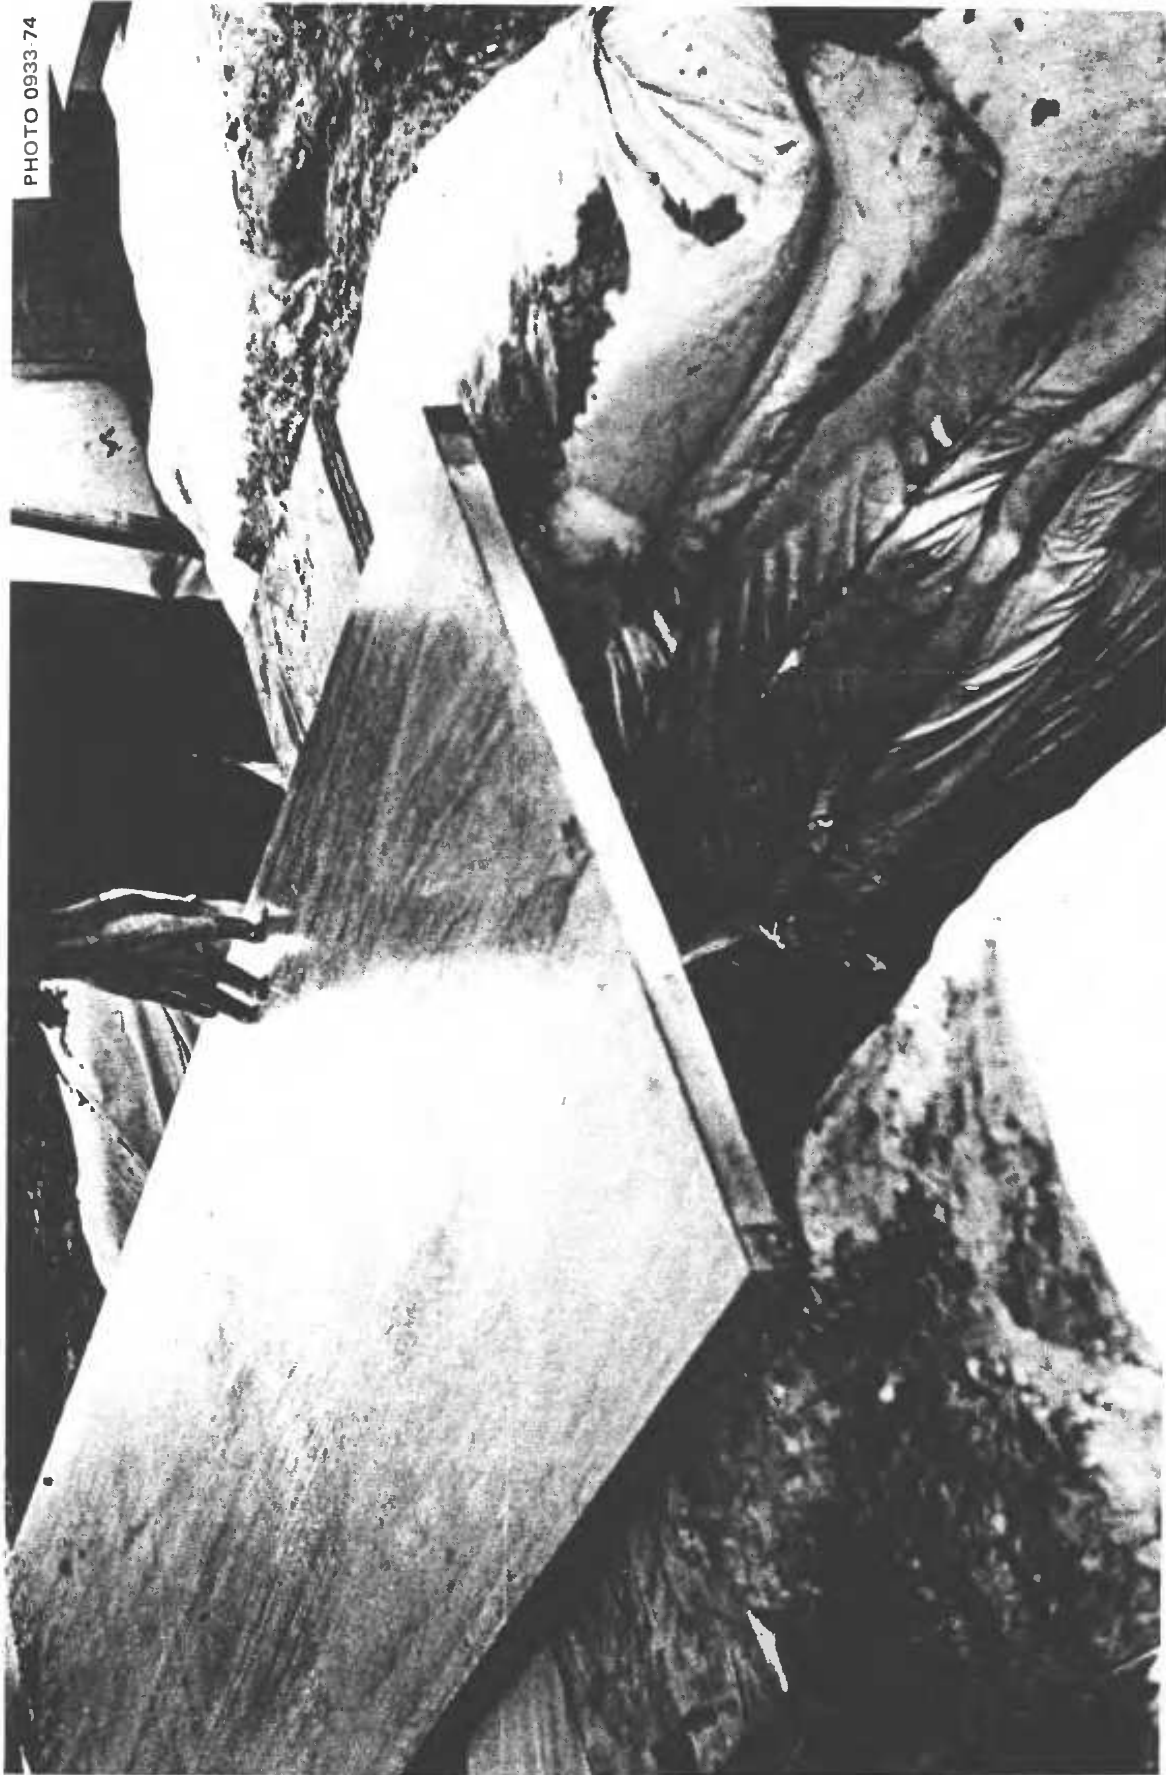
PHOTO 0933-74

Fig. 5-8. Placing an interior door over one end of the shelter and part of an entryway. The wall of this entryway consisted of 7 small rolls which were made by using pieces of sheets and other cloth, with the outer ends tucked in. The man was standing on the main part of the shelter, over which other doors were soon to be placed, all parallel to the pictured door.

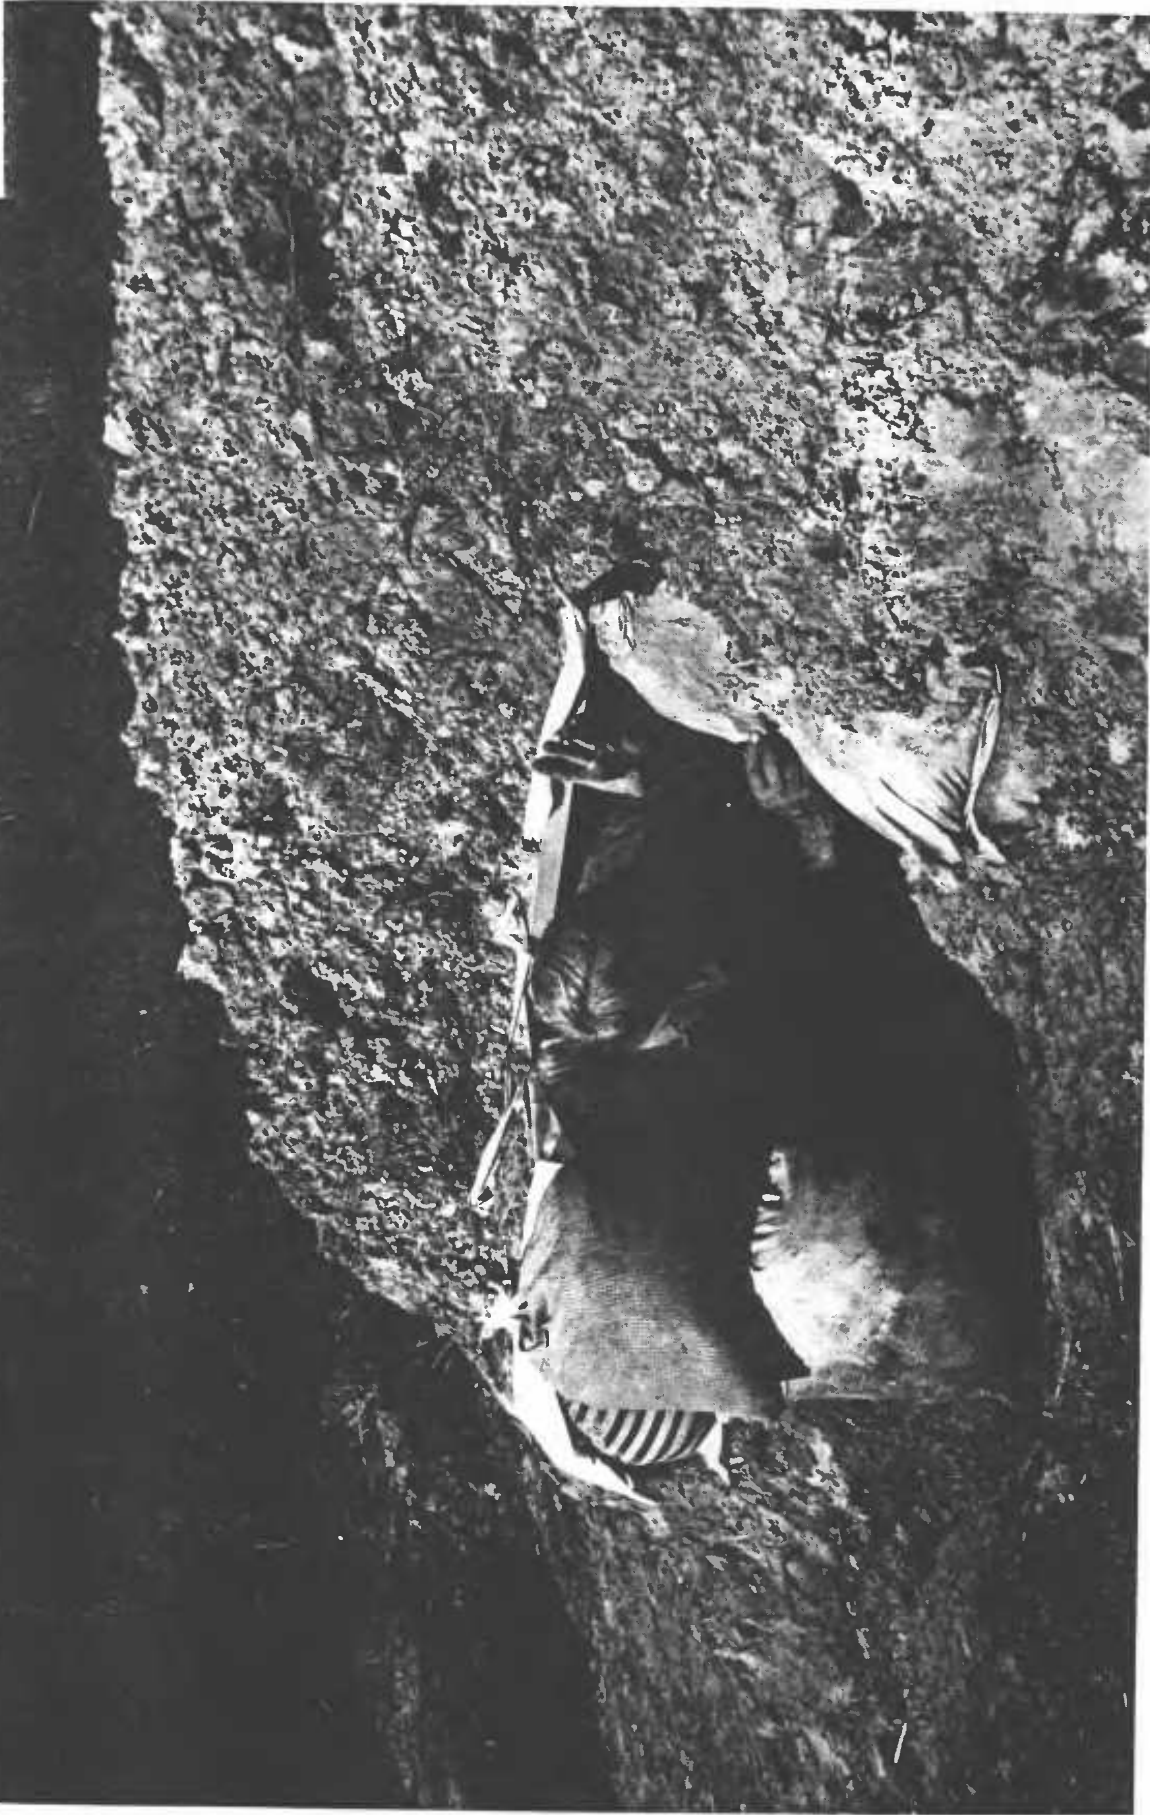
Fig. 5.10. A closeup view of the same entry pictured previously, showing the sandbags used to finish the ends of the entryway walls and to reduce radiation fallout on the ground, which otherwise would enter the shelter.

This shelter, like the other above-ground shelters designed for use in a hot, humid climate, had two entryways, facing in opposite directions, one at each end.

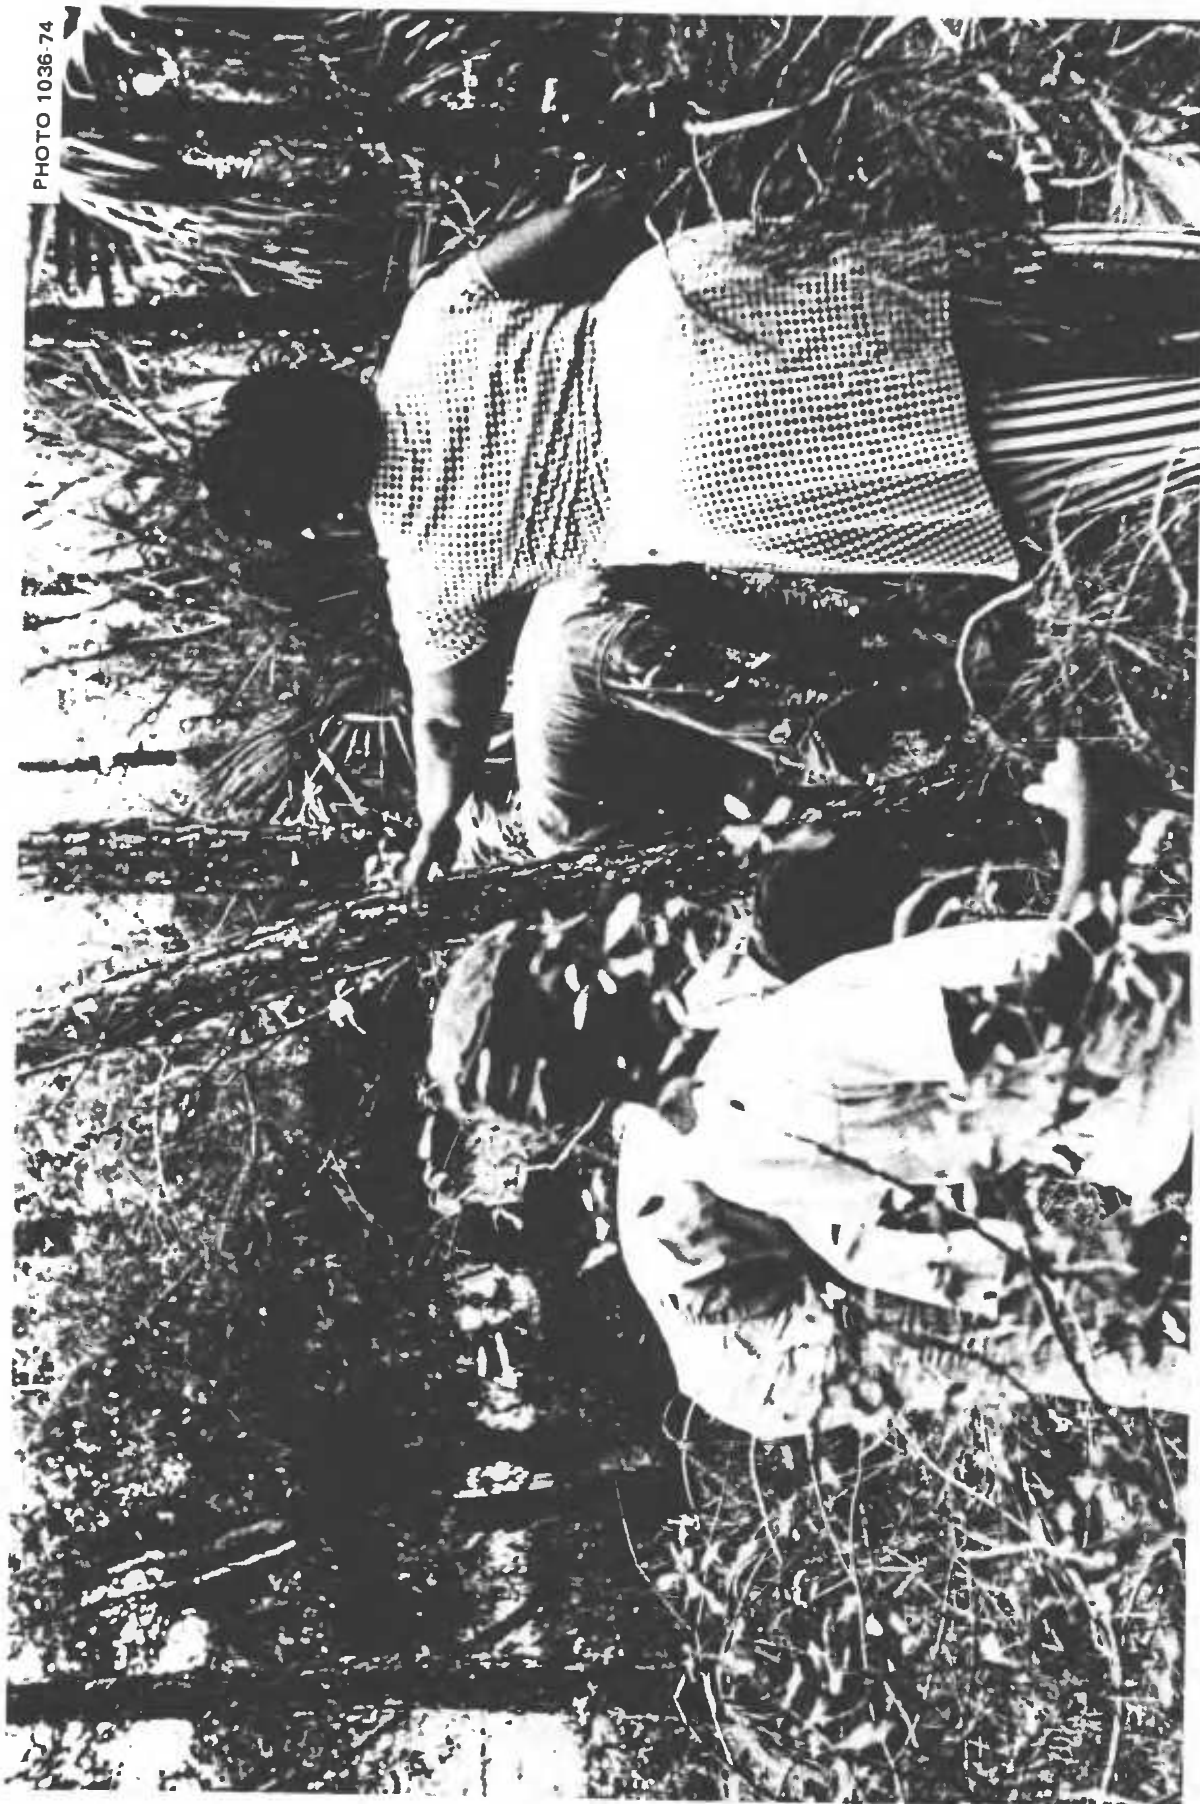
PHOTO 1036-74

**Fig. 5.14.** A Florida family cutting a small pine tree to build an above-ground Crib-Walled Shelter in Flagler County. This family had hard luck in that the months-long drought was broken by a 3-in., all-day rain lasting what would have been the first 12 hours of their shelter-building effort.

To fell trees, the father and his 16-year-old son used an old crosscut saw that they had sharpened before this experiment began officially.

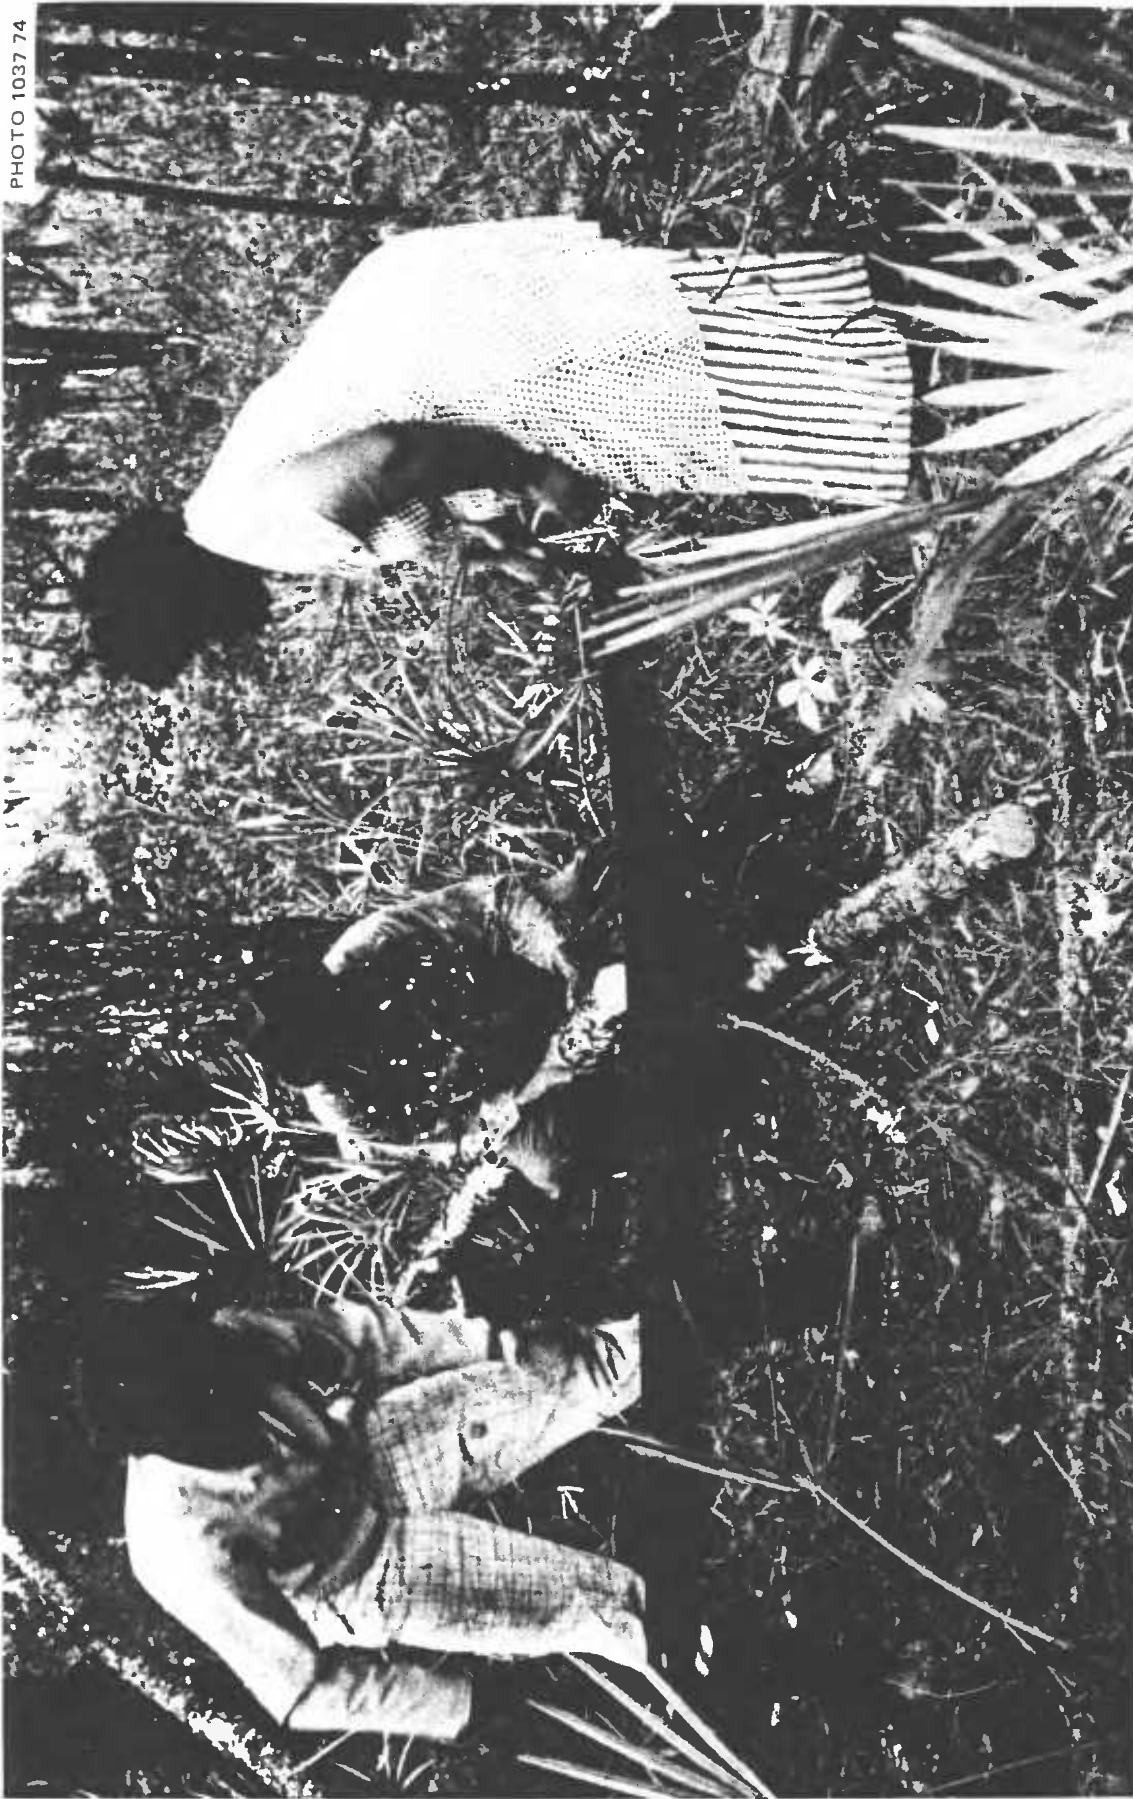
PHOTO 1039-74

Fig. 5.15. Cutting a small felled tree into one of the specified lengths needed to build pole cribs. Later the cribs were lined with bed sheets and then filled with earth. Instead of following the instructions and pulling long poles to the shelter-building site, where they should have been cut to the desired lengths, this family chose to have the children carry small poles one at a time to the site.

With only homemade kerosene torches made by filling pop bottles with kerosene and twisting pieces of cloth into the mouths for wicks, this family worked from sundown until 3 AM, felling trees and packing poles to the site at the edge of the woods. At 3 AM more heavy rain forced them to take cover under pieces of plastic and in the cab of their pickup truck, in which they had driven some 12 miles from their home near Bunnell to the rural site.

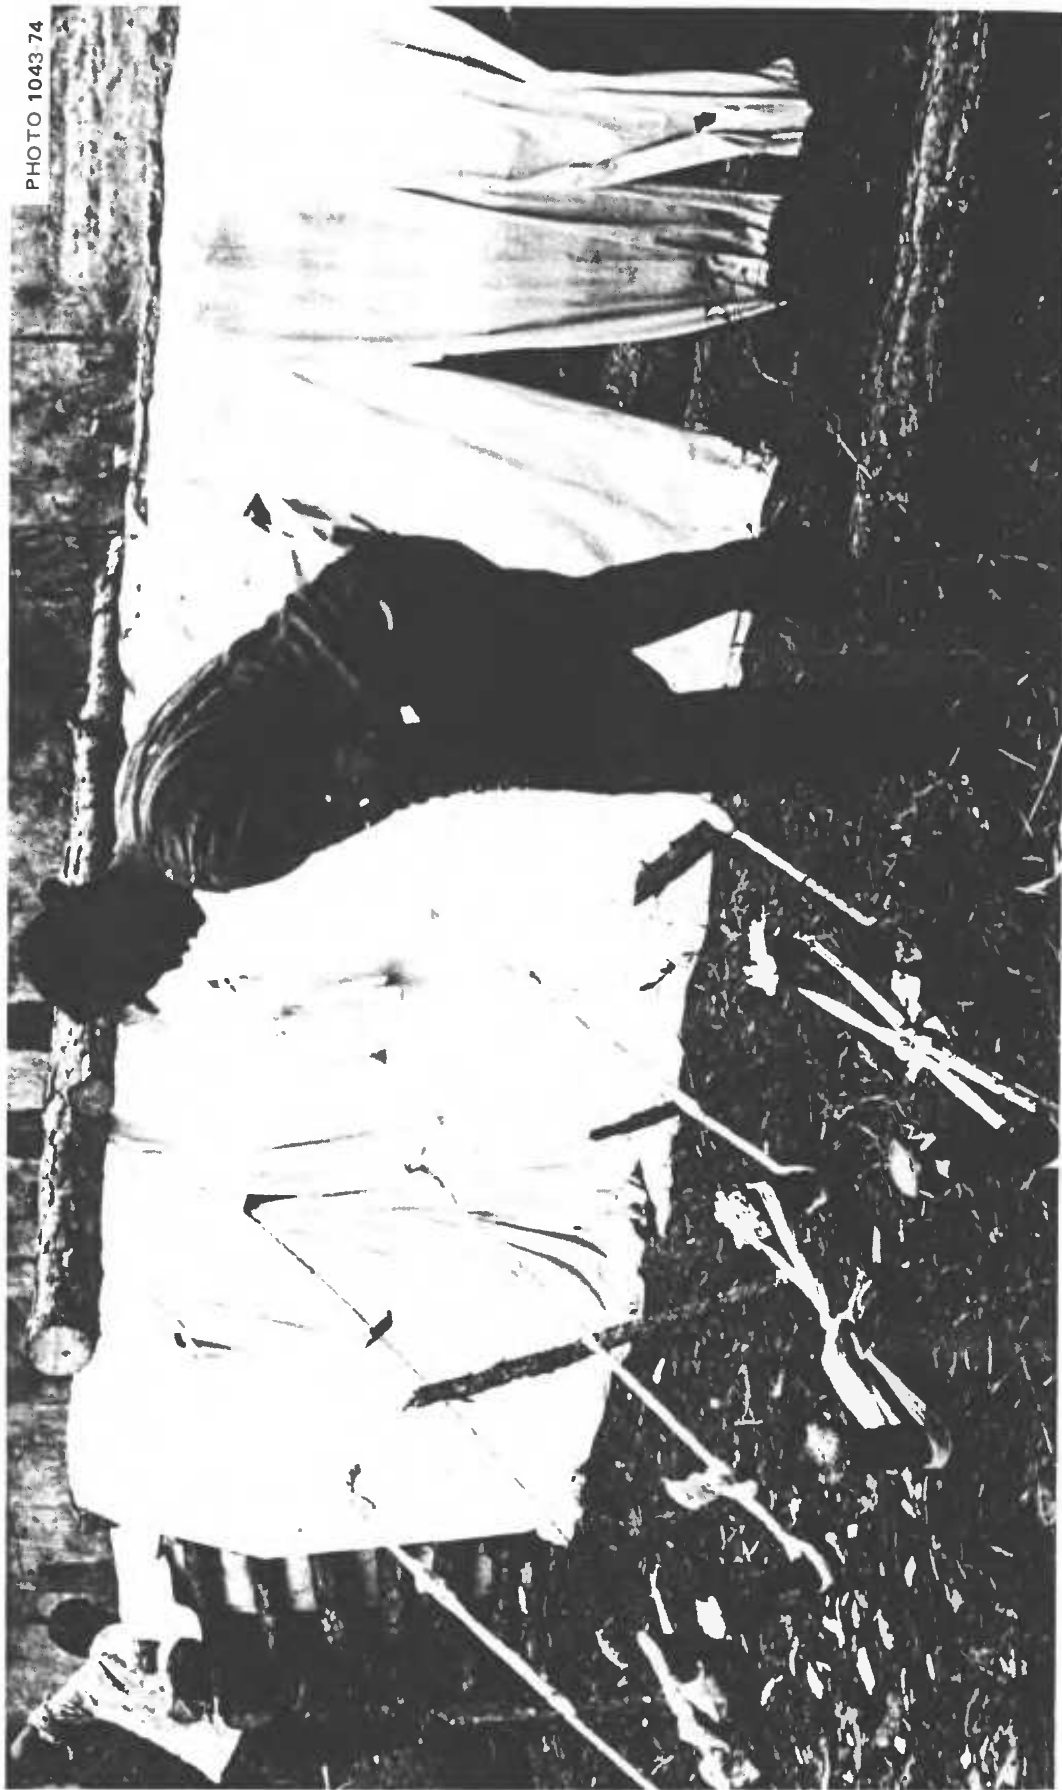
PHOTO 1043 74

Fig. 5.17. The outside of one of the spaced-pole walls of the shelter room, after it had been readied for mounding earth against it by guying vertical poles against the inside of this wall to stakes driven outside the wall. Note the guy ropes made of foot-wide strips of bed sheets, twisted and pulled tight by the twist-sticks near the inner line of stakes. These twist-sticks are kept from unwinding by being positioned so that their lower ends could be pressed against the ground. Later these guy ropes and sticks were completely covered by the earth mounded against this wall until the 2-ft-wide top layer was about 3 in. higher than the top of the spaced-pole wall. The bed sheets (with the help of earth arching) kept the earth from falling through the spaces between the poles.

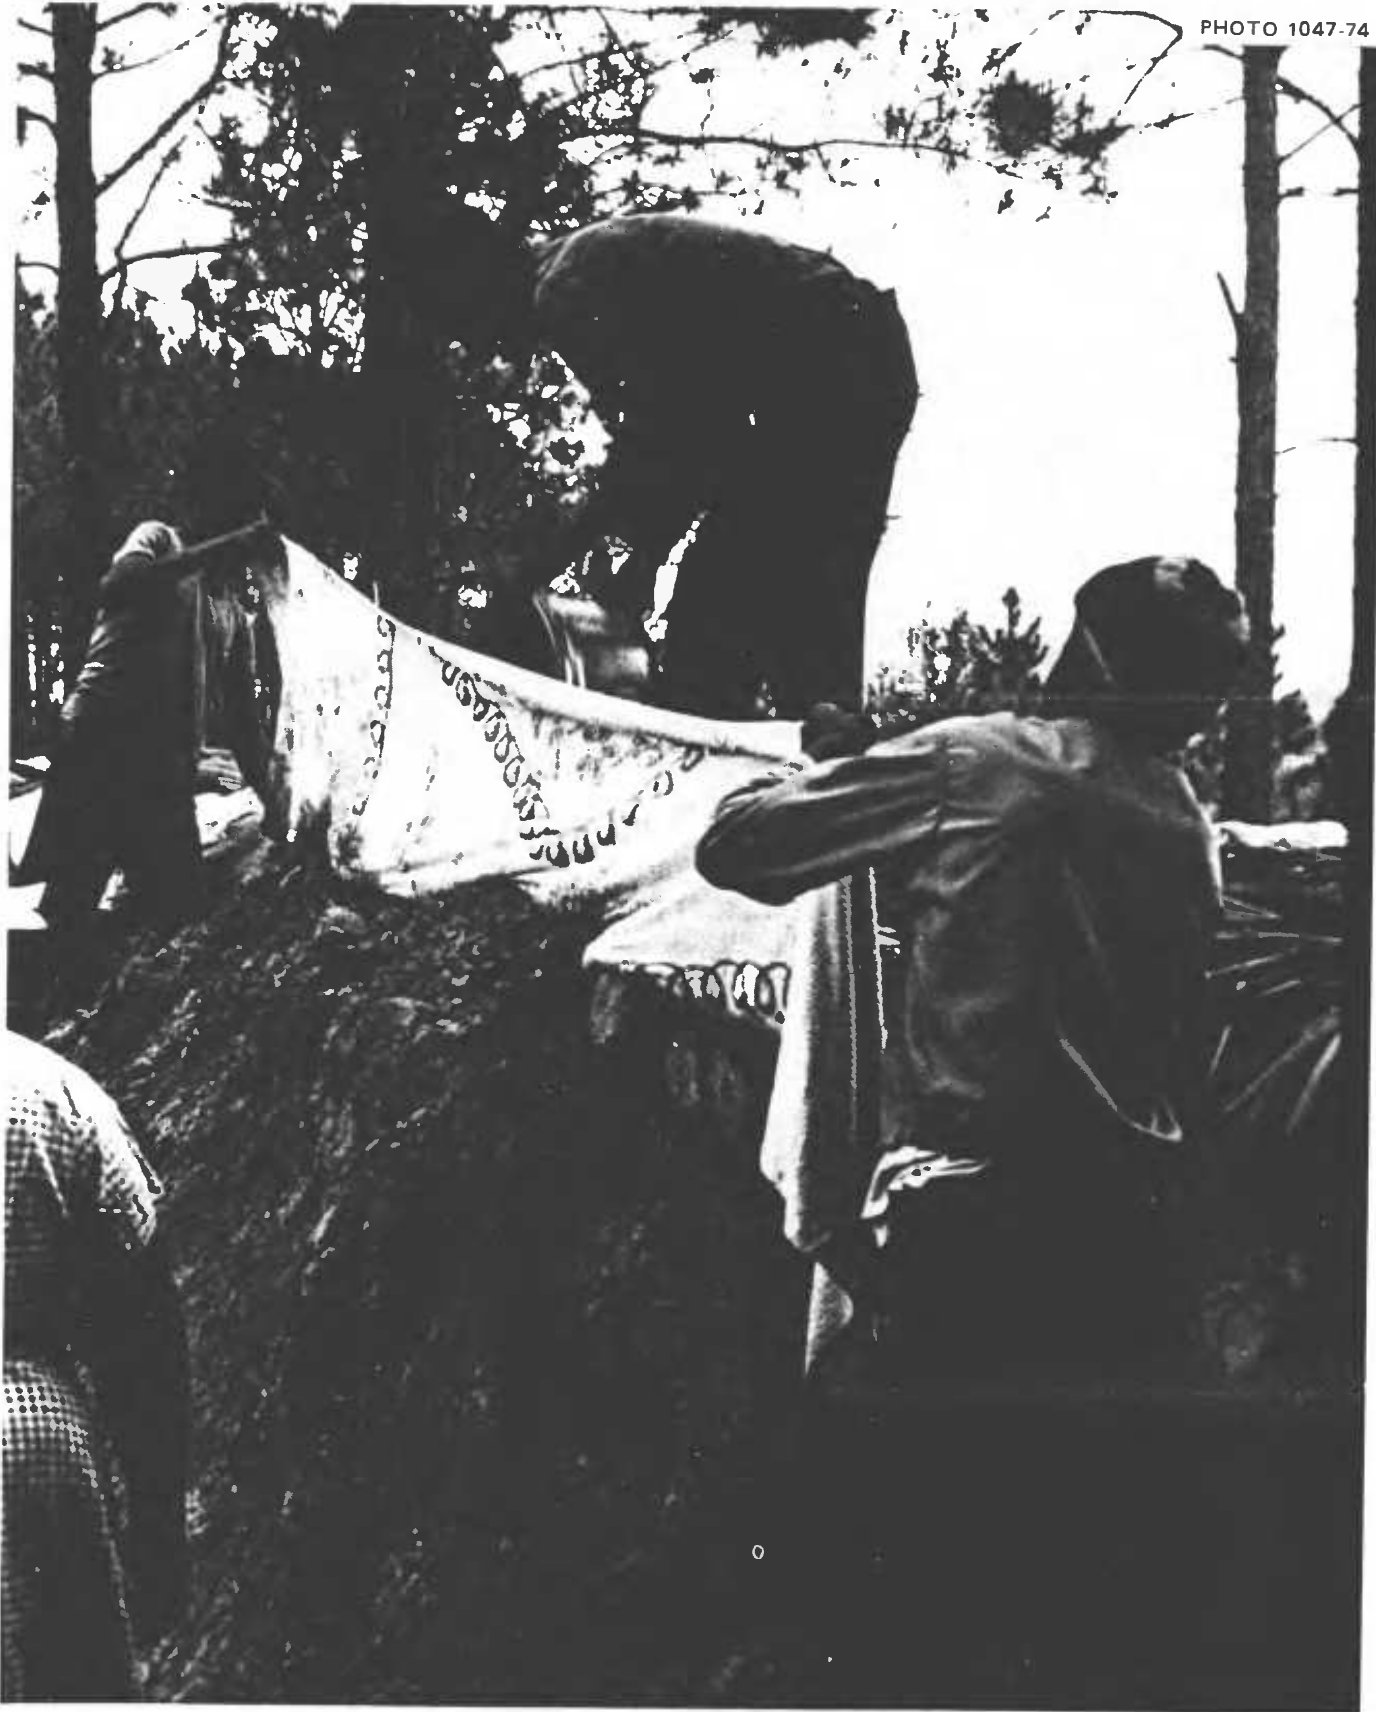
**Fig. 5.22.** Using an old bedspread to form an earth-filled roll along an upper edge of the essentially flat shelter roof of poles. The father is pouring earth out of a large bucket. These rolls made it possible to increase the stability of the earth covering around the edges of the roof, and also prevented heavy rains from washing any appreciable amount of shielding earth off the shelter roof.
