ORNL-5039  
UC-41-Health and Safety

EXPEDIENT SHELTER CONSTRUCTION AND  
OCCUPANCY EXPERIMENTS

Cresson H. Kearny

MARCH 1976

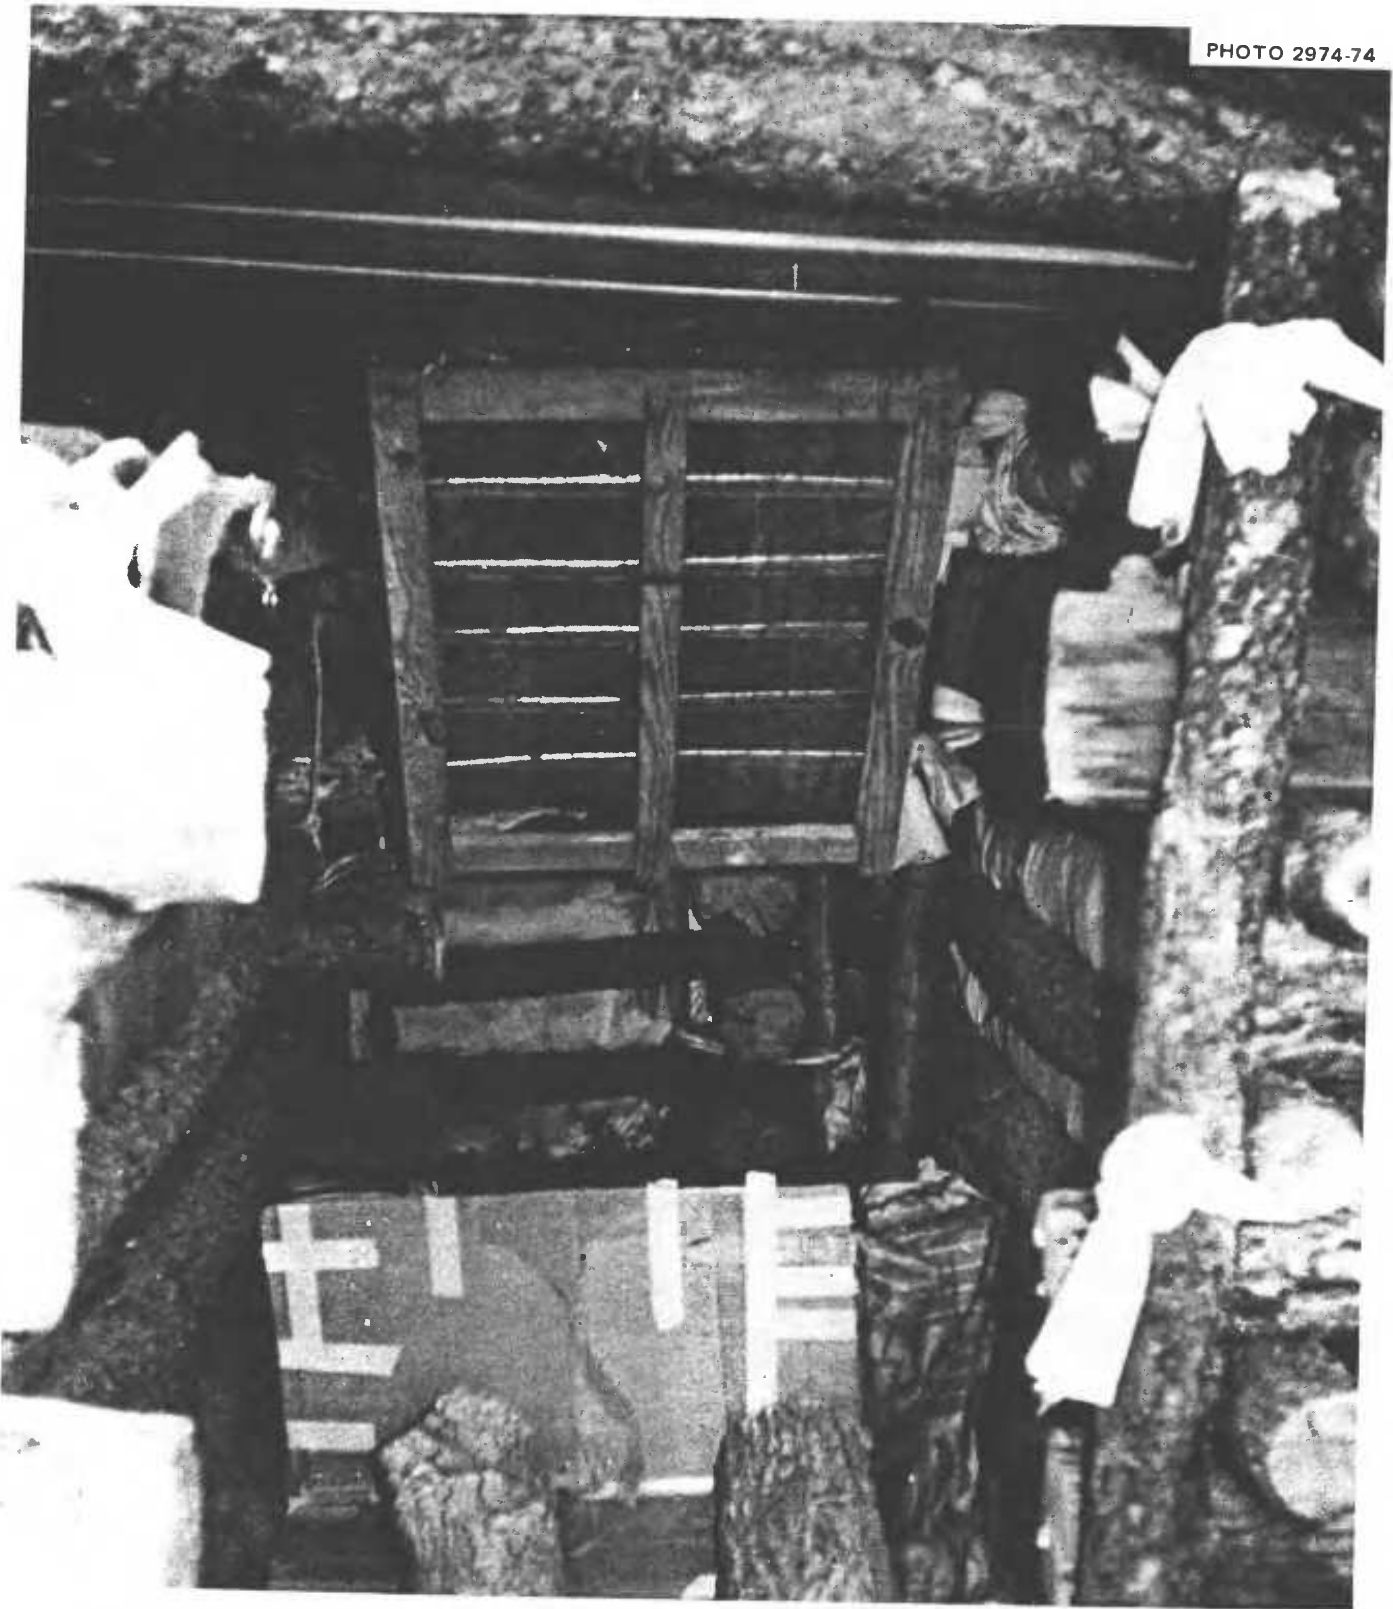
Fig. 5.28. A 20 X 24 in. KAP being used on a still day to pump an average of about 600 cubic feet per minute through an Above-Ground Crib-Walled Shelter. This shelter had an entrance at each end, each providing about 5 sq ft of effective cross-sectional area.

Six hundred cubic feet per minute is enough outdoor air to restrict the rise in the *effective temperature* of the shelter air, measured as it leaves the shelter, to only about 2°F for a larger shelter of this type occupied by 24 persons.

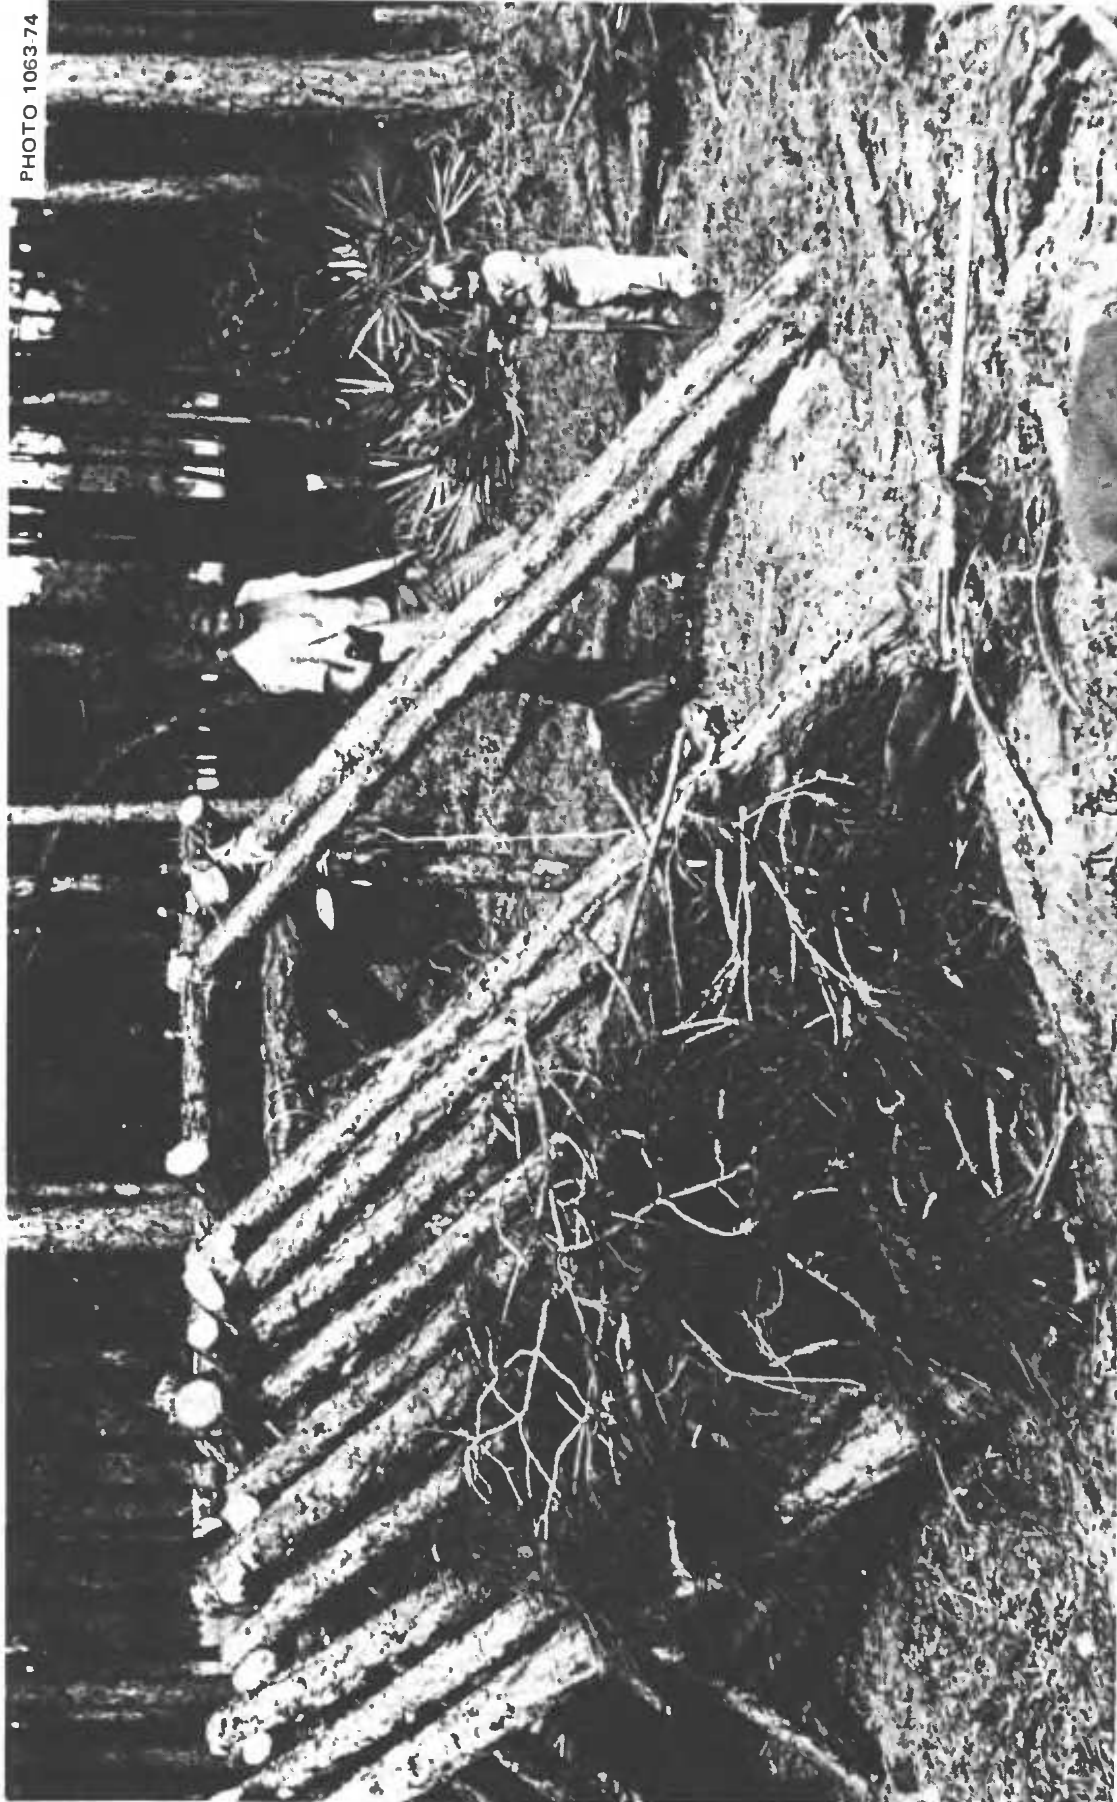
PHOTO 1063-74

Fig. 5.33. The Waldens' Ridge-Pole Shelter had a ridge pole 16 ft long, supported by 4 vertical posts, each with a shallow V notch in its upper end. The roof poles on the sides were each 9 ft long; their lower ends rested in a V trench only 4 in. deep. In these very shallow trenches were placed poles only about 3 or 4 in. in diameter, with one side flattened. The lower ends of the 9-ft roofing poles pressed against the flattened sides of these small poles that probably were unnecessary.

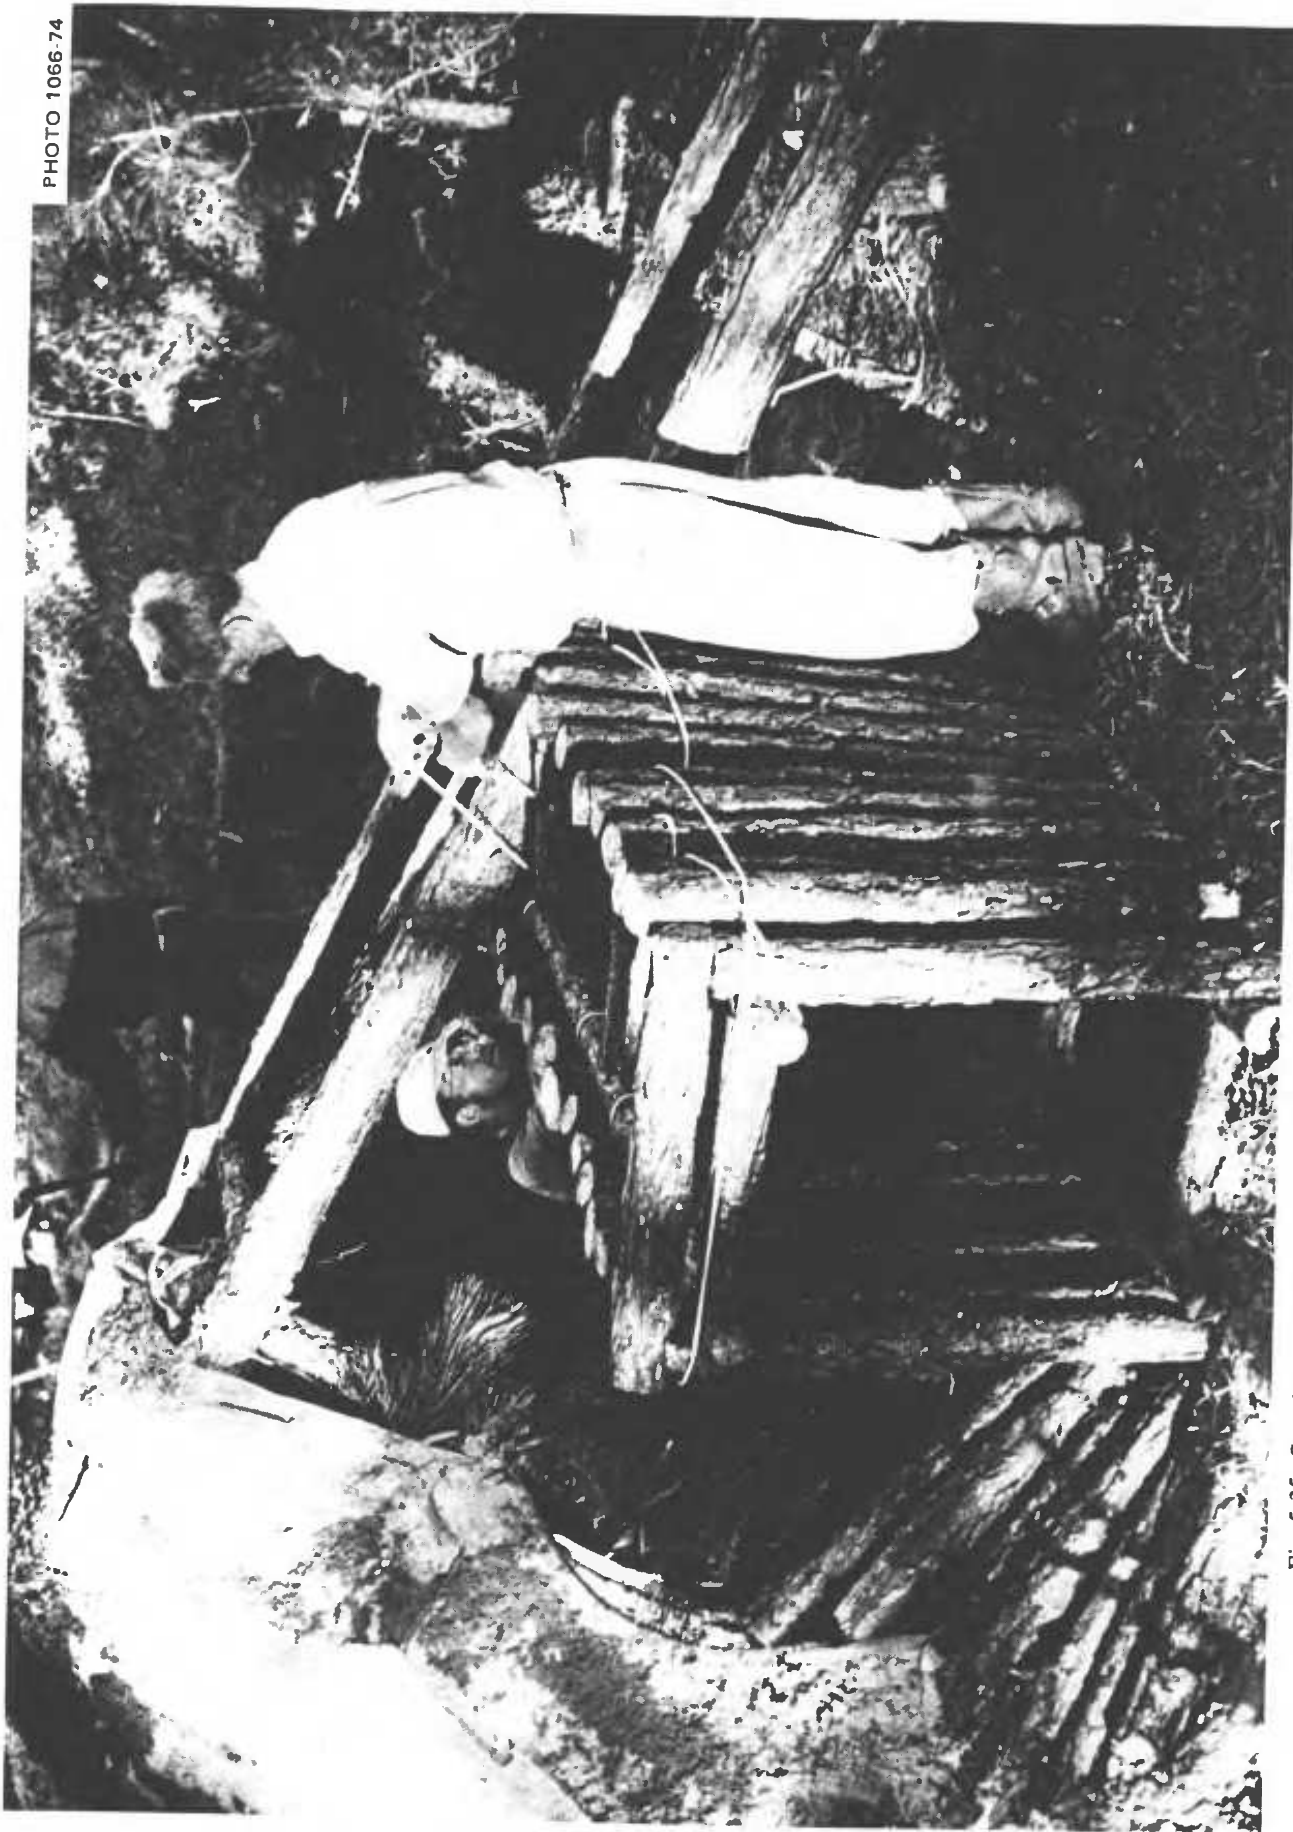
PHOTO 1066-74

Fig. 5.35. Securing the side walls of the outer part of an entryway that had a right-angle turn before it reached the main shelter room. This entryway was built like a miniature Small-Pole Shelter. When this photo was taken, the horizontal roofing poles of this entryway had not been placed on the upper ends of the vertical wall poles of the entryway. The vertical wall poles could have been held in place by miling earth against them.

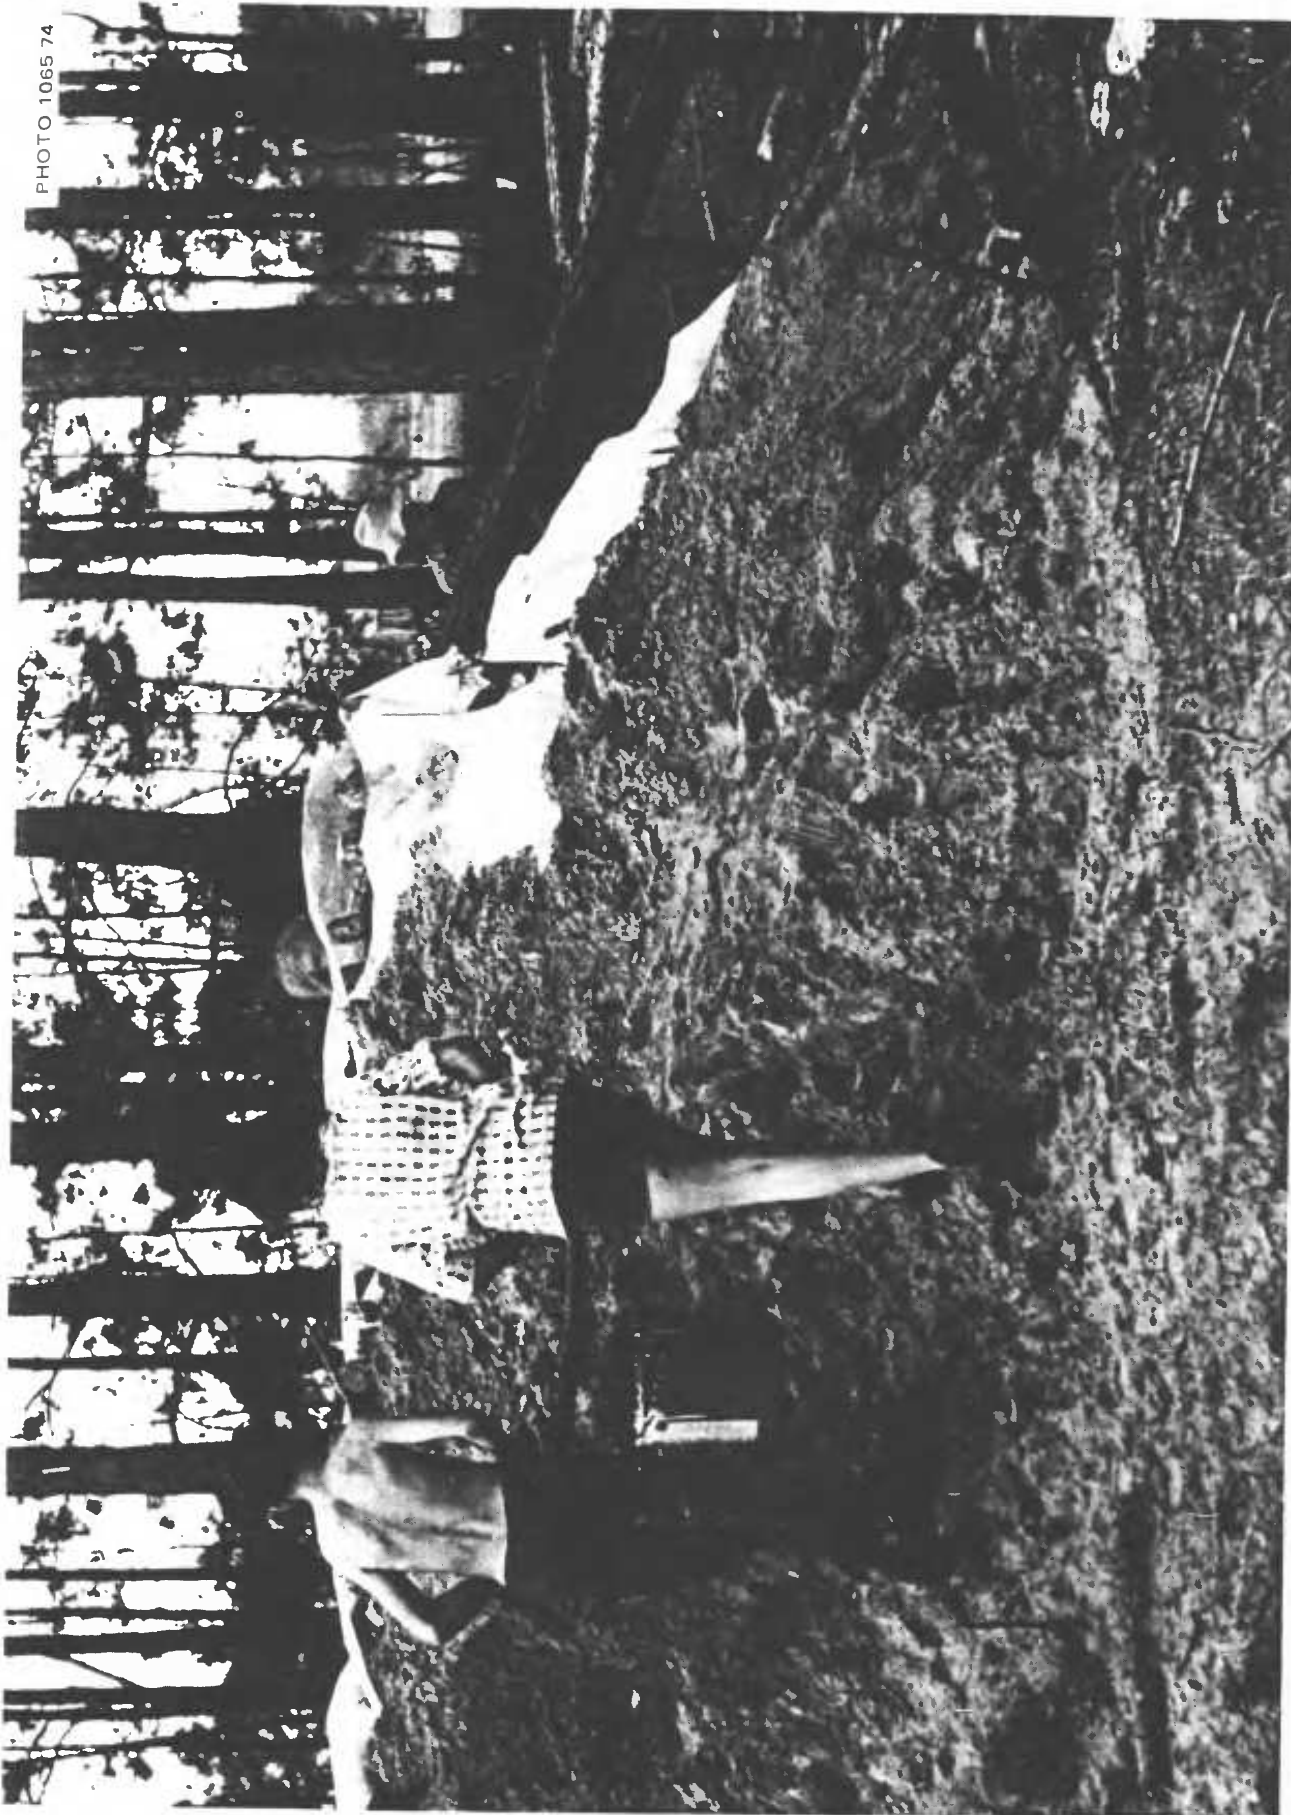
PHOTO 1065 74

Fig. 5.36. Two teenagers carrying earth in a 5-gallon bucket, from one of the shallow barrow pits. These builders found that carrying earth in this manner enabled even children to move earth effectively, all the way to the top of the shelter.

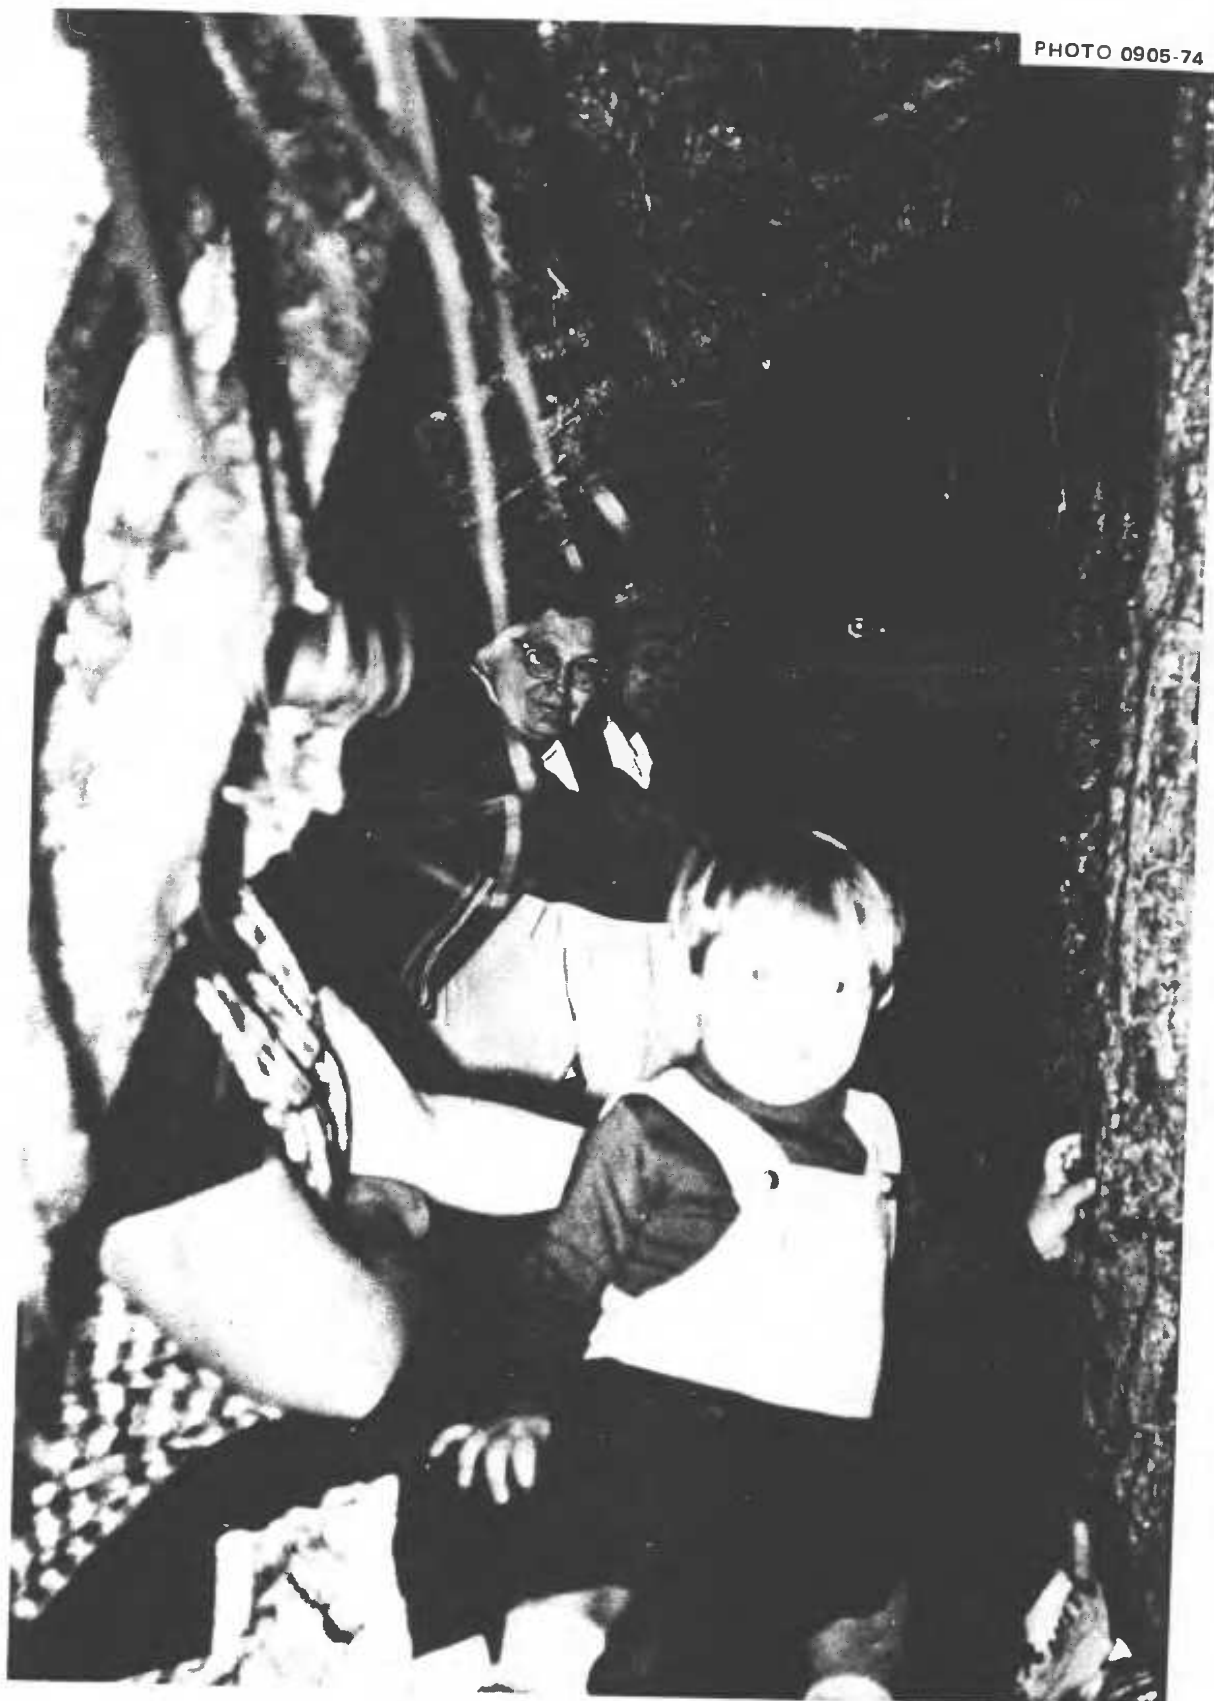
PHOTO 0905-74

**Fig. 5.38.** View inside the Waldens' Ridge-Pole Shelter, showing a part of one side. This shelter had a main room 13 ft wide and 16 ft long. The Waldens concluded that it was big enough to shelter at least 20 people, with plenty of room for food and other possessions. The four centerline posts were not objectionable.

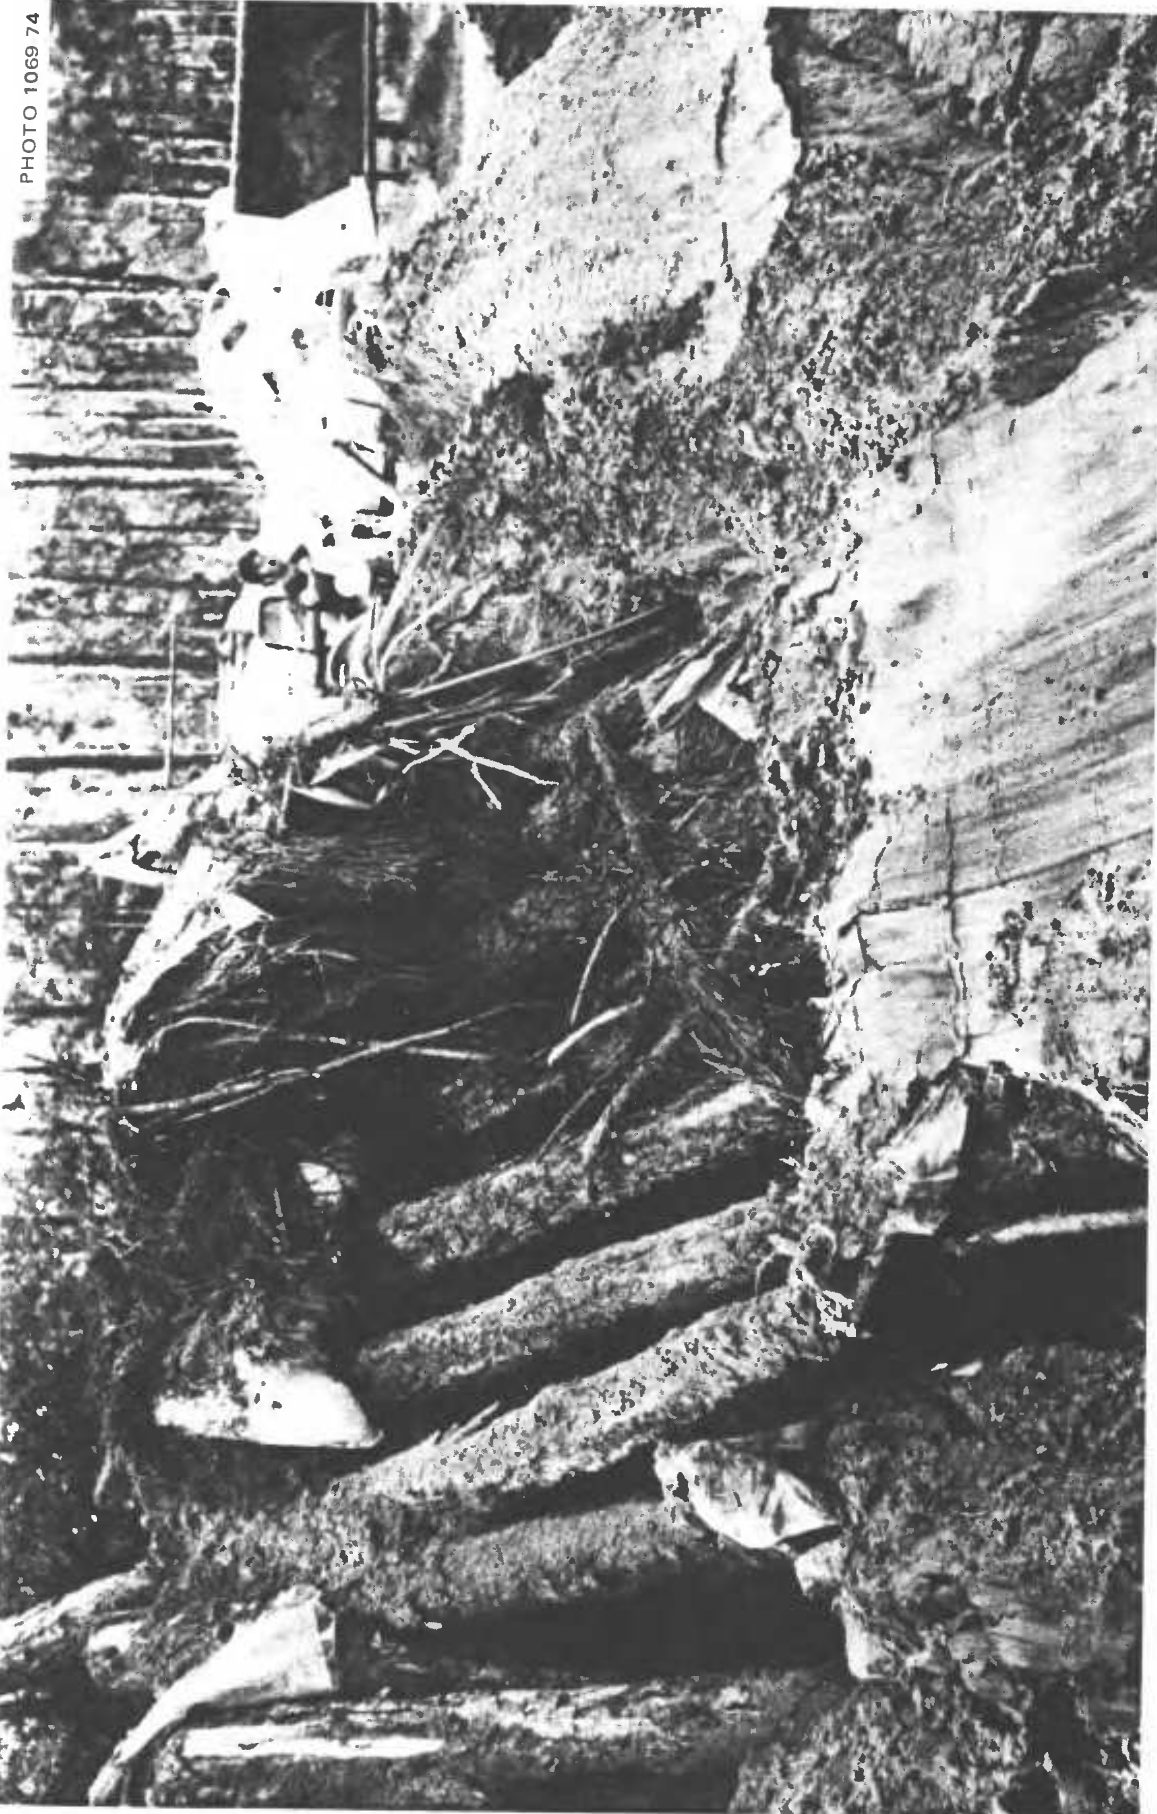
**Fig. 5.40.** View after a backhoe had started to demolish the Waldens' Ridge-Pole Shelter, which proved to be decidedly sturdy. Note that some of the wall poles were broken before they were moved off the ridge poles, or the ridge pole had been moved significantly.

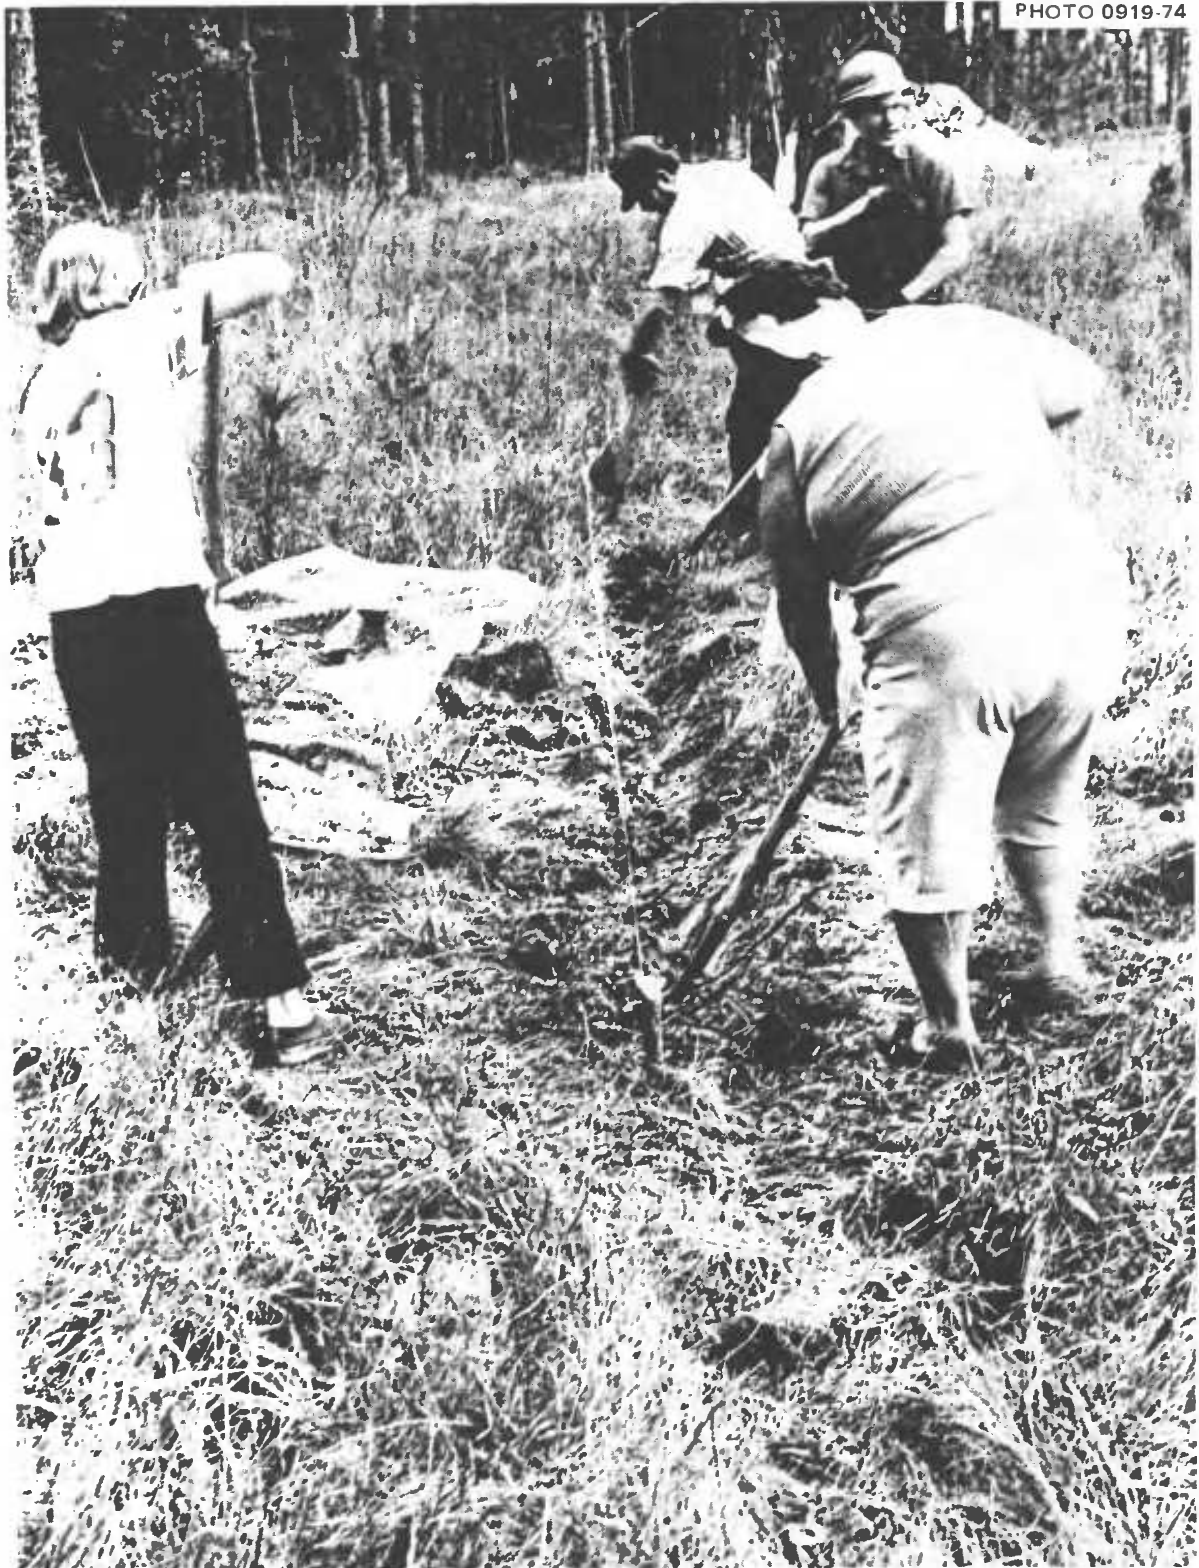
**Fig. 5.42.** Starting to build a 21-person above-ground A-Frame Pole Shelter. Five families, having 22 persons in all (including two babies and three adults unable to do heavy work) built this shelter with a main room 21 ft by 13 ft wide. The roof poles (not shown) had a minimum small-end diameter of  $3\frac{1}{2}$  in. and sloped approximately  $36^\circ$ . This photograph shows one of the 6-in.-deep, "V"-shaped trenches being dug to secure the lower ends of the 9-ft roof poles, that measured 9 ft on their short sides.

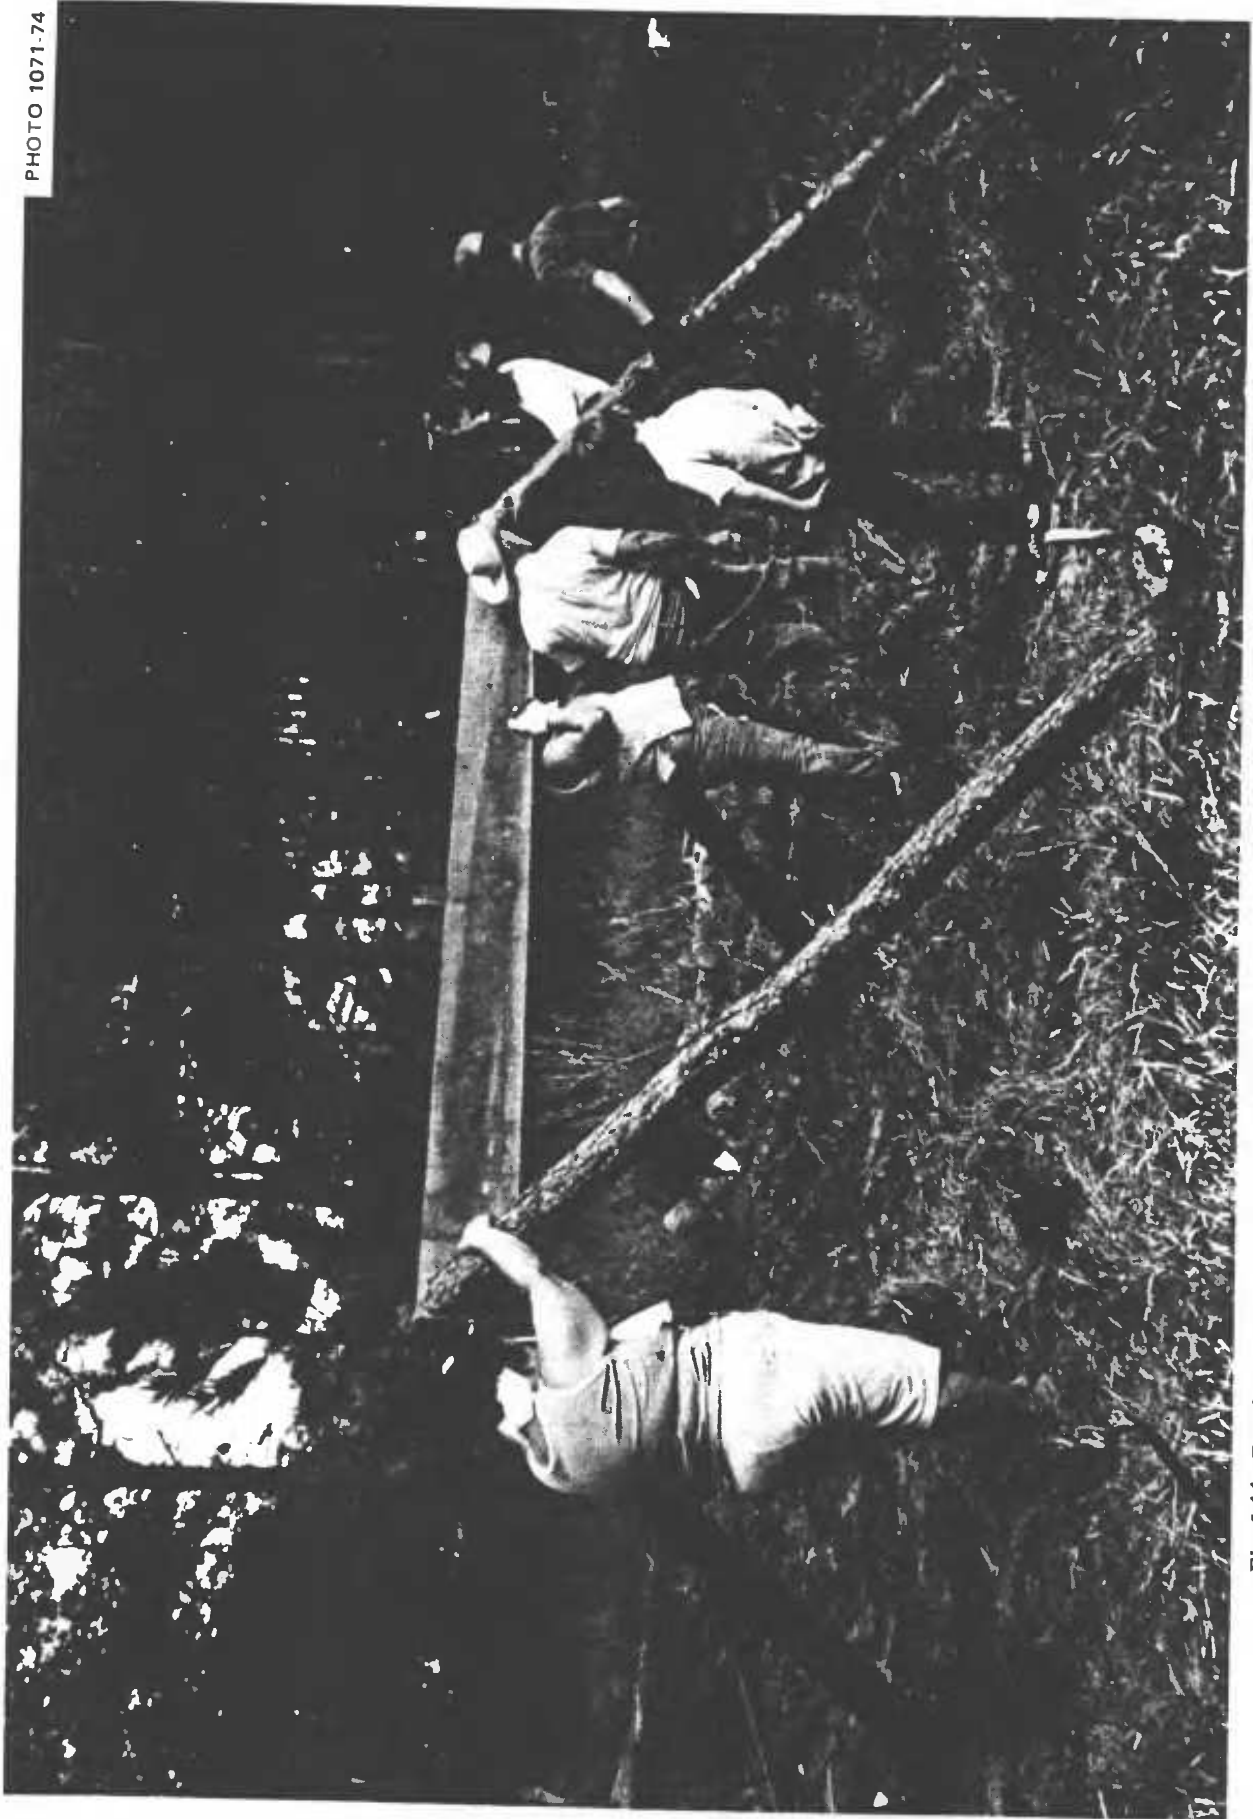
Fig. 5.44. Erecting a 16-ft-long section of the ridge board that later was extended to a 21-ft length. These decidedly competent rural people were so overconfident of their building abilities that they failed to read the instructions carefully. As a result, they made several errors that they had to correct. One of these errors was initially using a 5-in.-wide board for the first part of the ridge board; they found that the upper ends of some of the wall poles would not fit properly against a board so narrow.

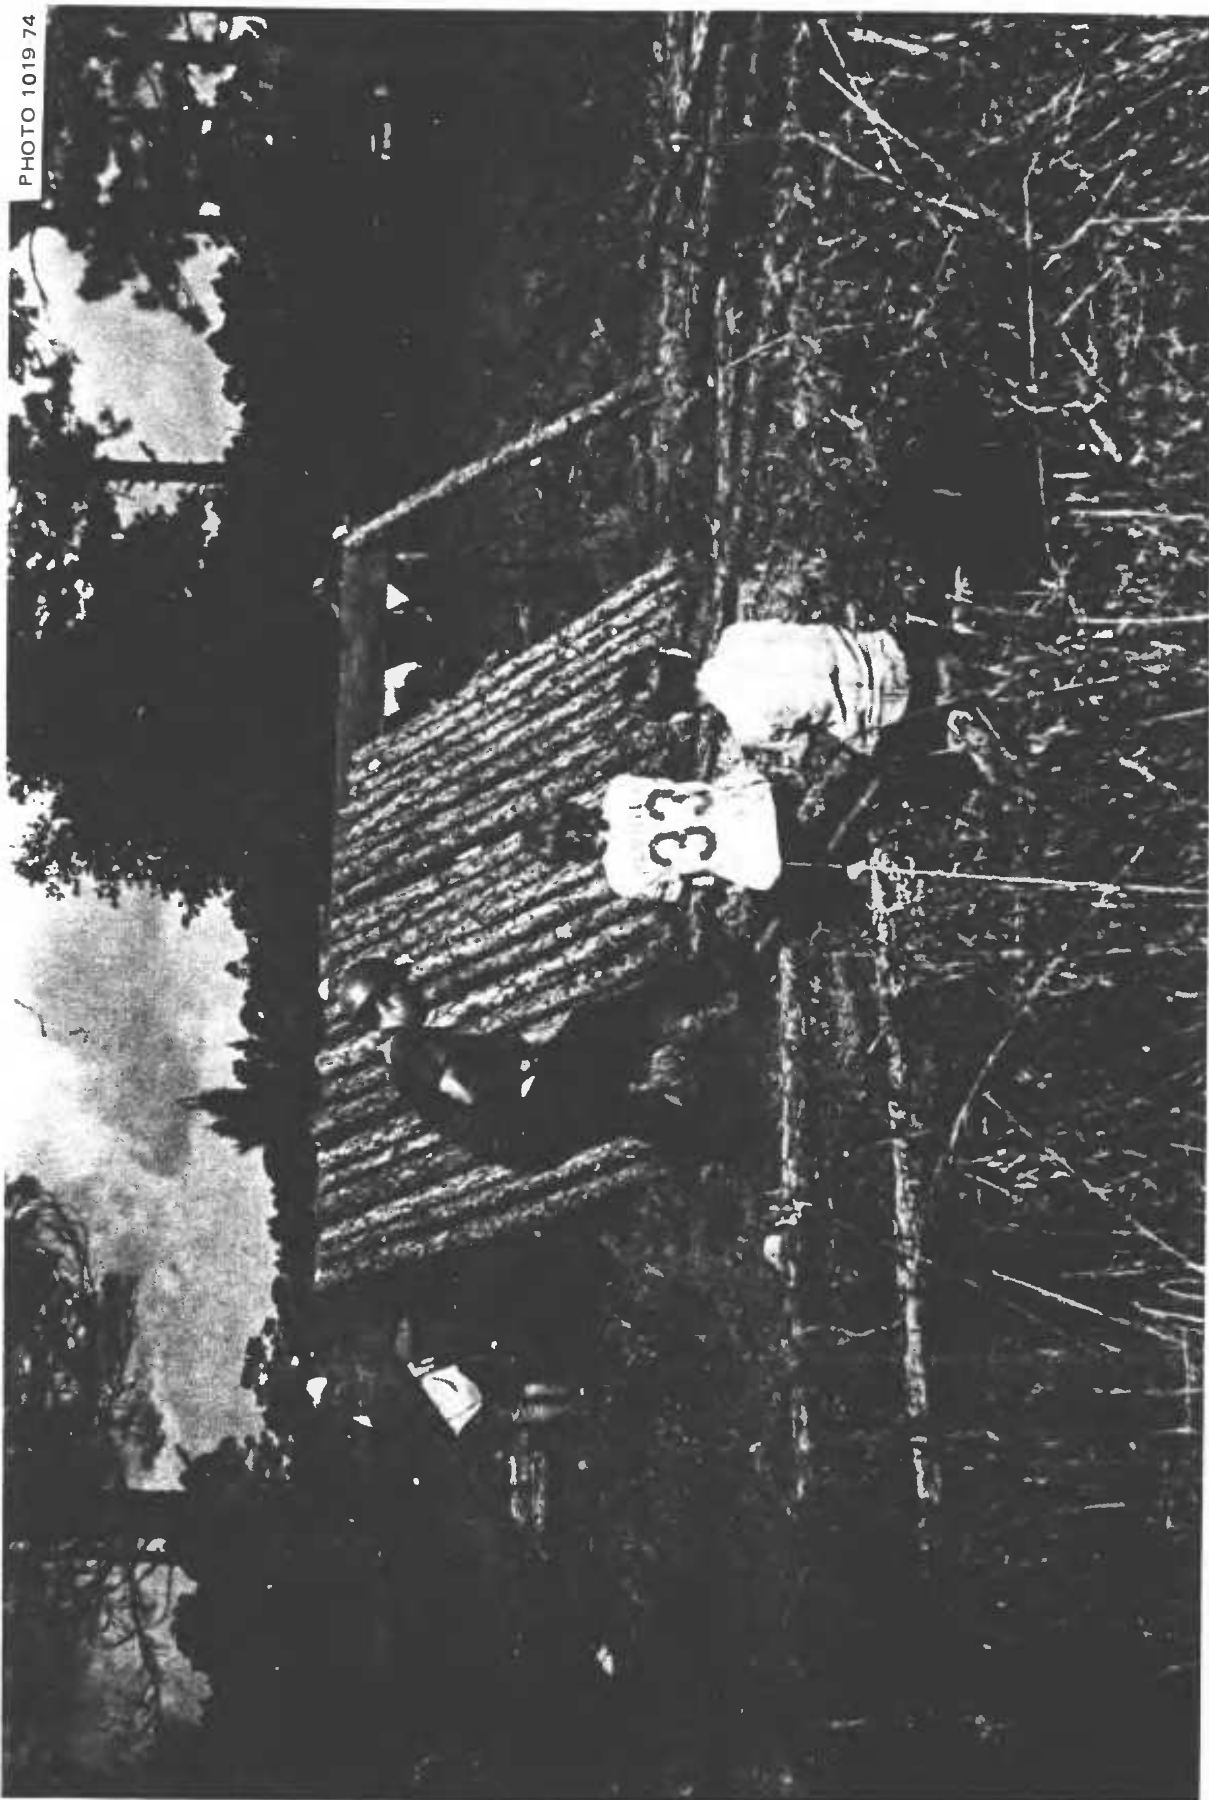
**Fig. 5.45. Chain saw operator using a templet to cut an upper end of a wall pole at the specified  $54^\circ$  angle and 9-ft length on its short side. The templet was made from a wide 10-ft board, with one end cut at  $54^\circ$ . A nail was driven 9 ft from the end of this  $54^\circ$  angle; the squared-off base of the pole was placed against this nail.**

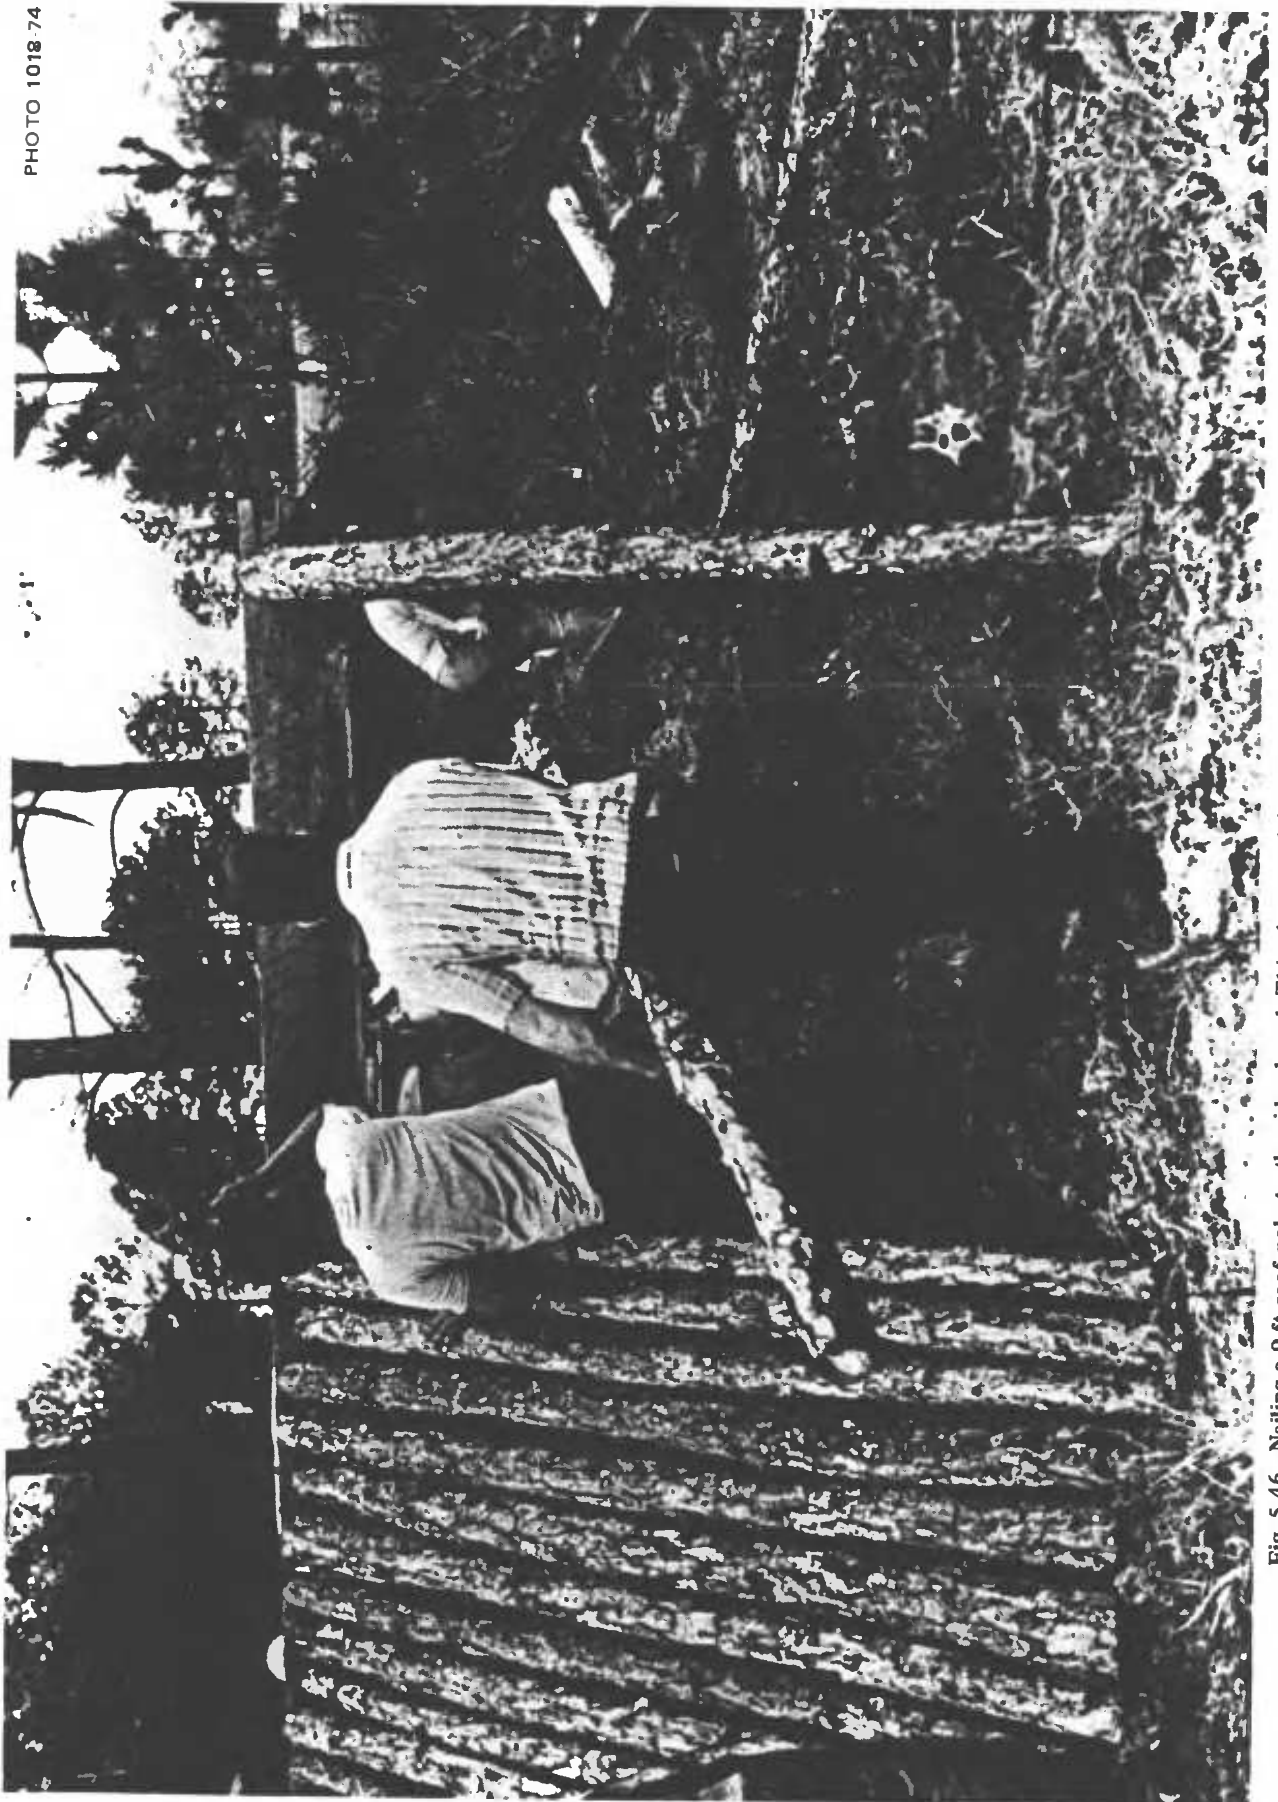
Fig. 5.46. Nailing a 9-ft roof pole to the ridge board. This photograph is misleading as regards the lower ends of the ridge poles; actually the ends rested against a 1 x 6 board placed against the outer side of the 6-in.-deep V trench that marked the edge of each shelter side wall.
