ORNL-5039  
UC-41-Health and Safety

EXPEDIENT SHELTER CONSTRUCTION AND  
OCCUPANCY EXPERIMENTS

Cresson H. Kearny

MARCH 1976

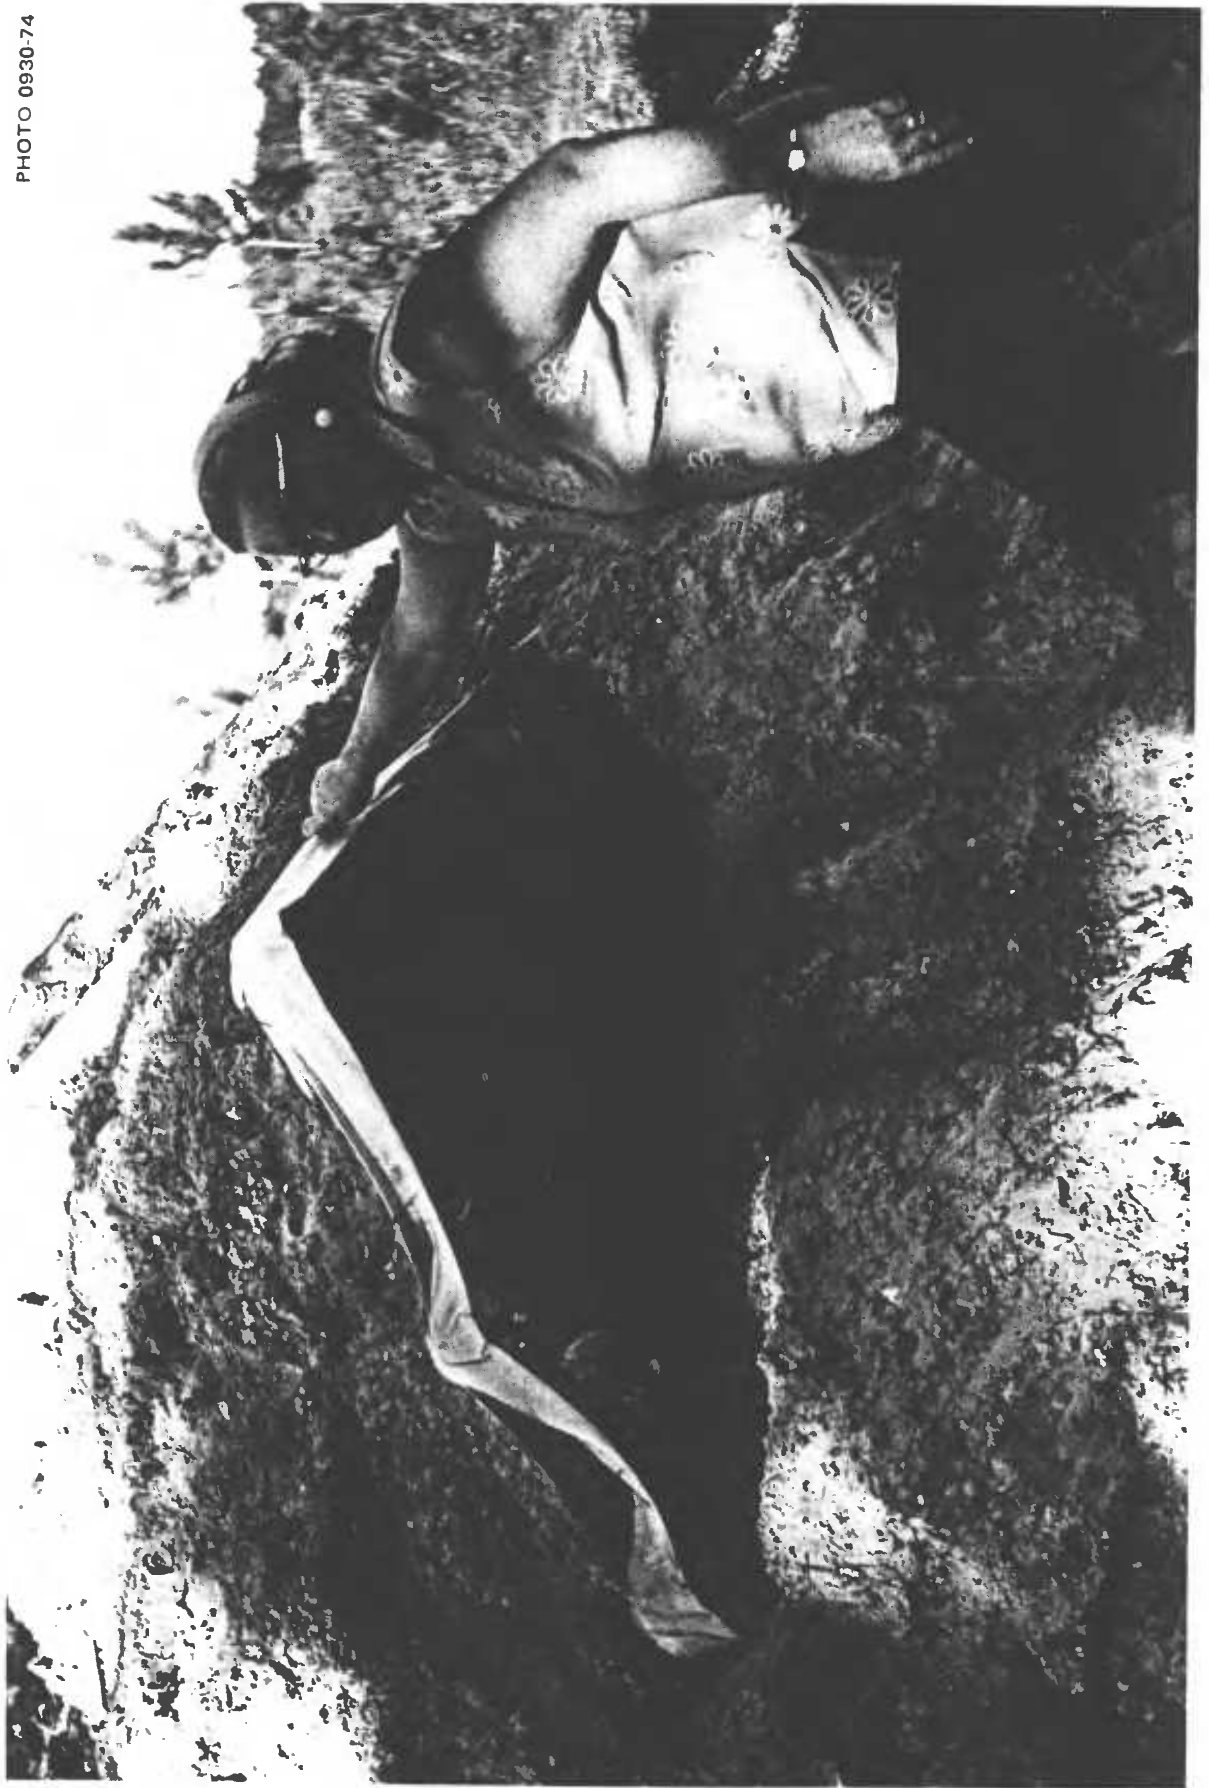
PHOTO 0930-74

Fig. 5-50. The simplified, but not as protective, ventilation opening constructed in what had been the end of the shelter toward which the skewing movement occurred. Seven-foot poles were placed on the roof poles, parallel to the ridge board and extending 3 ft beyond the outermost wall poles. Those 7-ft poles formed the overhanging gable shown in this photo. Later, the earth cover was thickened.

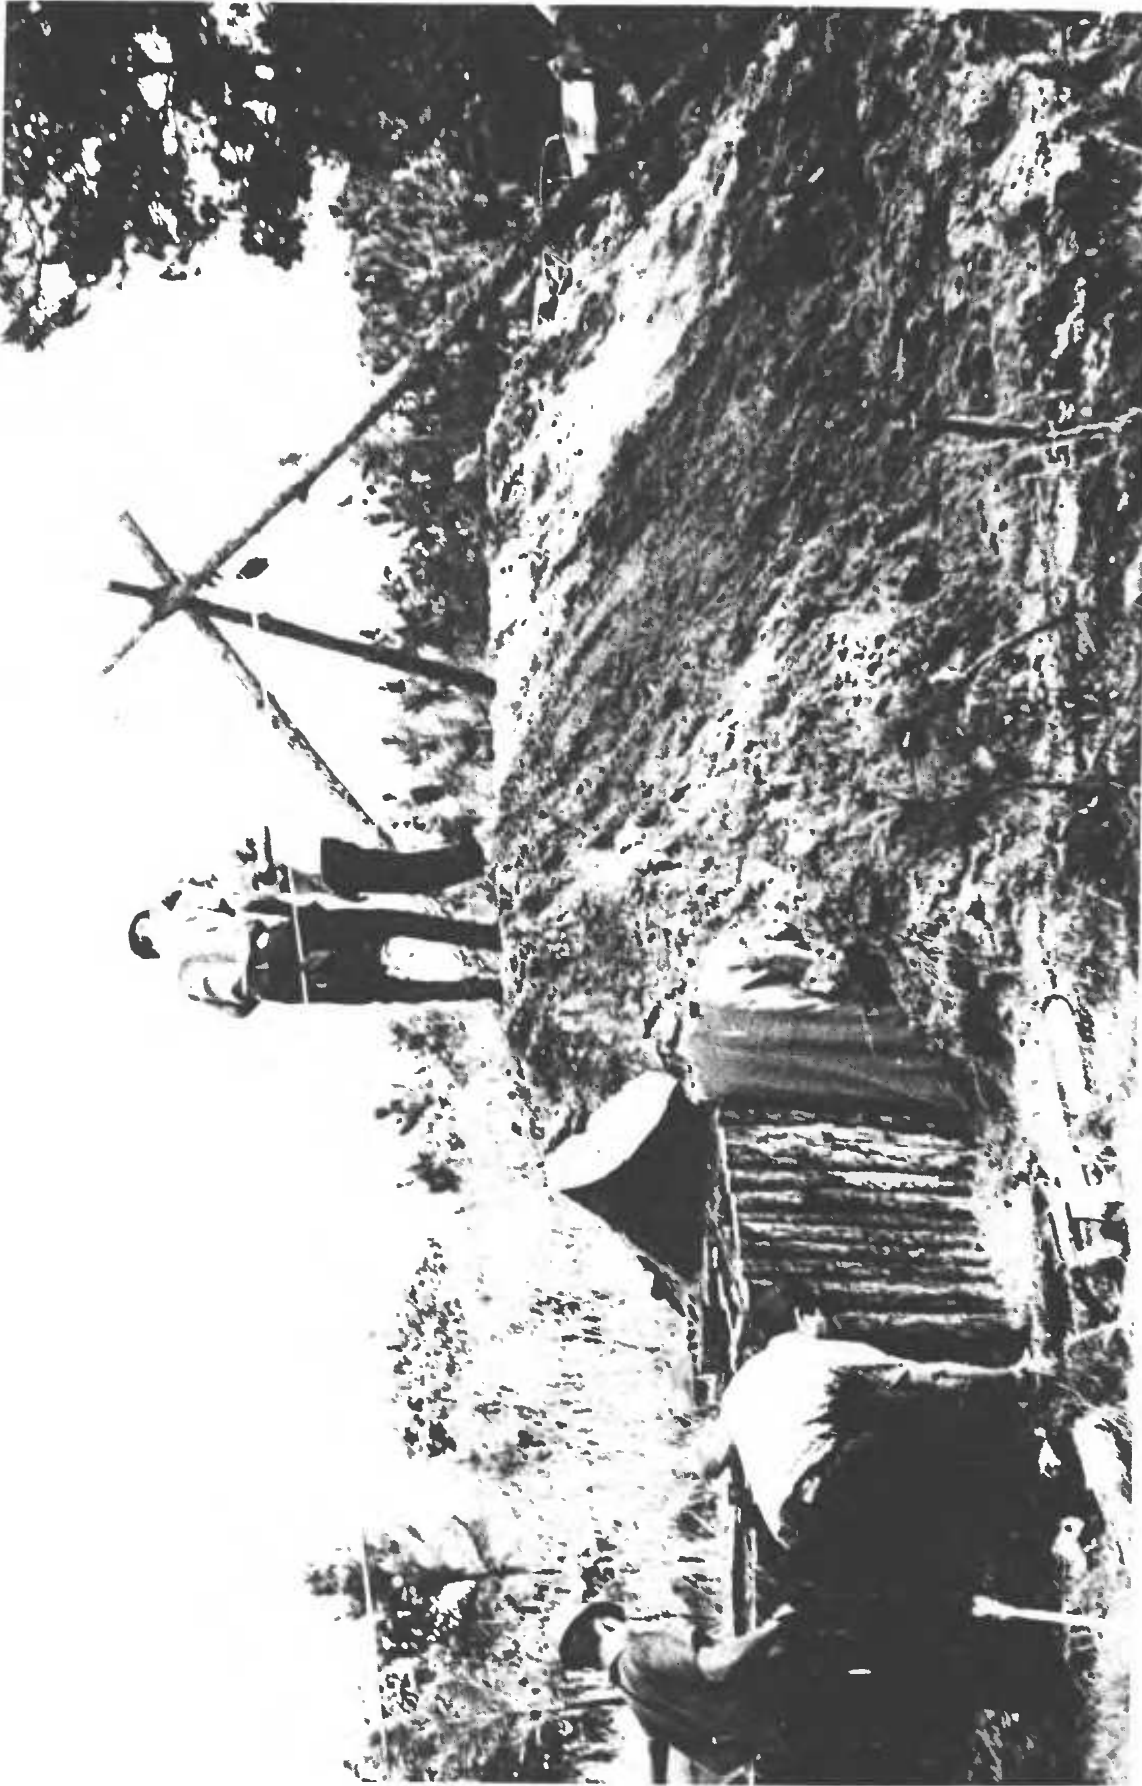
PHOTO 0925 74

Fig. 5.51. The pulley conveyor system actually wasted energy and time, since earth had to be lifted in a 5-gallon paint can up to the hook on the movable pulley; then the earth-filled can was pushed up the upward-sloping nylon rope to a position several feet above the top of the shelter. Then most of the earth rolled down below the top of the shelter, obviously wasting thousands of foot-pounds of work.

The entryway pictured is a miniature version of two small-pole shelters, joined so as to produce a 90° turn. The opening of this entryway faced away from the camera.

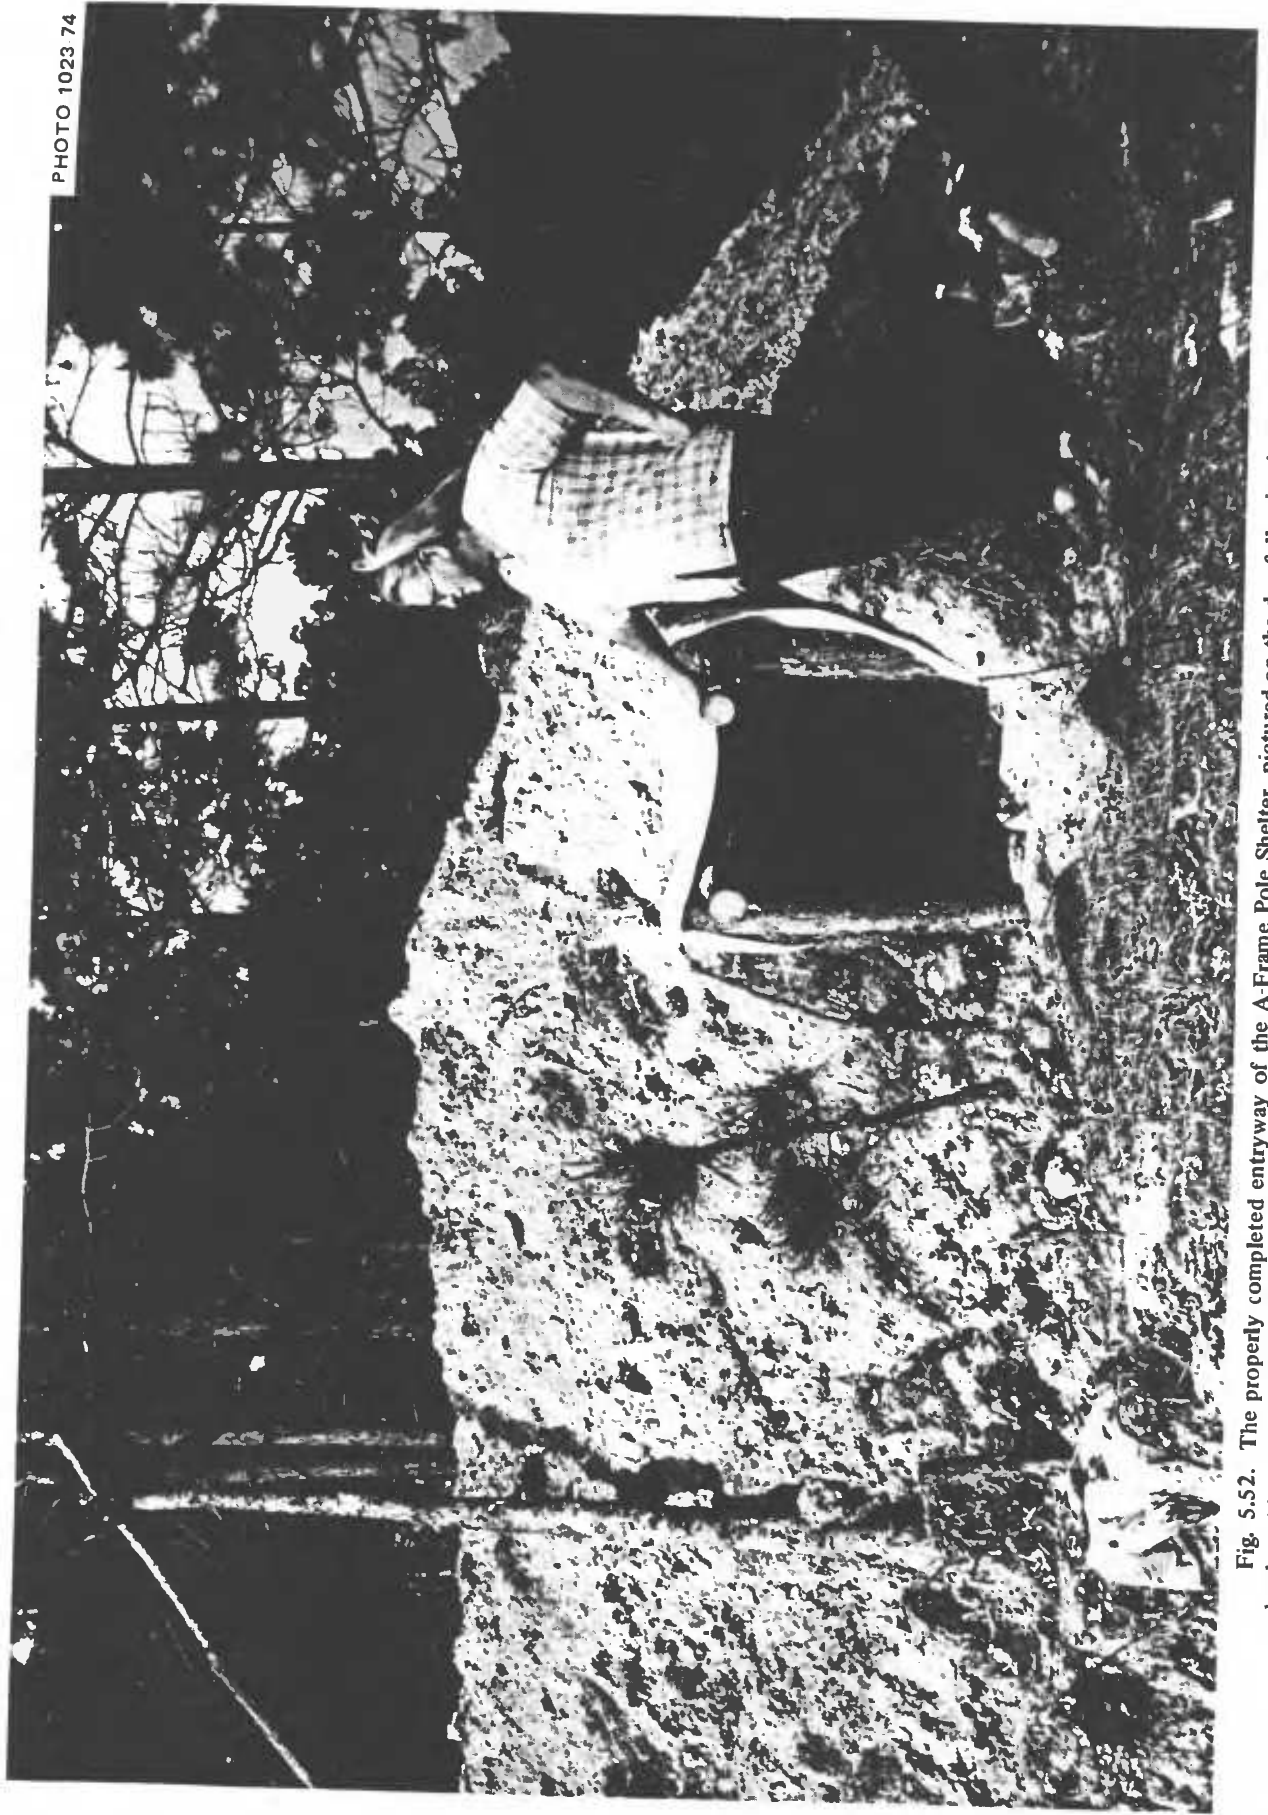
PHOTO 1023 74

Fig. 5.52. The property completed entryway of the A-Frame Pole Shelter, pictured on the day following its completion. These hard-working rural families built this 21-person shelter in 12 hours 14 minutes, from the time they received the instructions on a farm about 2 miles from the shelter-building site. The construction included moving and mounding some 80 tons of earth, using only manually powered tools to produce a covering having a minimum thickness of 6 ft.

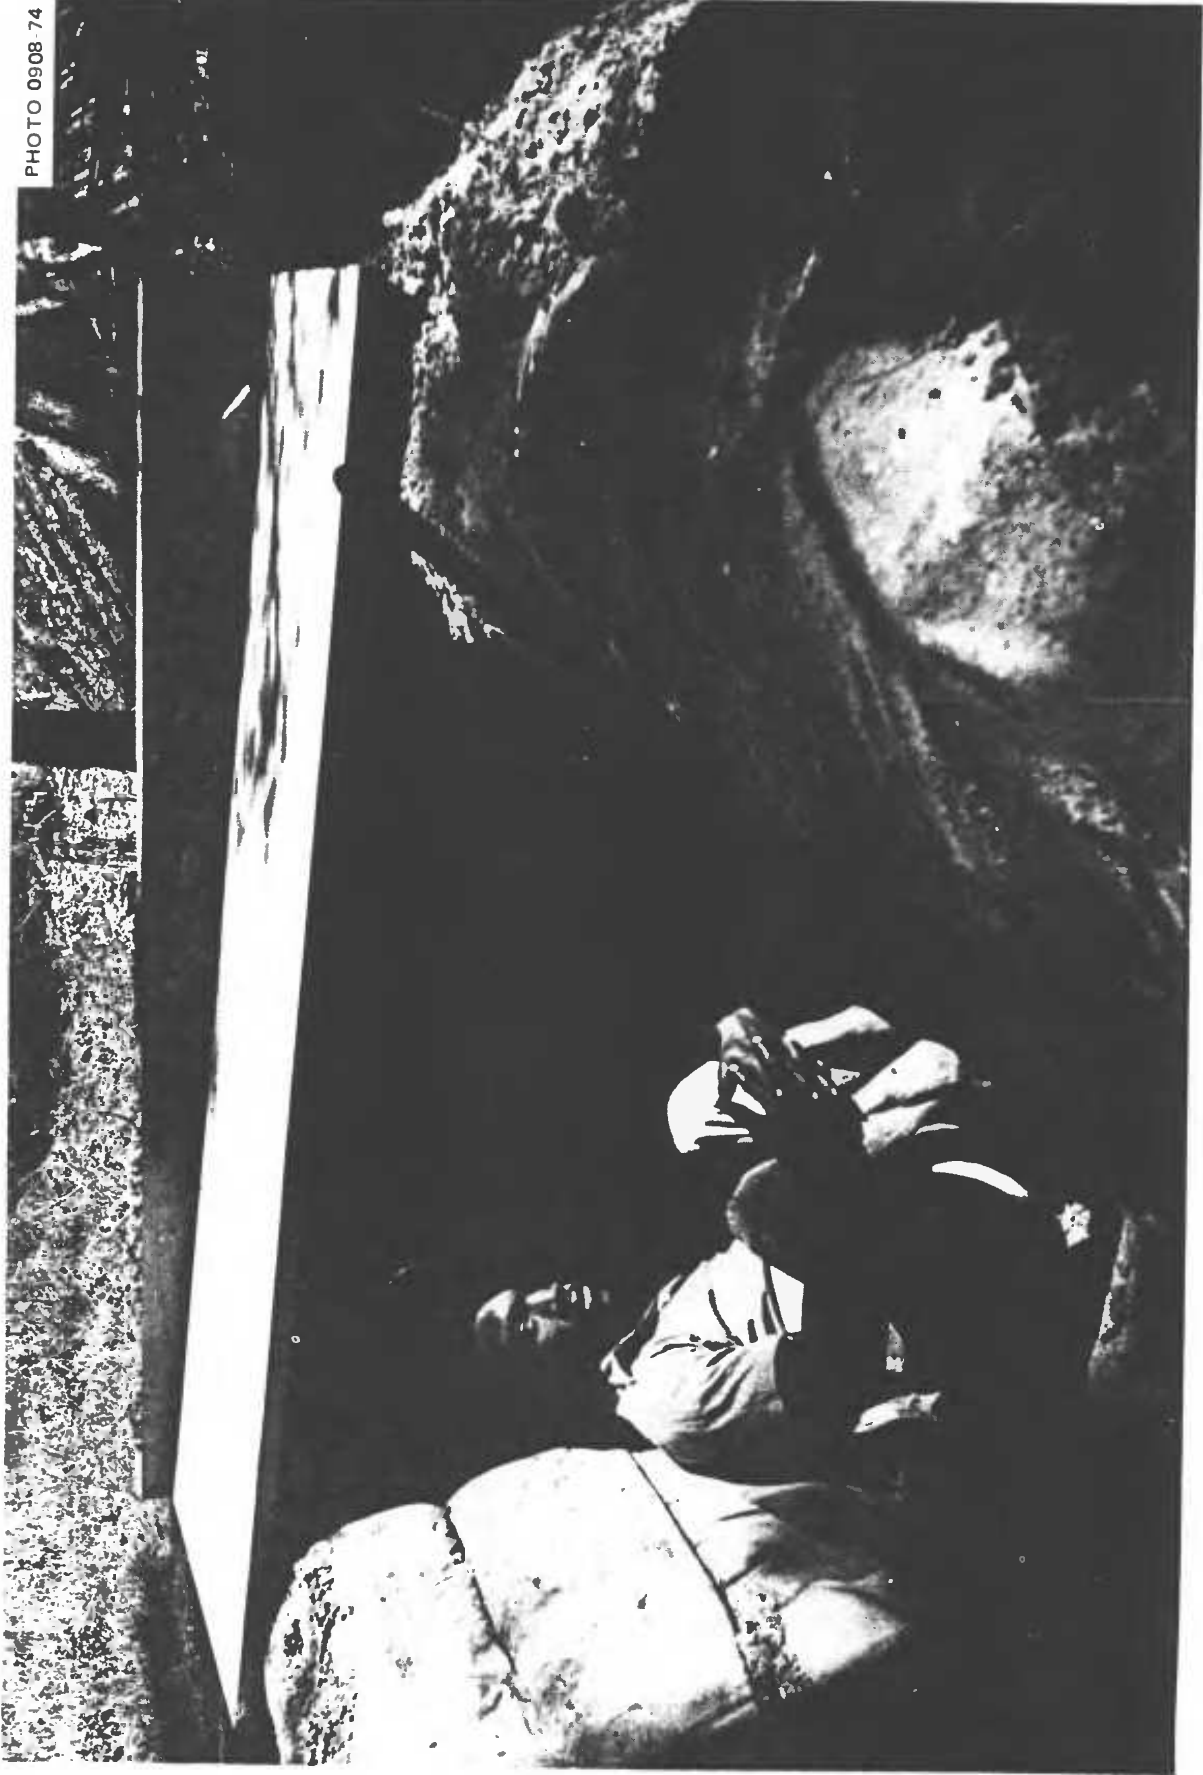
Fig. 5.55. The first of the hollow-core doors used to roof the initial prototype of an above-ground, door-covered shelter using earth-filled rolls for its walls. Since at this time Kearny did not realize that earth-filled rolls made of bed sheets or 4-mil plastic film could be used to form strong and stable *vertical* walls, these rolls were made sloping inward. This resulted in the free span of the roofing doors being about 5 ft wide. When the single-thickness doors of this roof were loaded with 15 in. of heavy, sandy soil, they broke within 1 to 3 days, although the earth was dry and no rain fell. Humidity, however, was high.

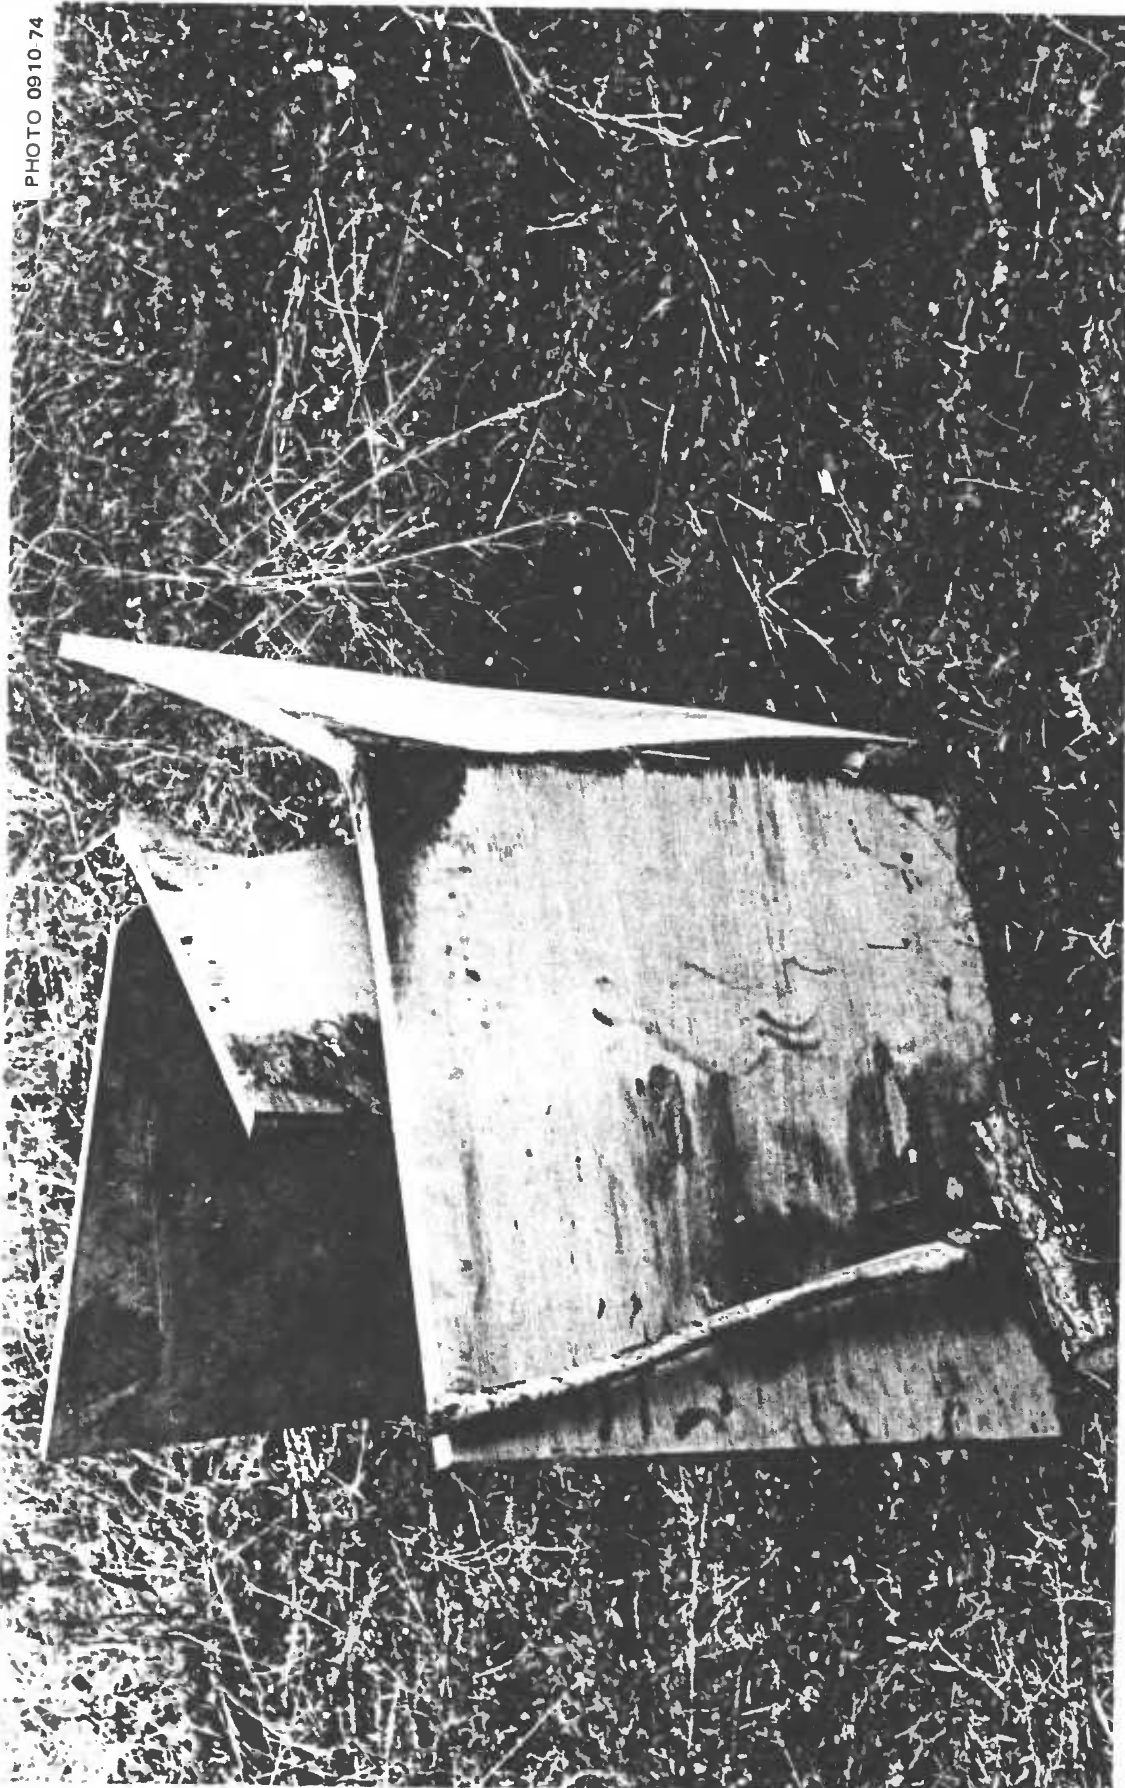
Fig. 5.56. Two of the broken roof doors after they were moved from the previously described shelter. Because the ratio of the depth of earth cover over these doors to the width of free span was too small, the centers of these broken doors fell to the floor of the shelter.

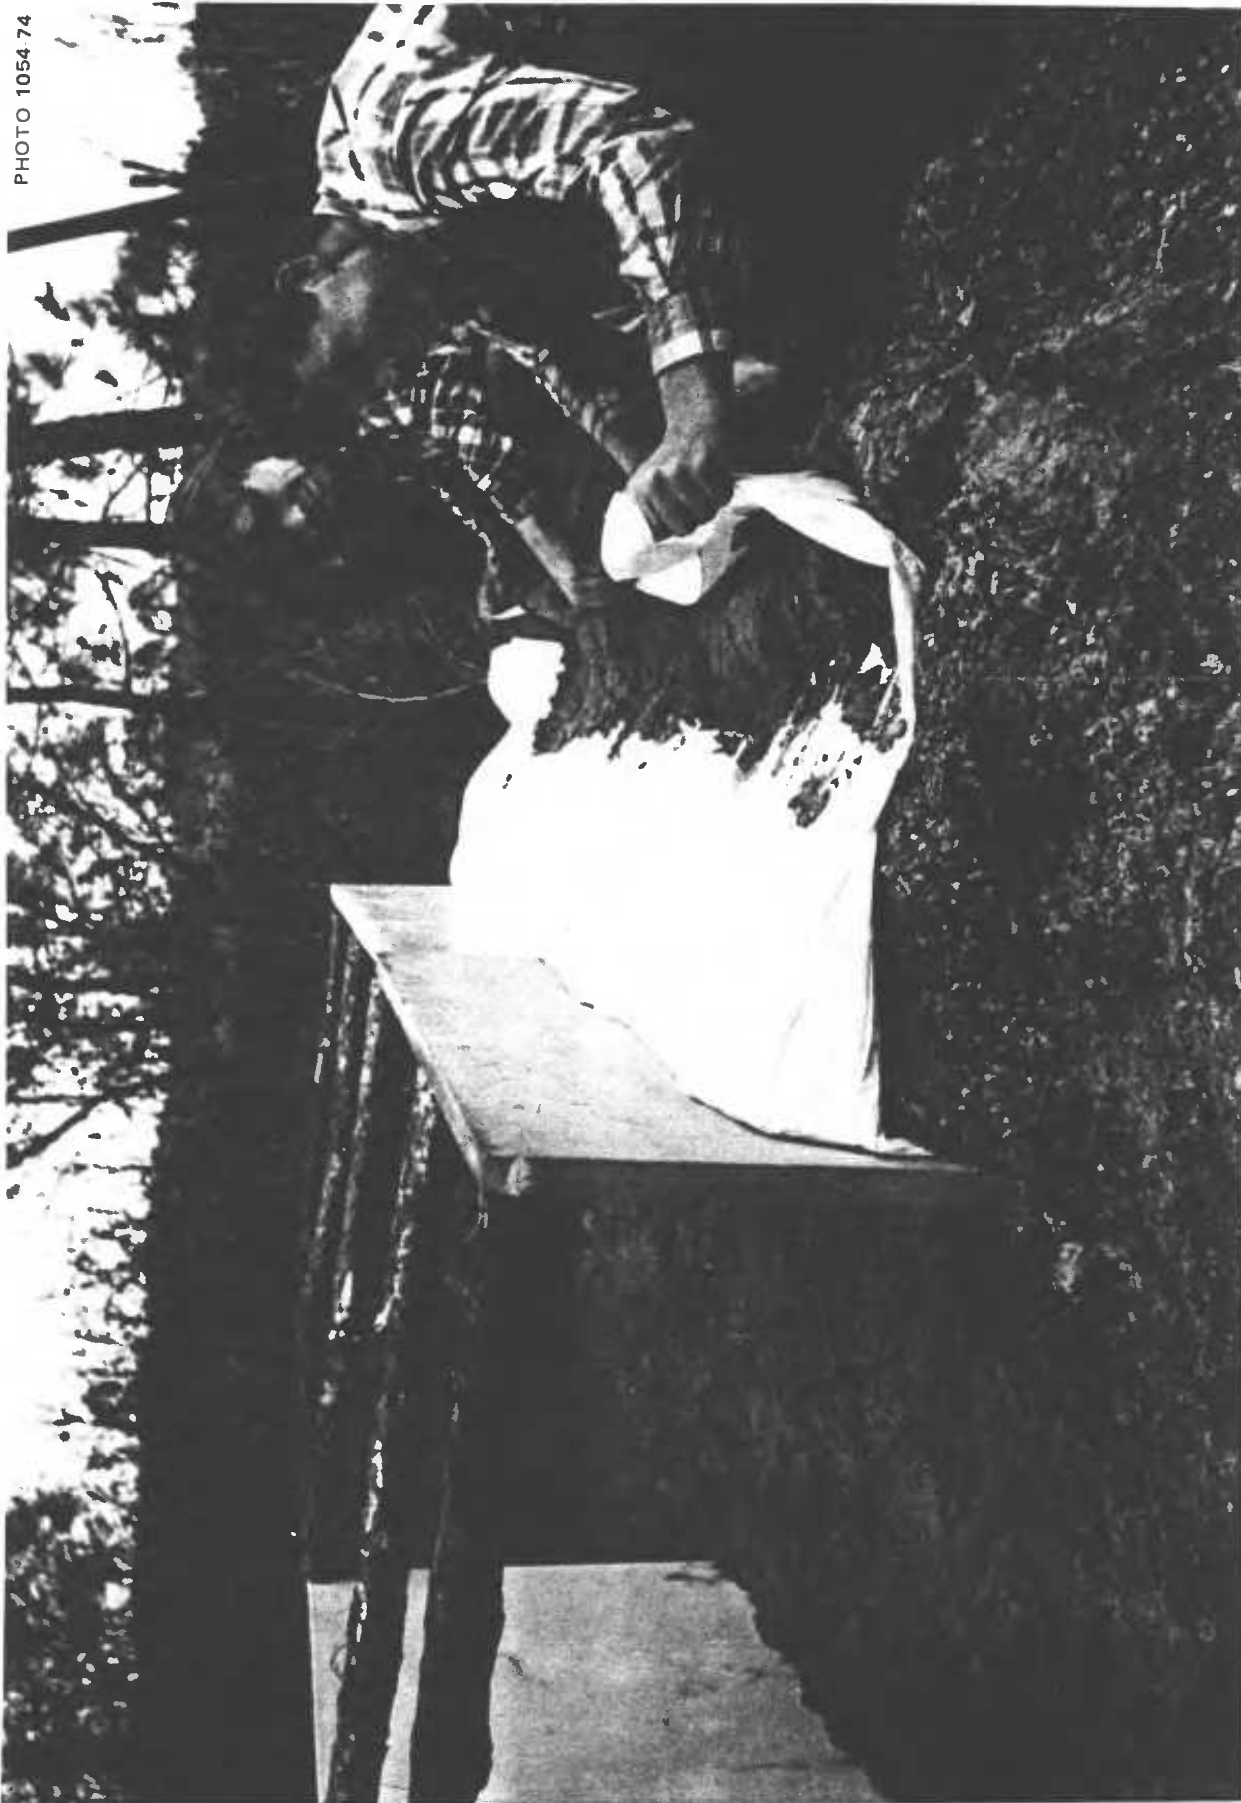
**Fig. 5.58. Workmen building the first prototype of a shelter with vertical interior walls consisting of 2 or 3 rolls, stacked one on top of the other. This photo shows the workers forming an earth-filled "hook," which holds the part of a sheet forming the upper side of a roll in place, so that especially the vertical inner side of the roll will remain in place when the door form is removed.**

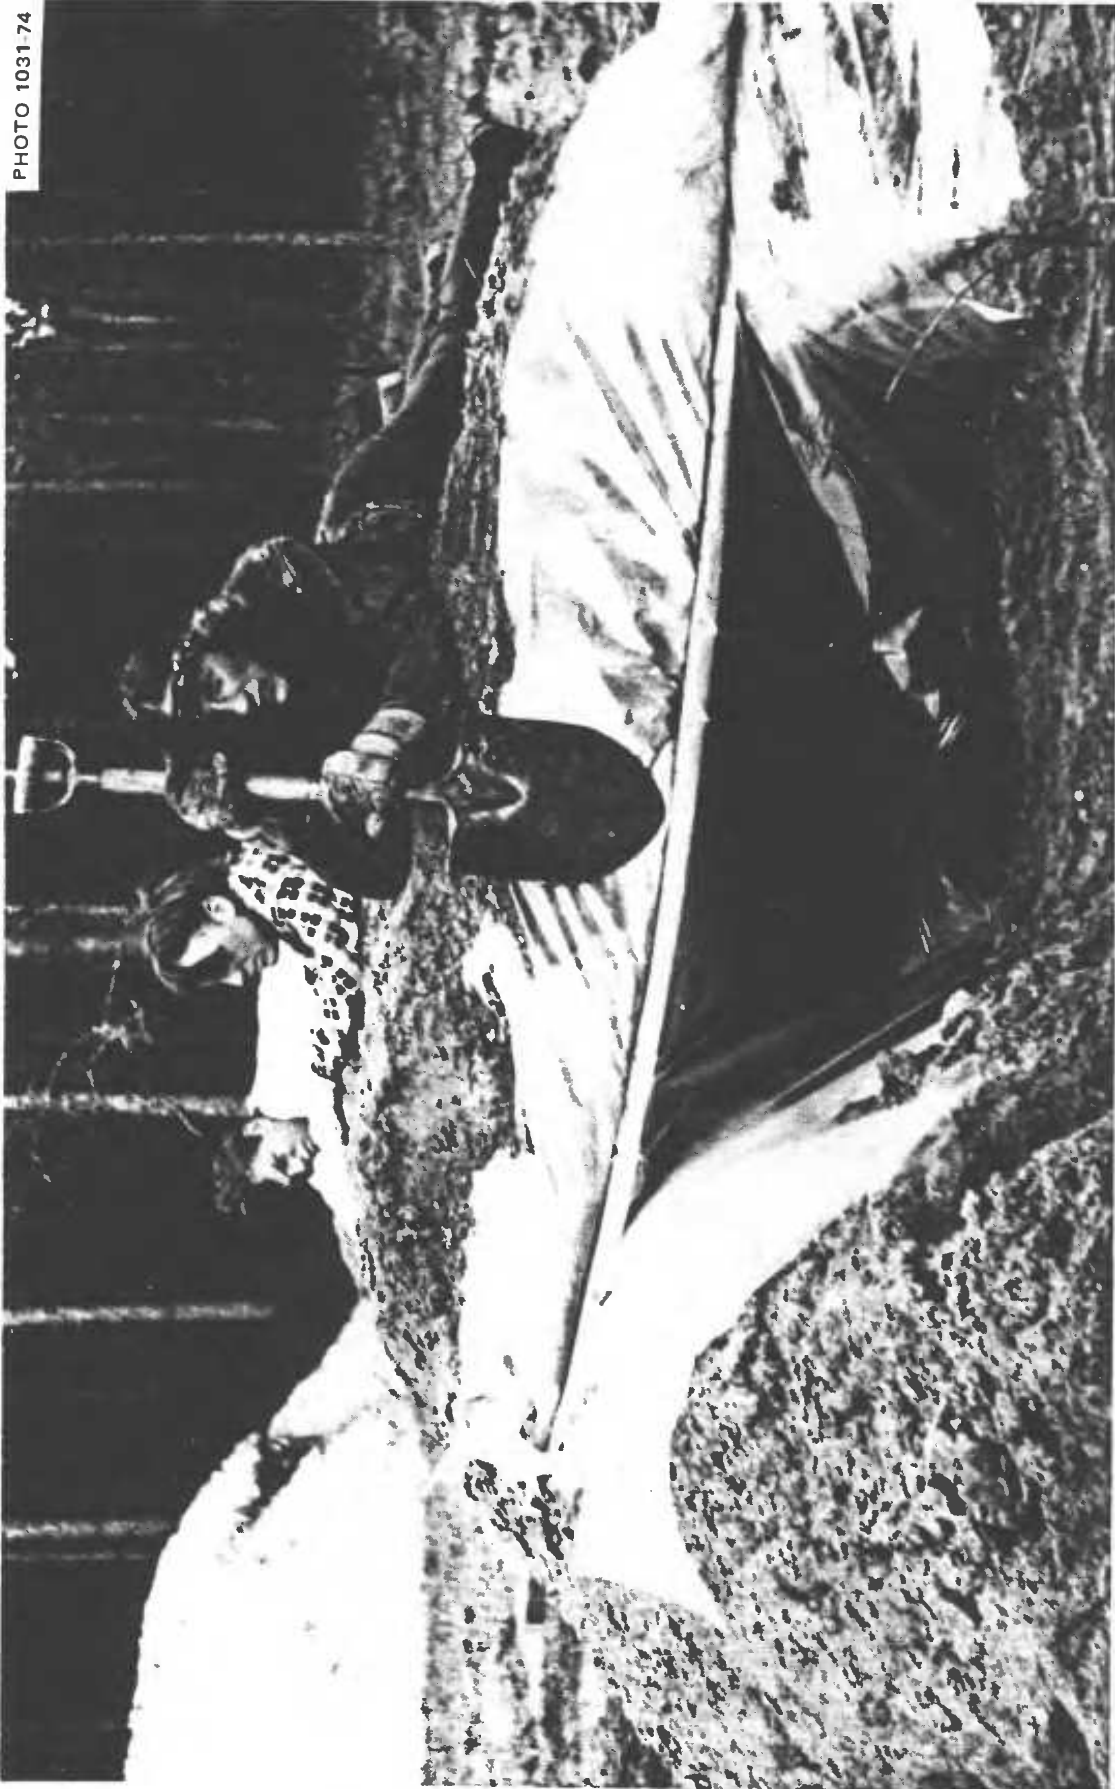
Fig. 5.59. A view of one end of an experimental setup designed to test the strength and dependability of hollow-core doors used to roof an above-ground shelter with vertical walls made of earth-filled rolls, under humid, wet conditions. Two doors that had been painted with two coats of interior-type latex paint were only slightly bowed after being subjected to the pictured loading for almost a month. The doors were protected from moisture by a sheet of 4-mil polyethylene placed directly on them. Note that this roof slopes to the right, so that water will not leak through the plastic.

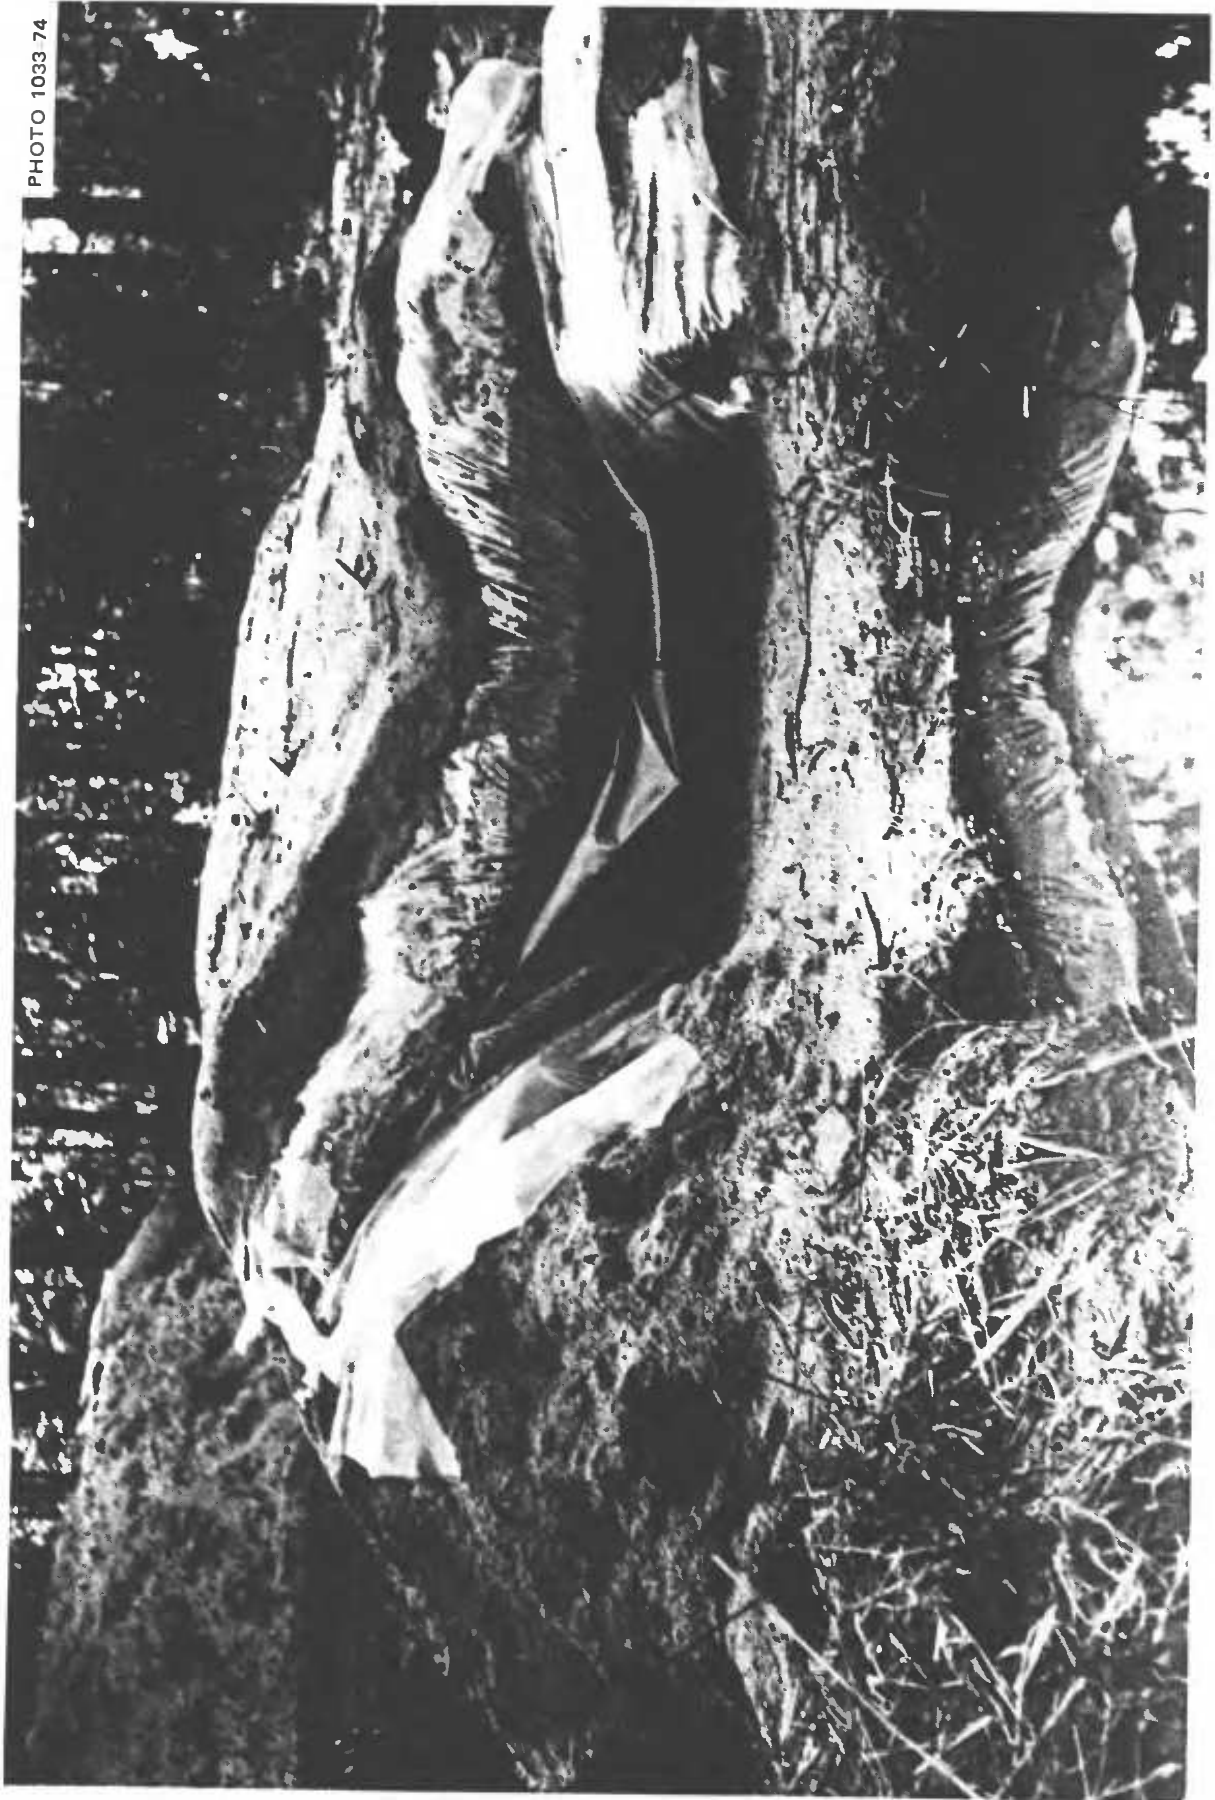
PHOTO 1033 74

Fig. 5.6.1. The opposite end of the roof-door experimental setup, photographed almost one month after the beginning of this experiment. This broken-in door was unpainted. The same type of polyethylene film covered all the doors in this test. The unpainted door absorbed more moisture and was broken by the same thickness of wet earth cover that the painted doors survived. However, if the roof broke in this manner, occupants of a shelter would not have been injured, due to the fact that earth arching prevented the broken door from being dangerously depressed into the shelter.

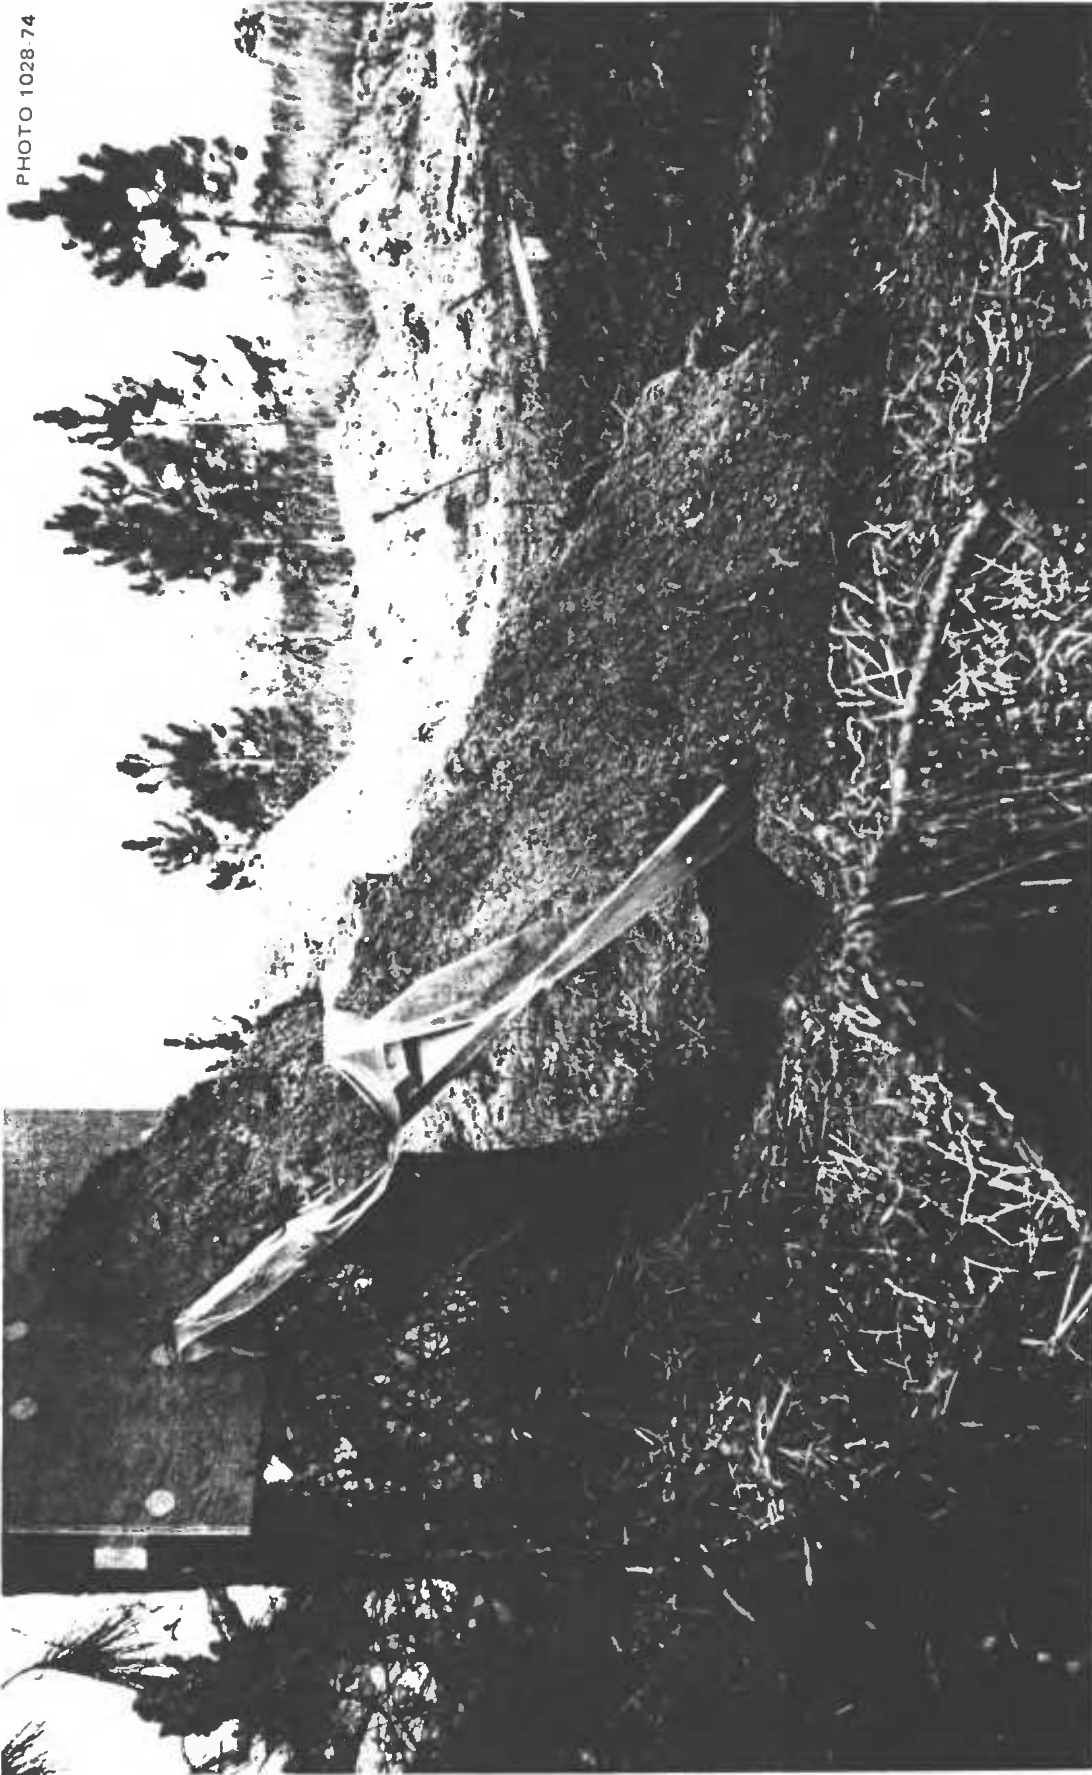
PHOTO 1028-74

Fig. 5.64. The door was loaded with about half the specified average thickness and weight of earth, due to earth falling off the sides.

Note the protective covering of 4-mil polyethylene film placed directly on the door. Prior tests in this humid part of Florida showed that if waterproofing material is not placed directly on a hollow-core door, the cardboard honeycomb of the door becomes damp, and the door fails much sooner than if the damp, wet earth is not in direct contact with it.

When this single roof door was thus loaded with approximately half the weight per square foot of earth specified for a double-thickness door roof, this door was not over-stressed, and the downward bow did not increase for the three days of testing before the earth was removed.

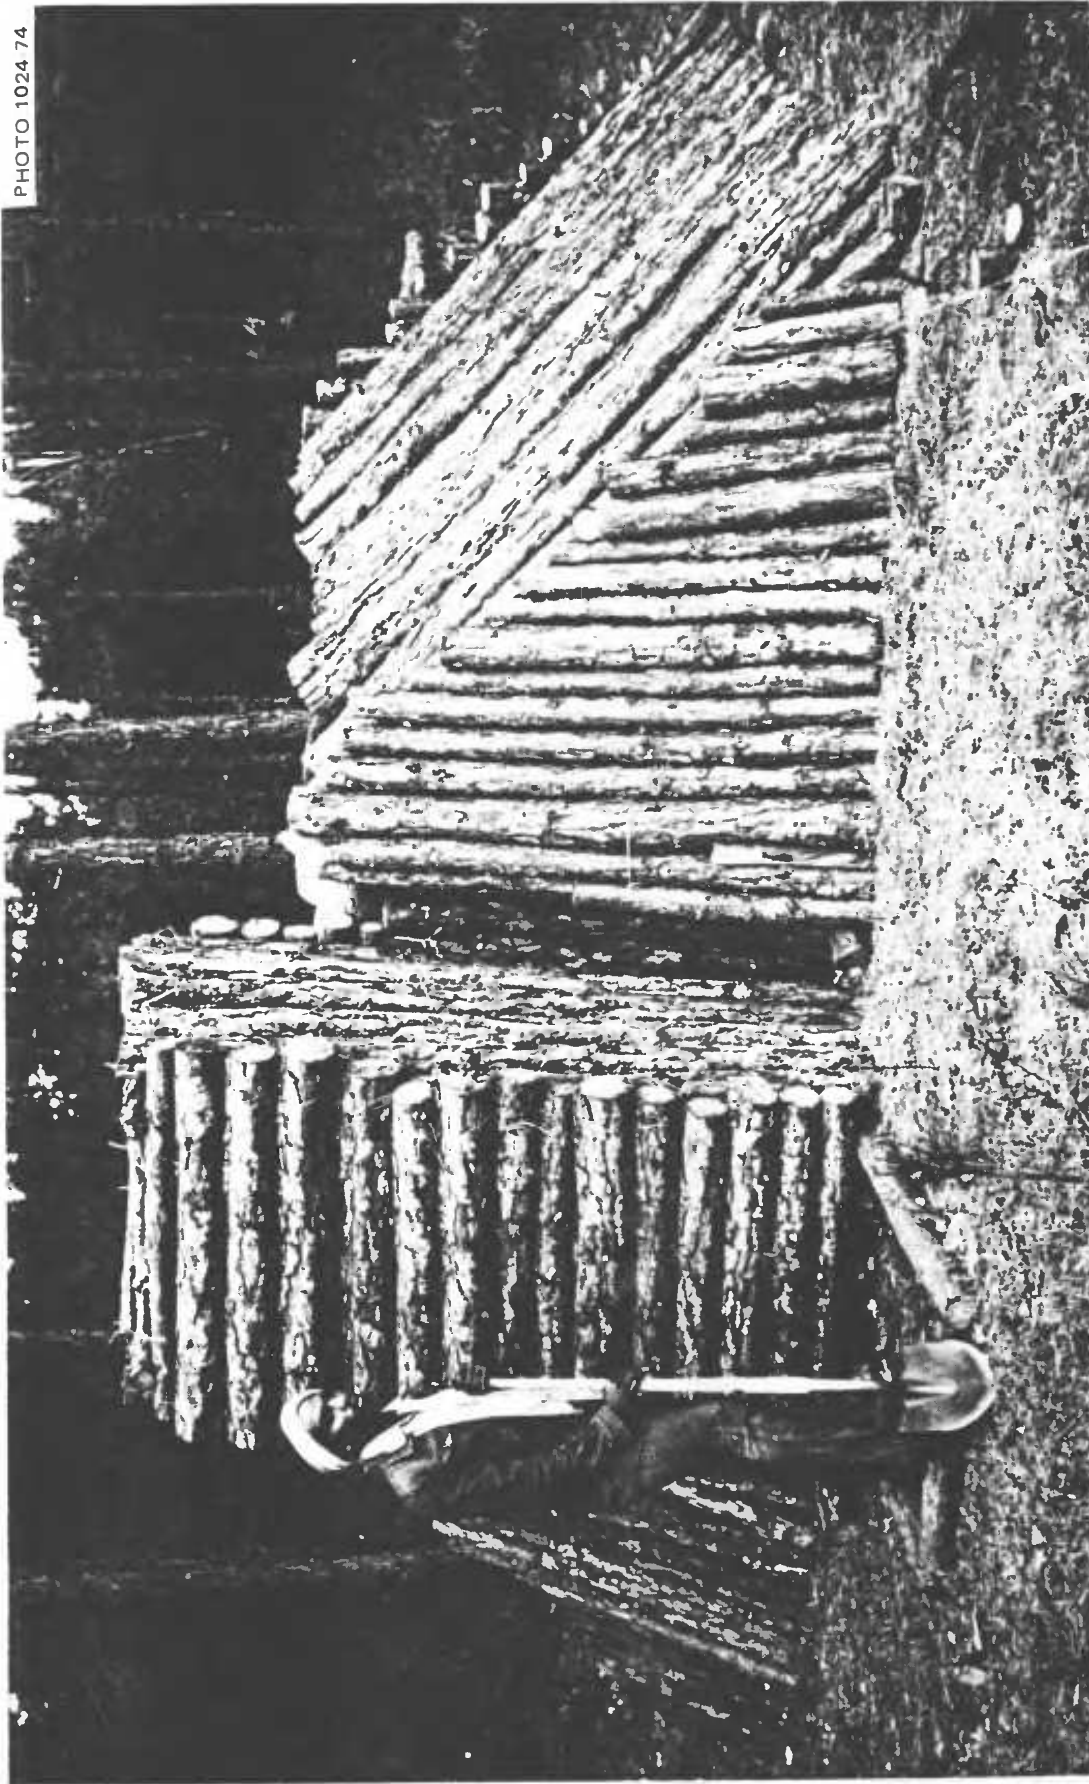
PHOTO 1024 74

**Fig. 5.66.** An above-ground Small-Pole Shelter with an interconnected room on each side, beneath 9-ft side-wall poles that slope at  $36^\circ$ . This prototype shelter had 200 sq ft of floor space in its three rooms, was built by a contractor's workmen, and later was covered with a full 2 ft of earth by a backhoe.

Kearny concluded this shelter was impractical for even average *rural* Americans to build because: (1) The two doorways near the ends of the two side rooms were quite difficult to build, yet did not result in a measurable volume of air flowing through the side rooms even when a KAP was forcing a pleasant breeze through the center room; and (2) Ridge-Pole and A-frame Above-Ground Shelters are easier to build and cover with earth, and permit straight-through, efficient ventilation, both natural and forced.
