ORNL-5039  
UC-41-Health and Safety

EXPEDIENT SHELTER CONSTRUCTION AND  
OCCUPANCY EXPERIMENTS

Cresson H. Kearny

MARCH 1976

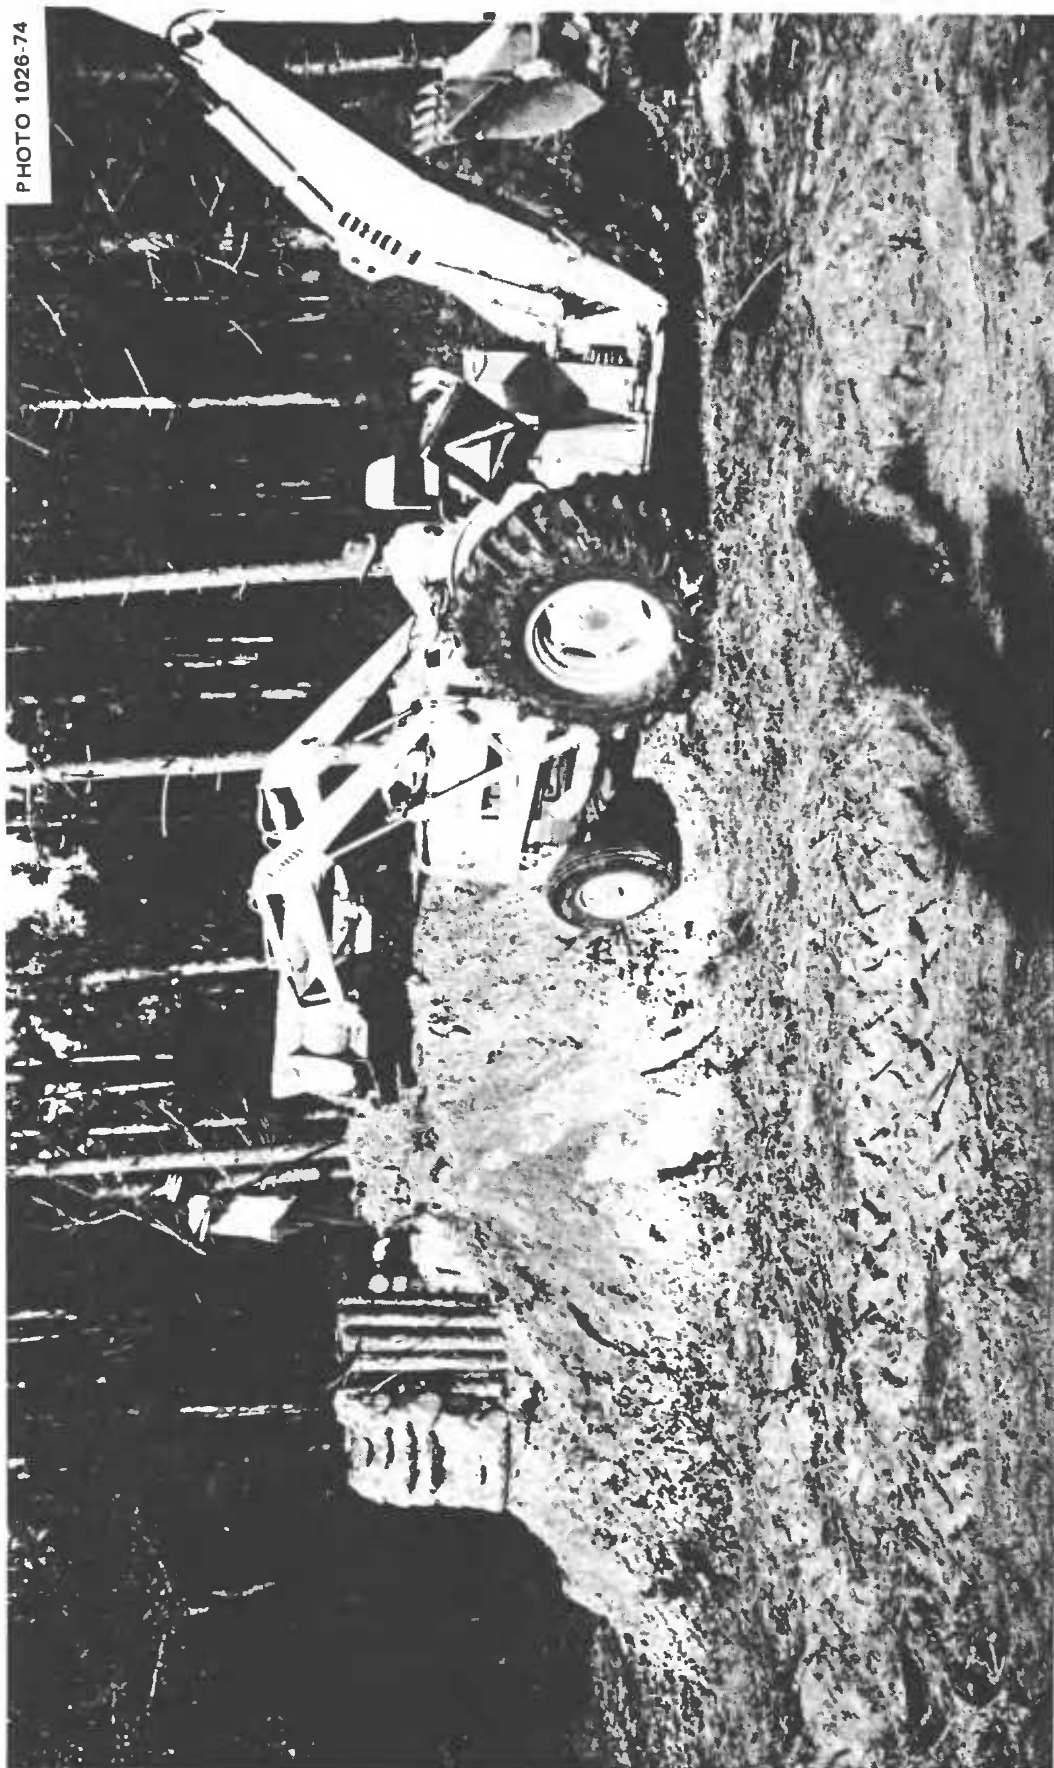
PHOTO 1026-74

**Fig. 5.68. Backhoe covering the unsuccessfully modified Small-Pole Shelter with three rooms built entirely above ground. The backhoe worked for almost 5 hours to place earth on this shelter to a minimum depth of 2 ft, because it could excavate only a little over a foot deep without getting stuck. The backhoe repeatedly had to lift itself out of the mud on both its buckets, although this work was done toward the end of a long dry spell.**

Machines in areas with high water tables are relatively more handicapped than are men working with hand tools. Kearny concluded that above-ground, stoop-in, single-room shelters with roofs that slope upward rather gently on both sides to a ridge line are more practical for builders to cover with shielding earth than are shelters with rectangular cross sections that have equal maximum ceiling heights and equal floor areas. The former shelters require less than half as much earth to cover to a minimum depth of 2 ft than do the latter shelters, with their vertical sides.

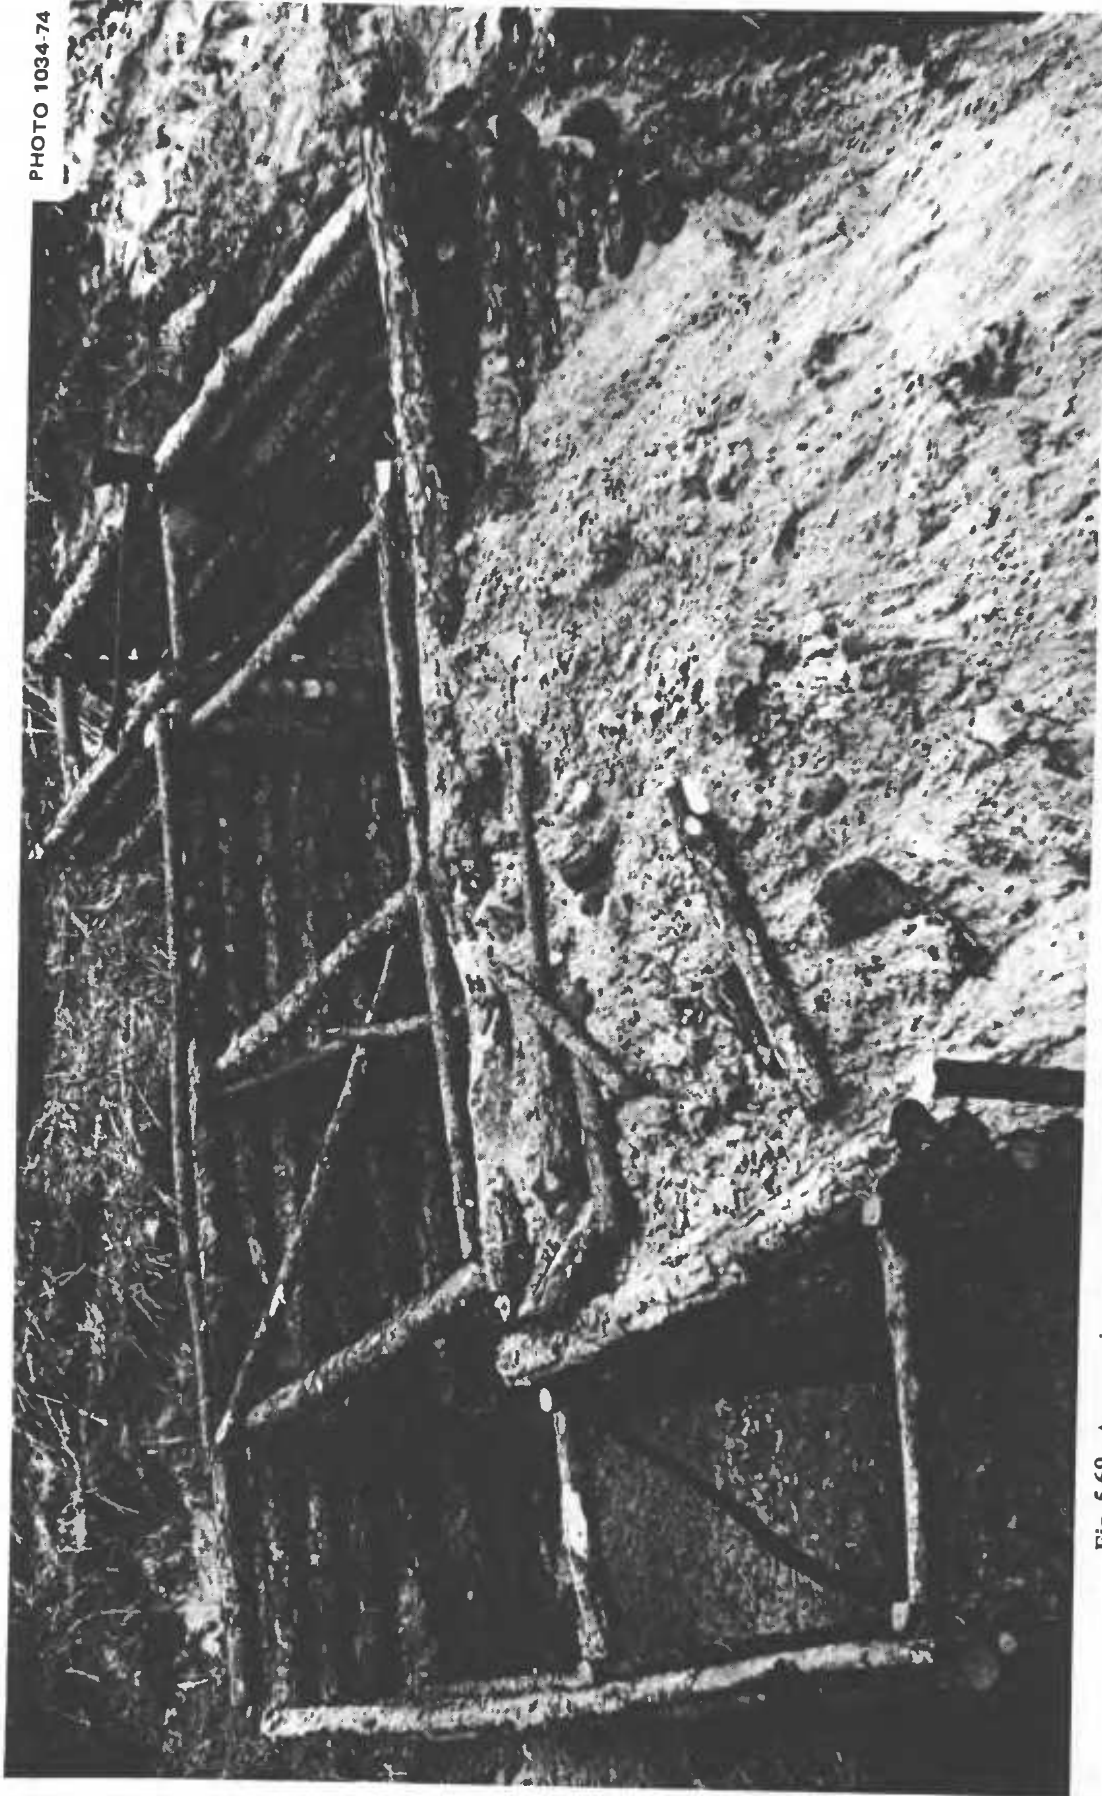
PHOTO 1034-74

Fig. 5.69. An experimental, partially completed, prototype stoop-in pole shelter designed by Kearny with horizontal wall poles, in order to minimize the cutting of poles needed to build a given area of walls. After the level of the earth mounded around this shelter had been raised about 3 in. higher than the uppermost poles, the 6-ft-wide shelter was roofed with 9-ft poles resting on the mounded earth. Then 2 ft of earth cover was placed on the roof.

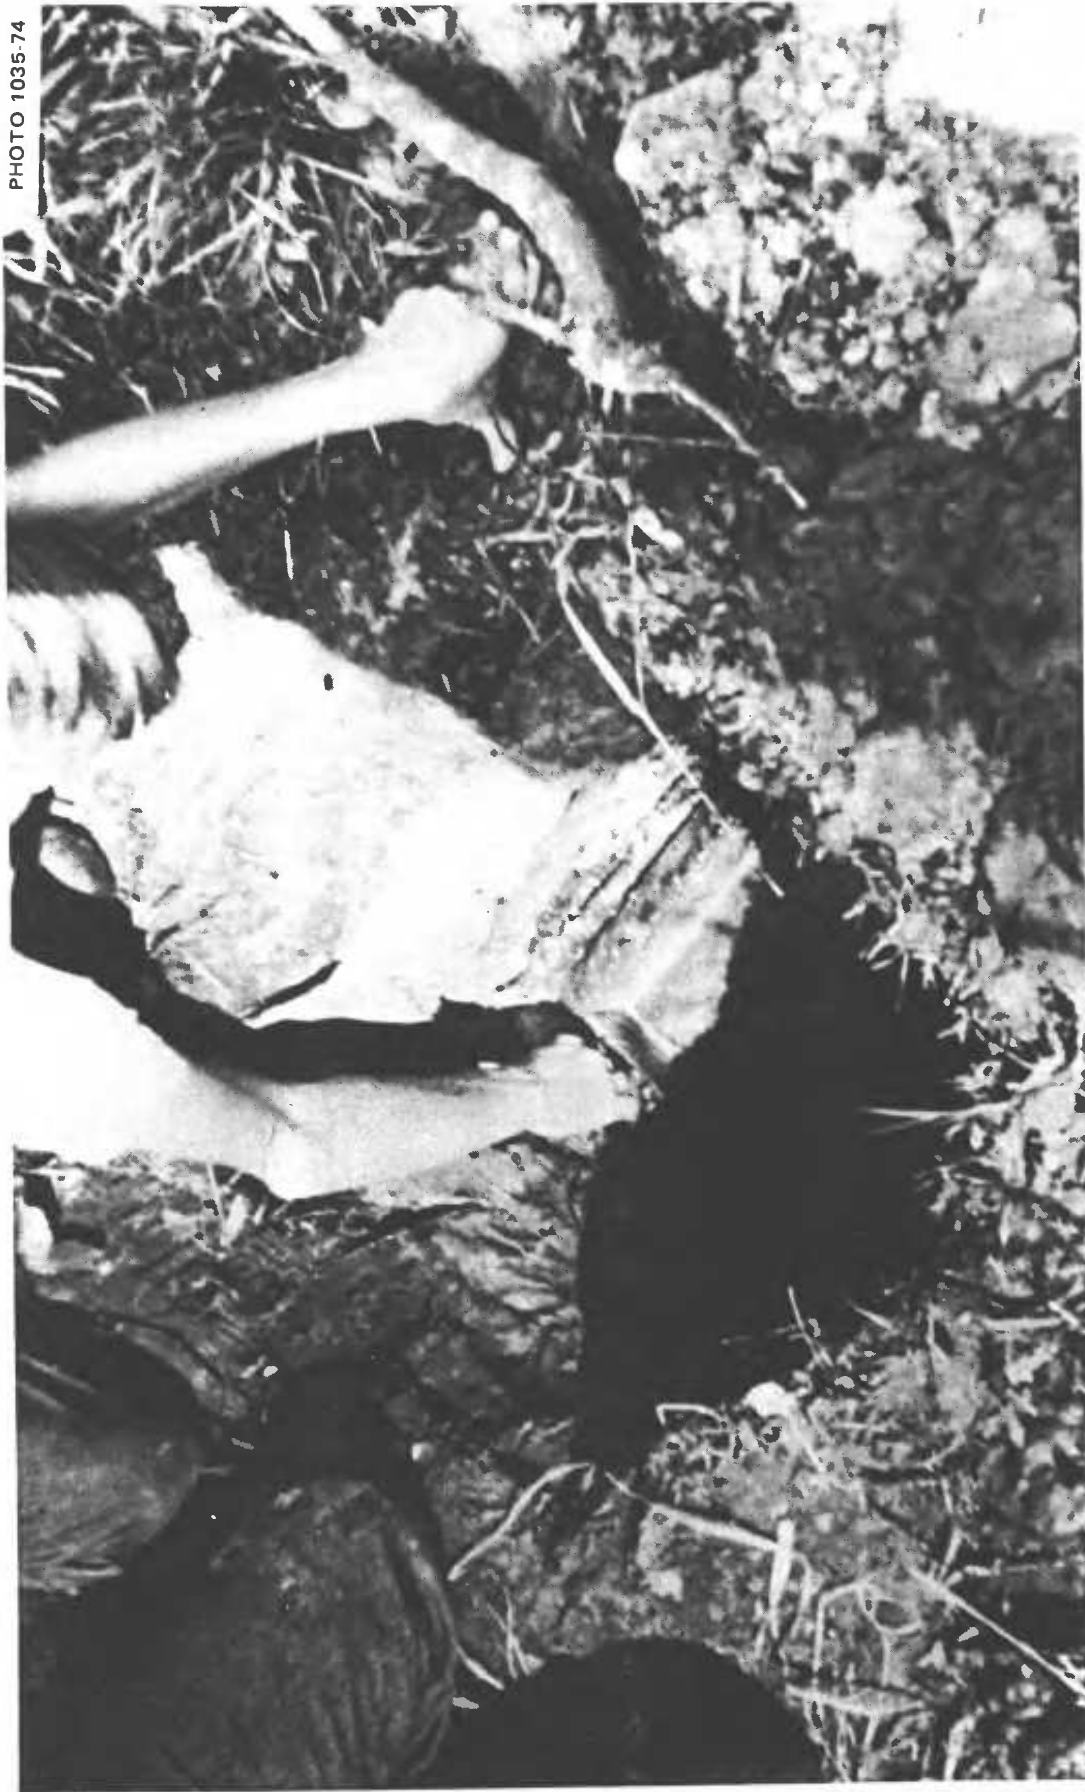
PHOTO 1035-74

**Fig. 5.70. A shallow well for drinking water, dug into the free-flowing sand below the water table. Note the rectangular board shoring, which was forced downward as the free-flowing sand was dug out from inside and below this shoring frame. Twigs and leaves were stuffed in behind the frame, to help check the inward flow of sand, that otherwise would have led to the collapse of the sides of this well. Without instructions, average Americans would not be able to dig a well inside their shelter, from which they could dip water repeatedly without causing disastrous caving.**

Kenny successfully dug another shallow water well in this area, by driving eight 3-ft pole stakes in a circle 18 in. in diameter. He drove these stakes from the bottom of a 2-ft-diameter hole after first digging to the top of the water table, which was 15 in. below the surface. He placed thin saplings and grapevines behind the eight stakes, as the well was dug deeper, to prevent sand from flowing into the well.

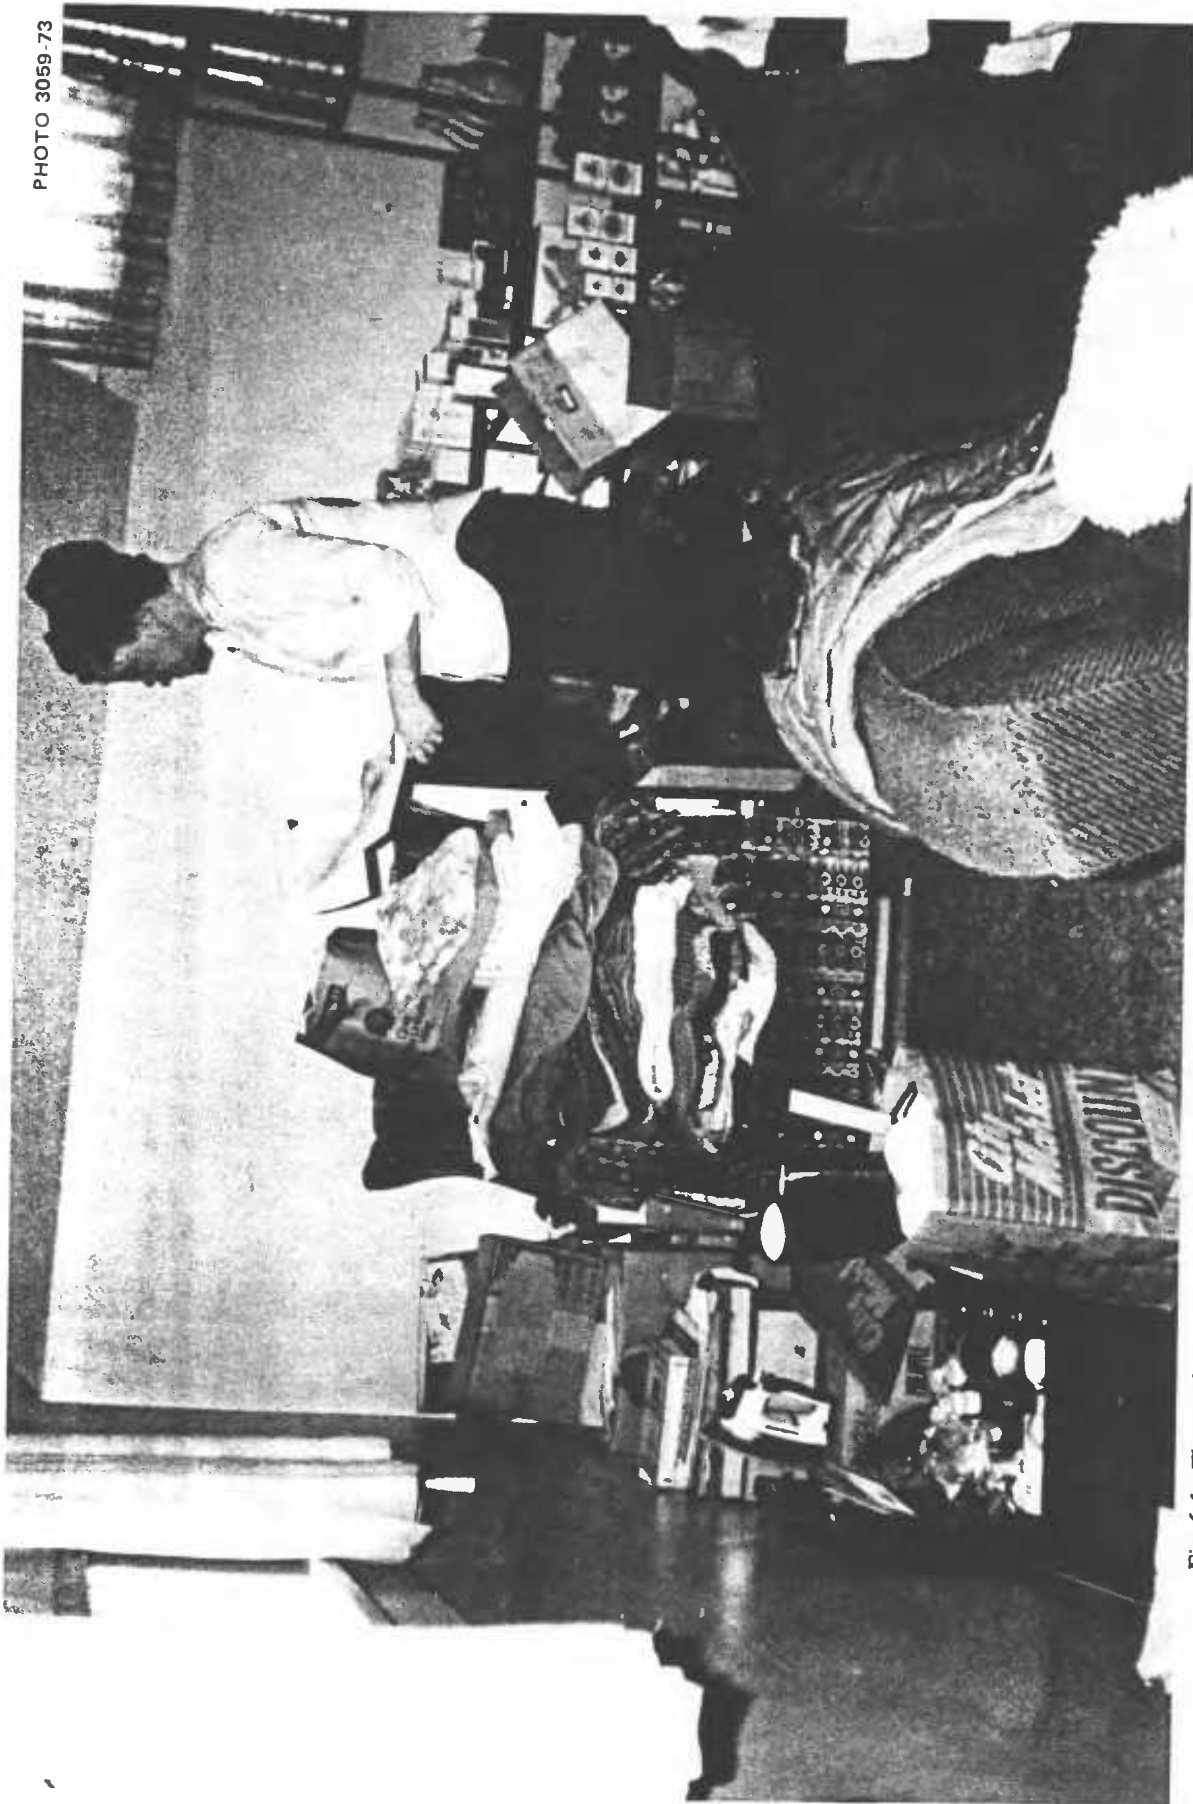
PHOTO 3059-73

Fig. 6.1. The mother of an urban family assembling the recommended categories of items (see Evacuation Check List, Table 1), preparatory to simulating evacuating a city in their family car and building a Car-Over-Trench Shelter. This family had recently come to Montrose, Colorado, from Los Angeles and had not yet finished settling into their small apartment in the town of Montrose. On receiving the check list for evacuees and the shelter-building instructions at 8:03 AM on Nov. 24, 1973 (simulating their receiving this survival information in a crisis edition of the local newspaper), they first spent 12 minutes reading, then started assembling the various categories of recommended items to be taken in their car.

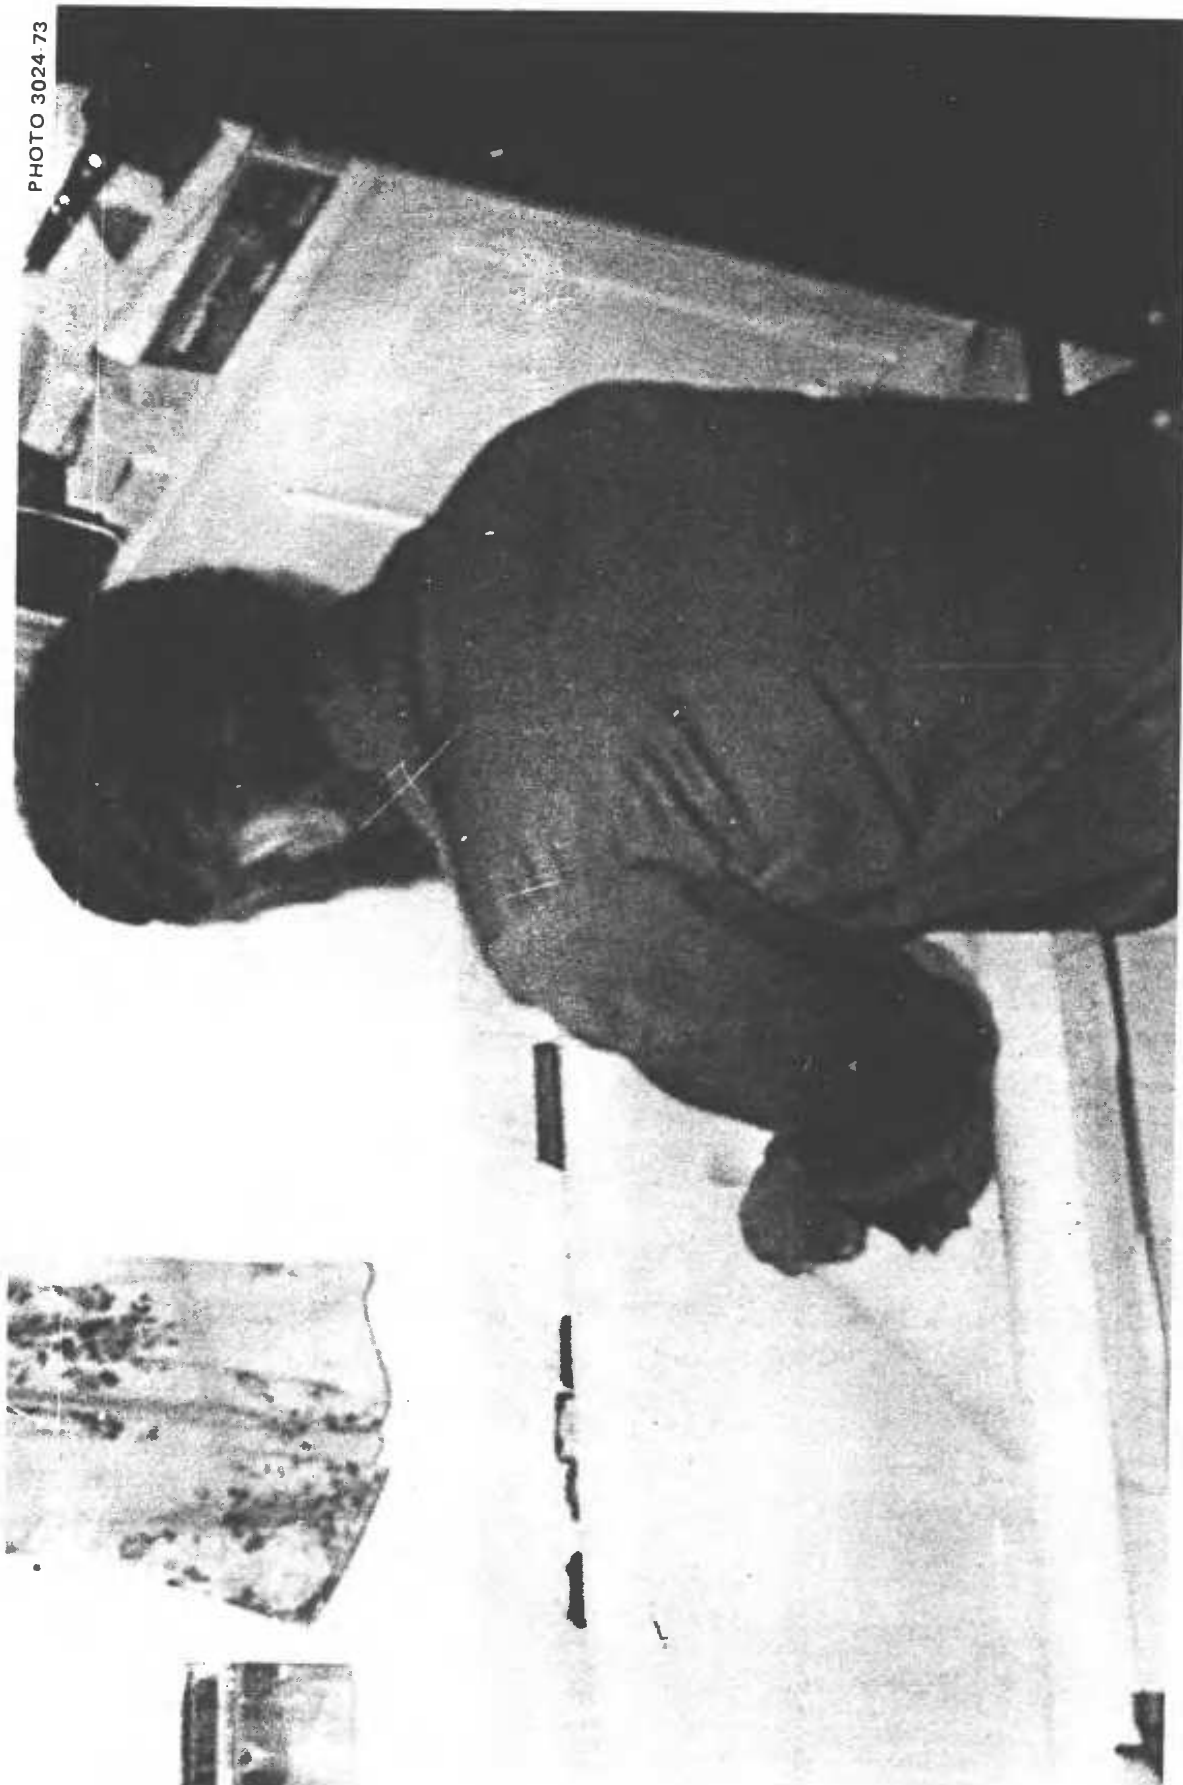
PHOTO 3024 73

**Fig. 6.2. The father washing three plastic garbage disposal cans (each about 5-gallon capacity) preparatory to disinfecting them with Clorox. He followed the instructions for providing large-volume water containers. One of these lidded cans was filled with water and, nested inside the two empty cans, was carried in the car to the building site.**

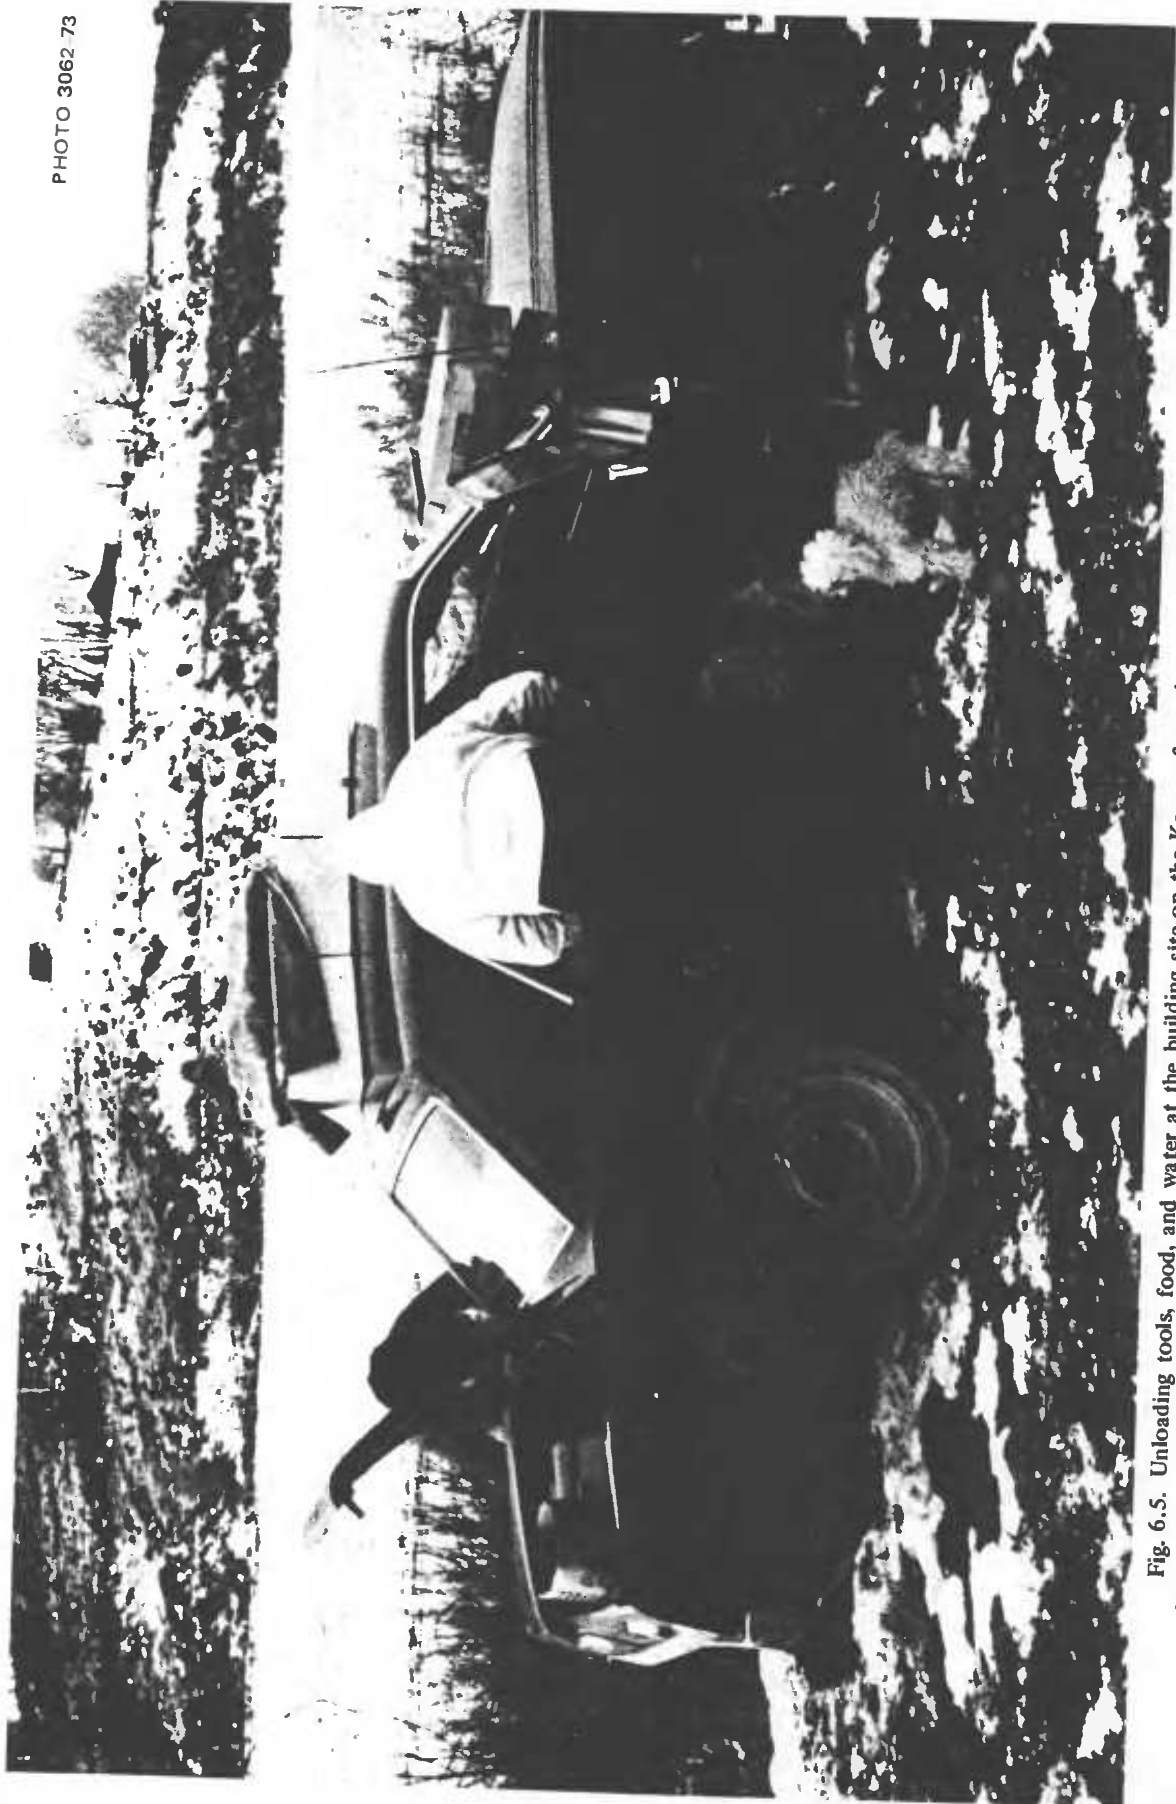
PHOTO 3062-73

**Fig. 6.5. Unloading tools, food, and water at the building site on the Kearny farm about 5 miles from Montrose. Work on the shelter began at 10:11 AM. This family brought along two items that were not on the Evacuation Check list (and will not be), but which they said they would carry with them in a real evacuation: their .38 automatic with extra ammunition and their toy poodle. Both the pampered poodle and daughter stayed in the car almost all of the time.**

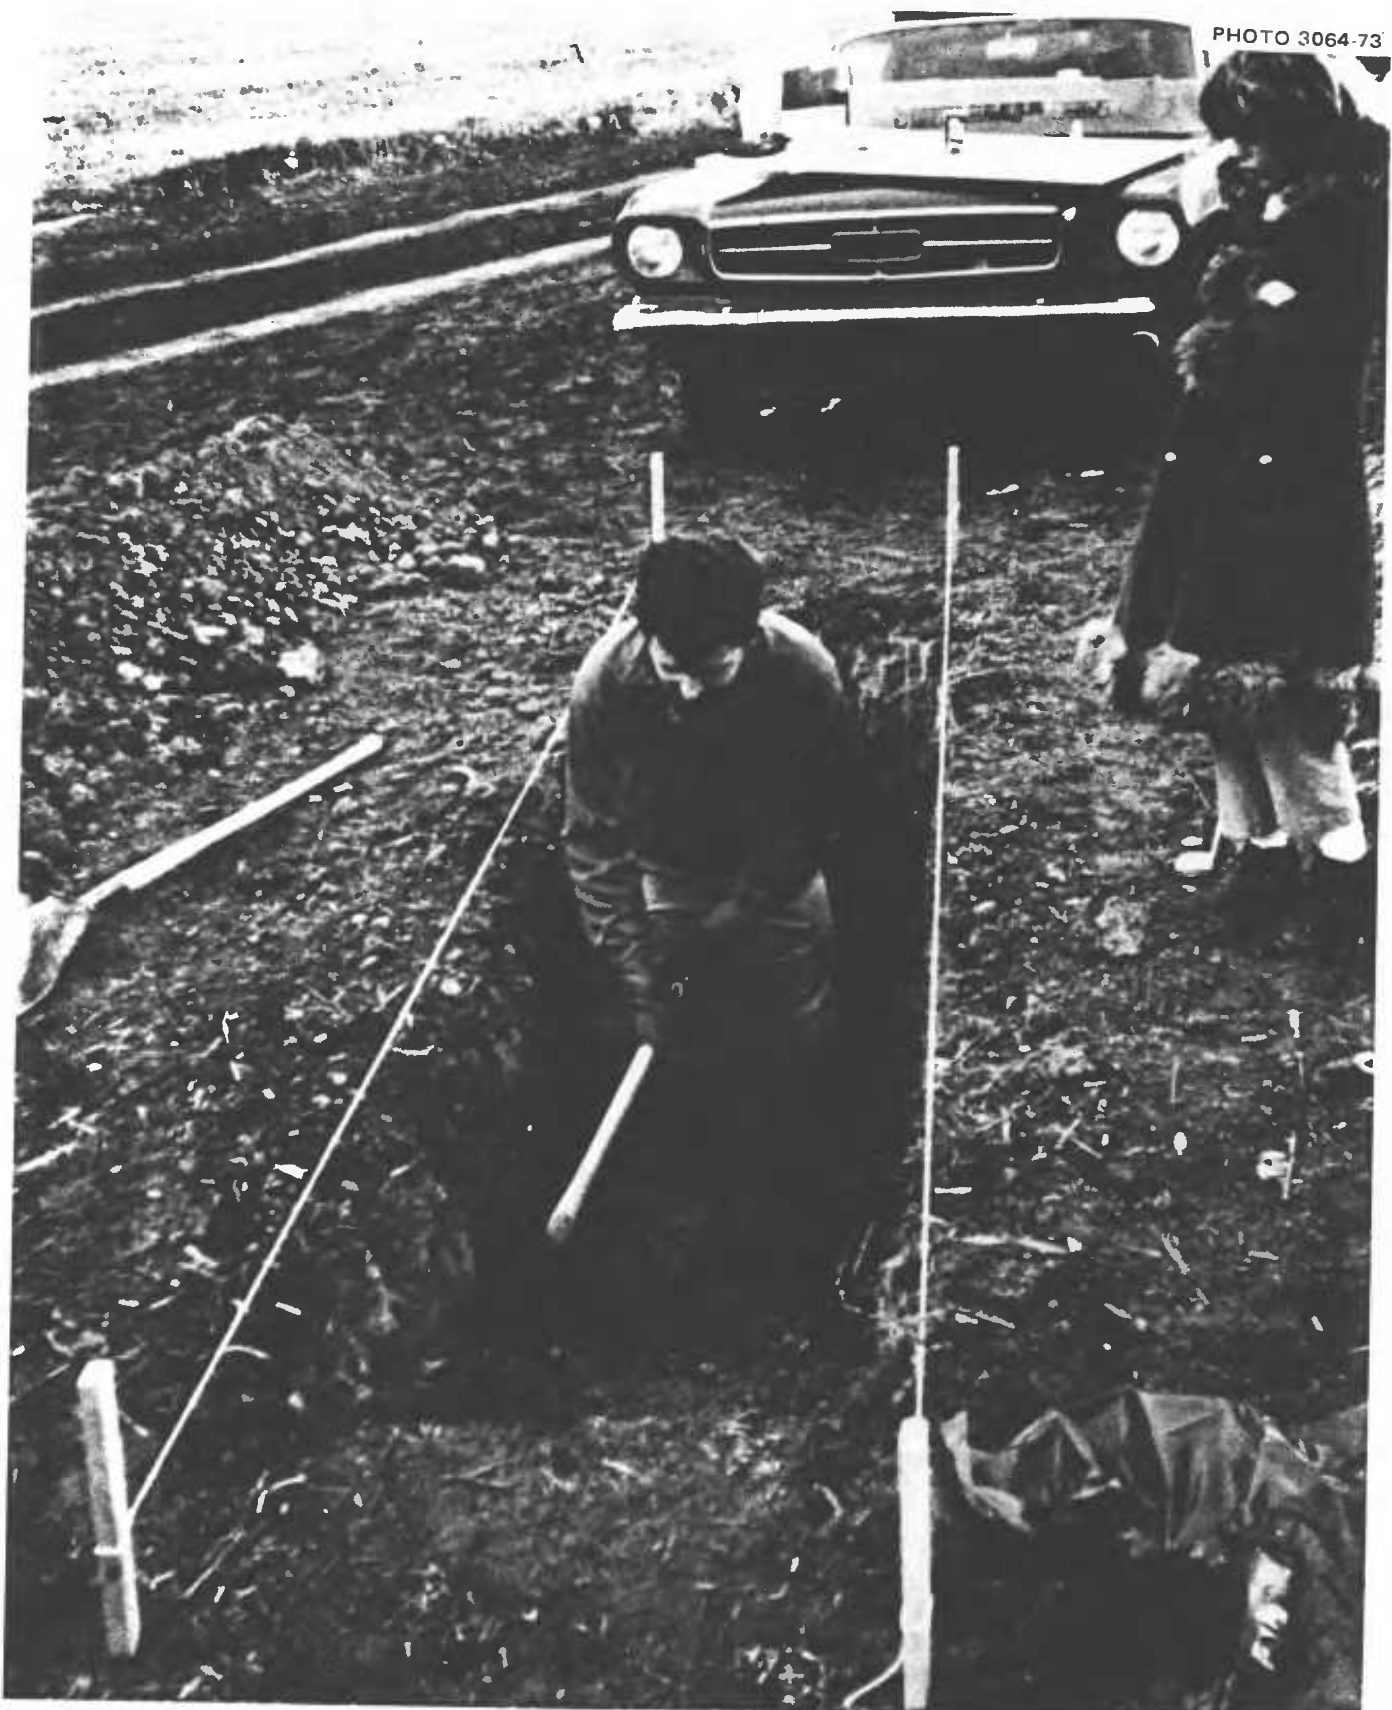
Fig. 6.6. The father swung his pick properly, a result of his learning to use an ax as a boy of 12, when his family spent a while in rural Oregon. However, he tied unnecessary strings between the stakes, and left them tied, and dug the trench too narrow. Later, he spent about two hours inefficiently widening it.

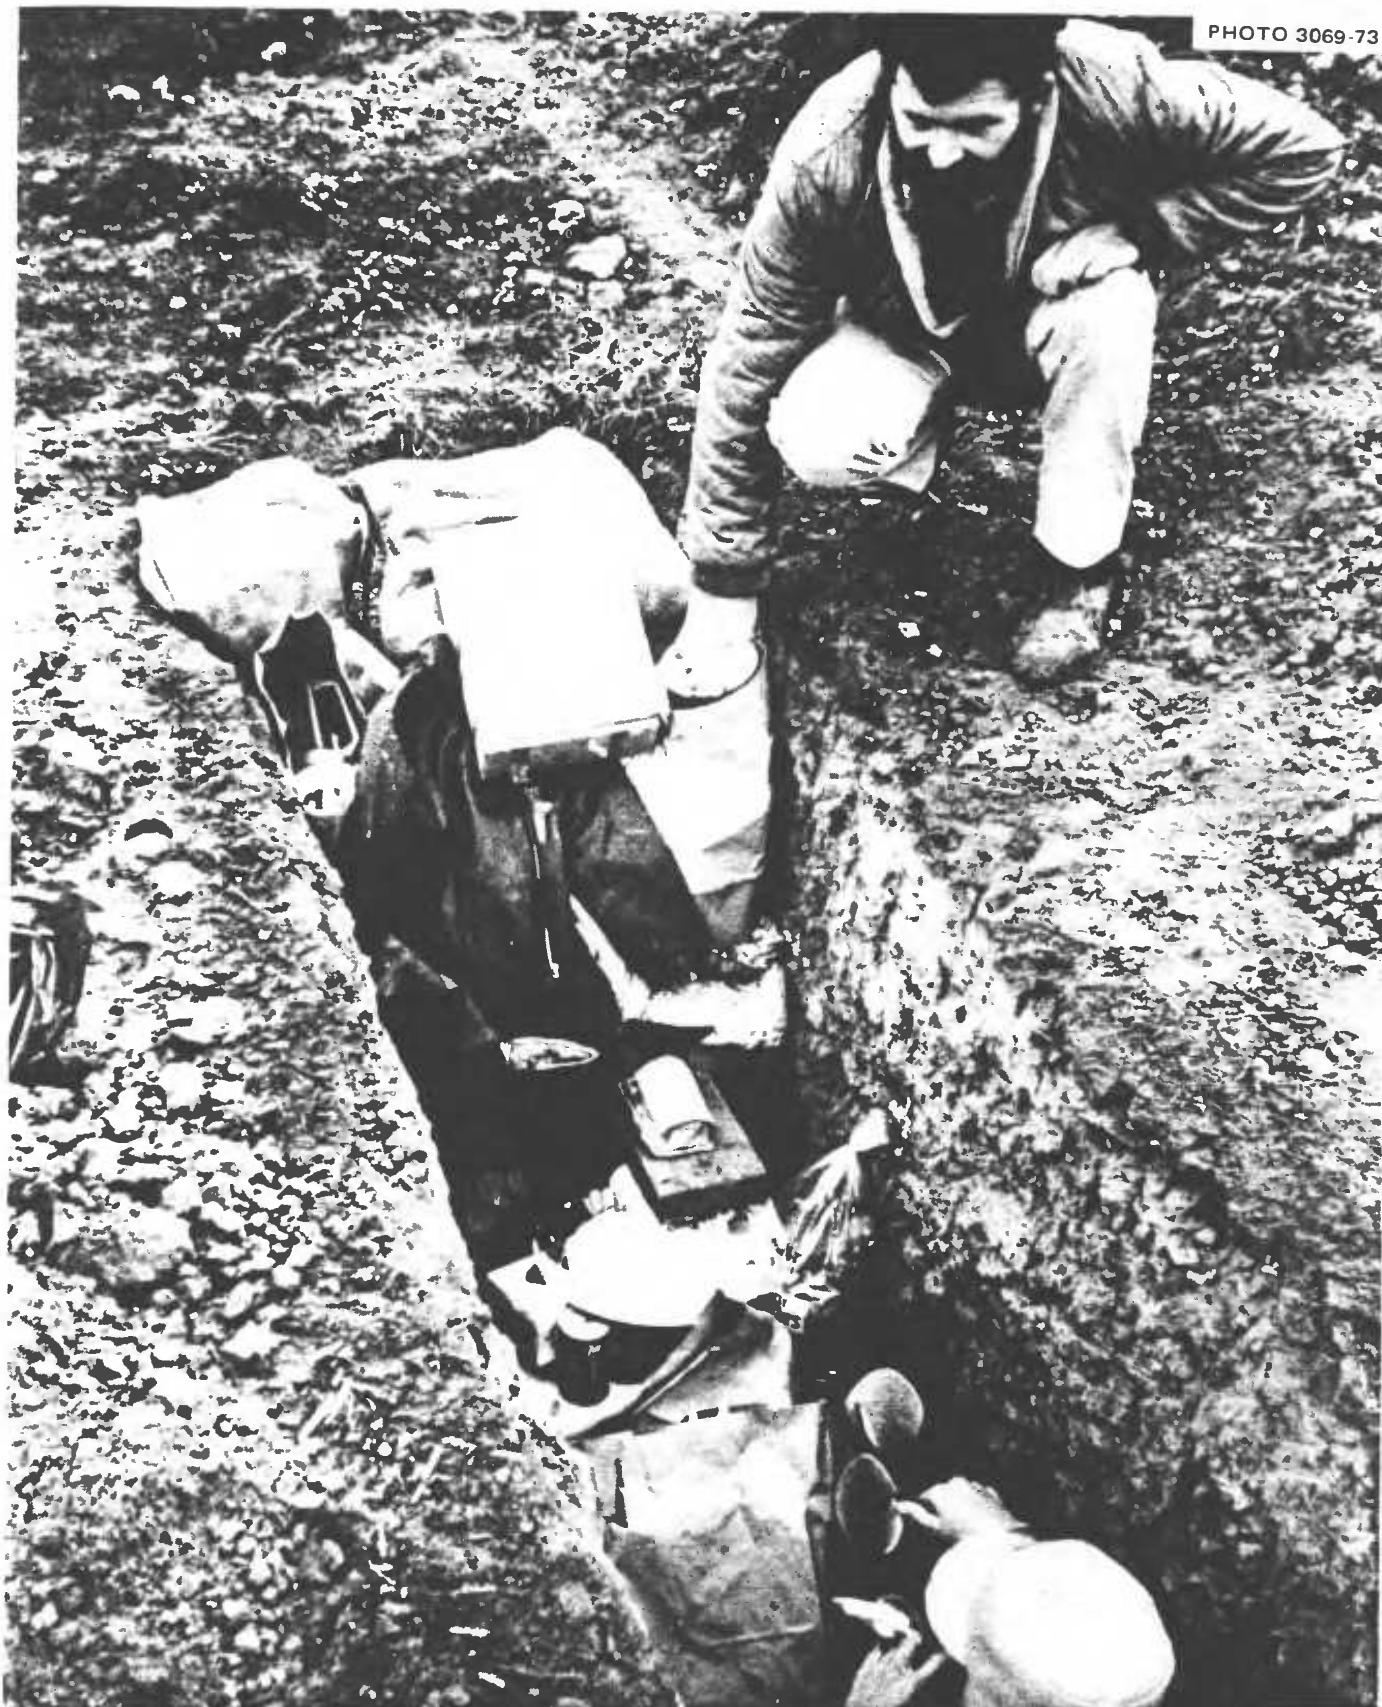
Fig. 6.8. Some of each category of survival items stored for the night in the completed and very dry main trench. The family was parked for the night over the stocked trench. The father, tired, quit at 5:33 PM, and was driven to his apartment in town to join his half-sick wife and daughter.

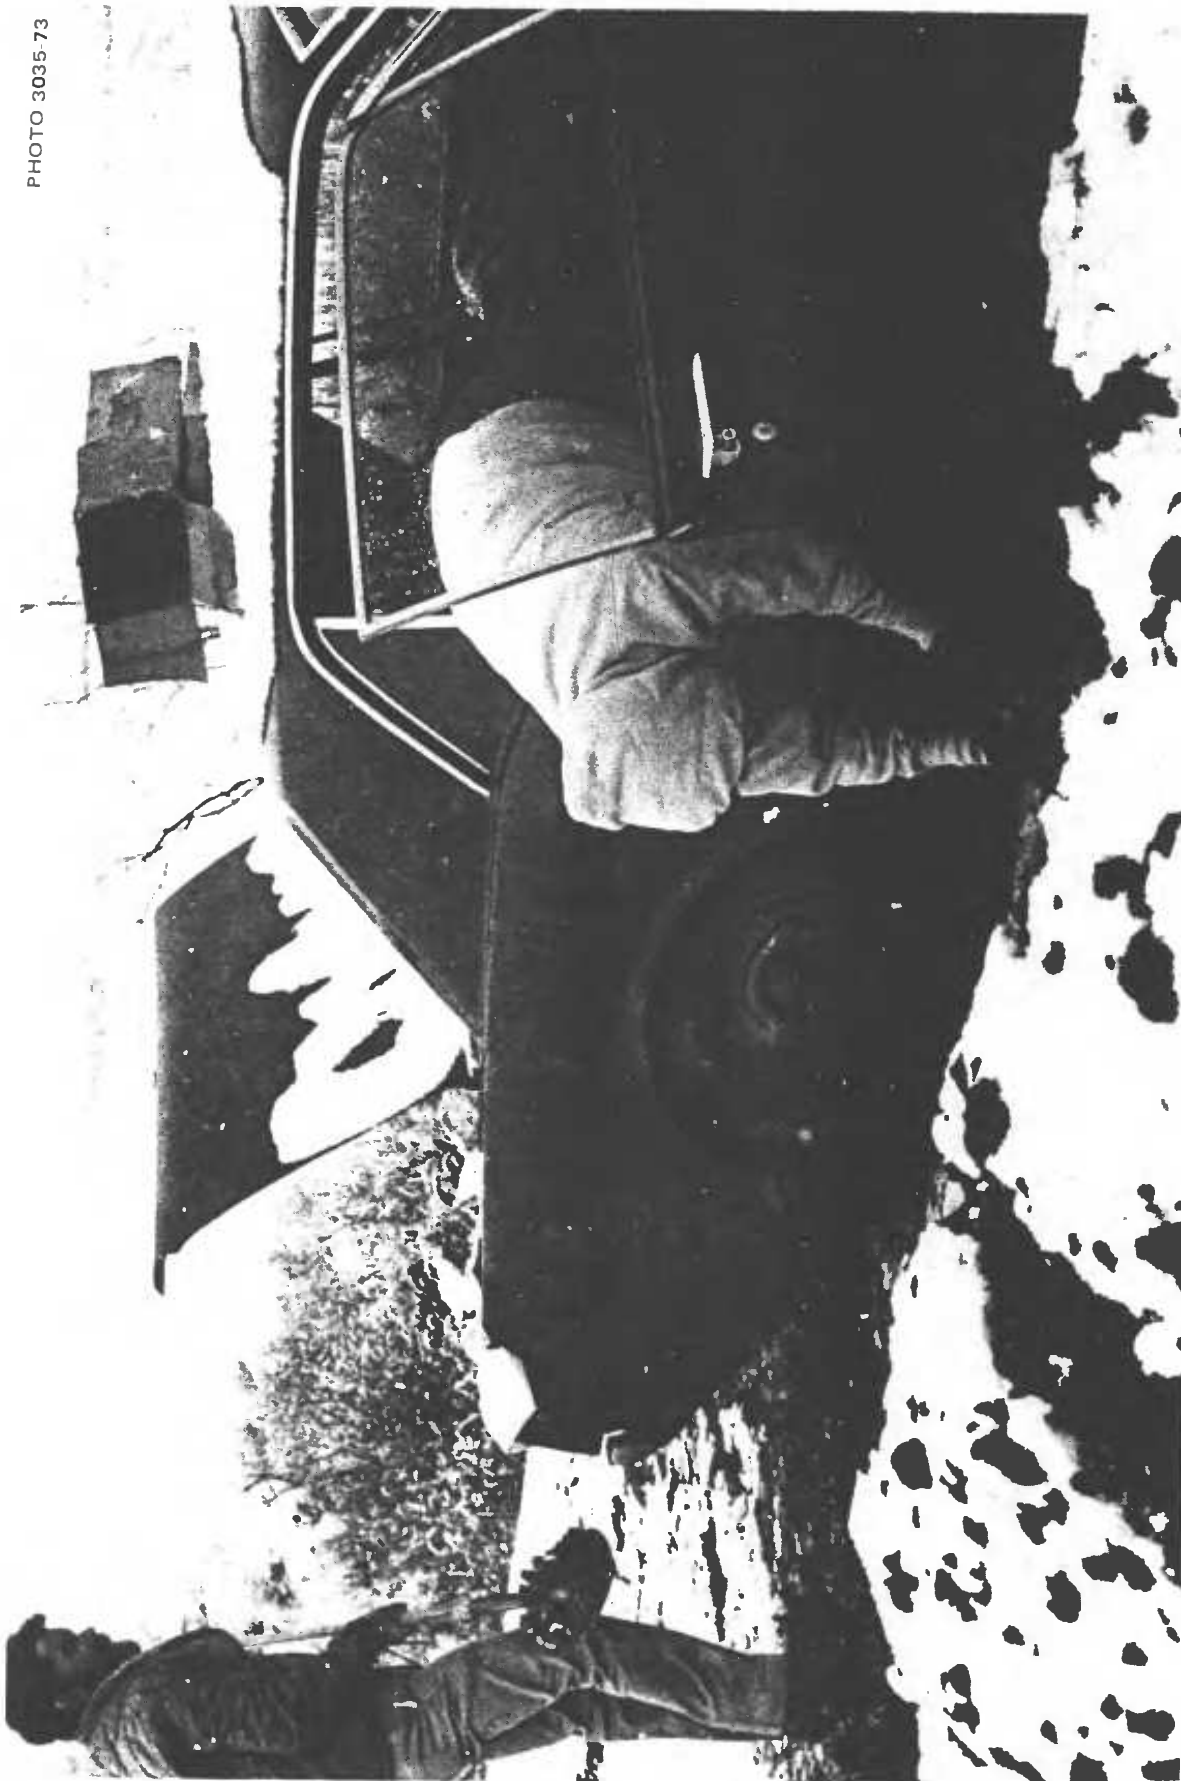
PHOTO 3035-73

Fig. 6.10. Putting a foot of earth inside the car and in the trunk. Unfortunately, before loading the car with about 2 tons of earth, the father and mother put many of their possessions under their car and on the surface of the ground around the edges of the trench. As a result, when the car body was depressed by its earth load, potatoes in a bag were crushed and cans were pushed into the wet earth near the surface.

For want of a second shovel, the mother used an empty can to help dump earth inside the car.

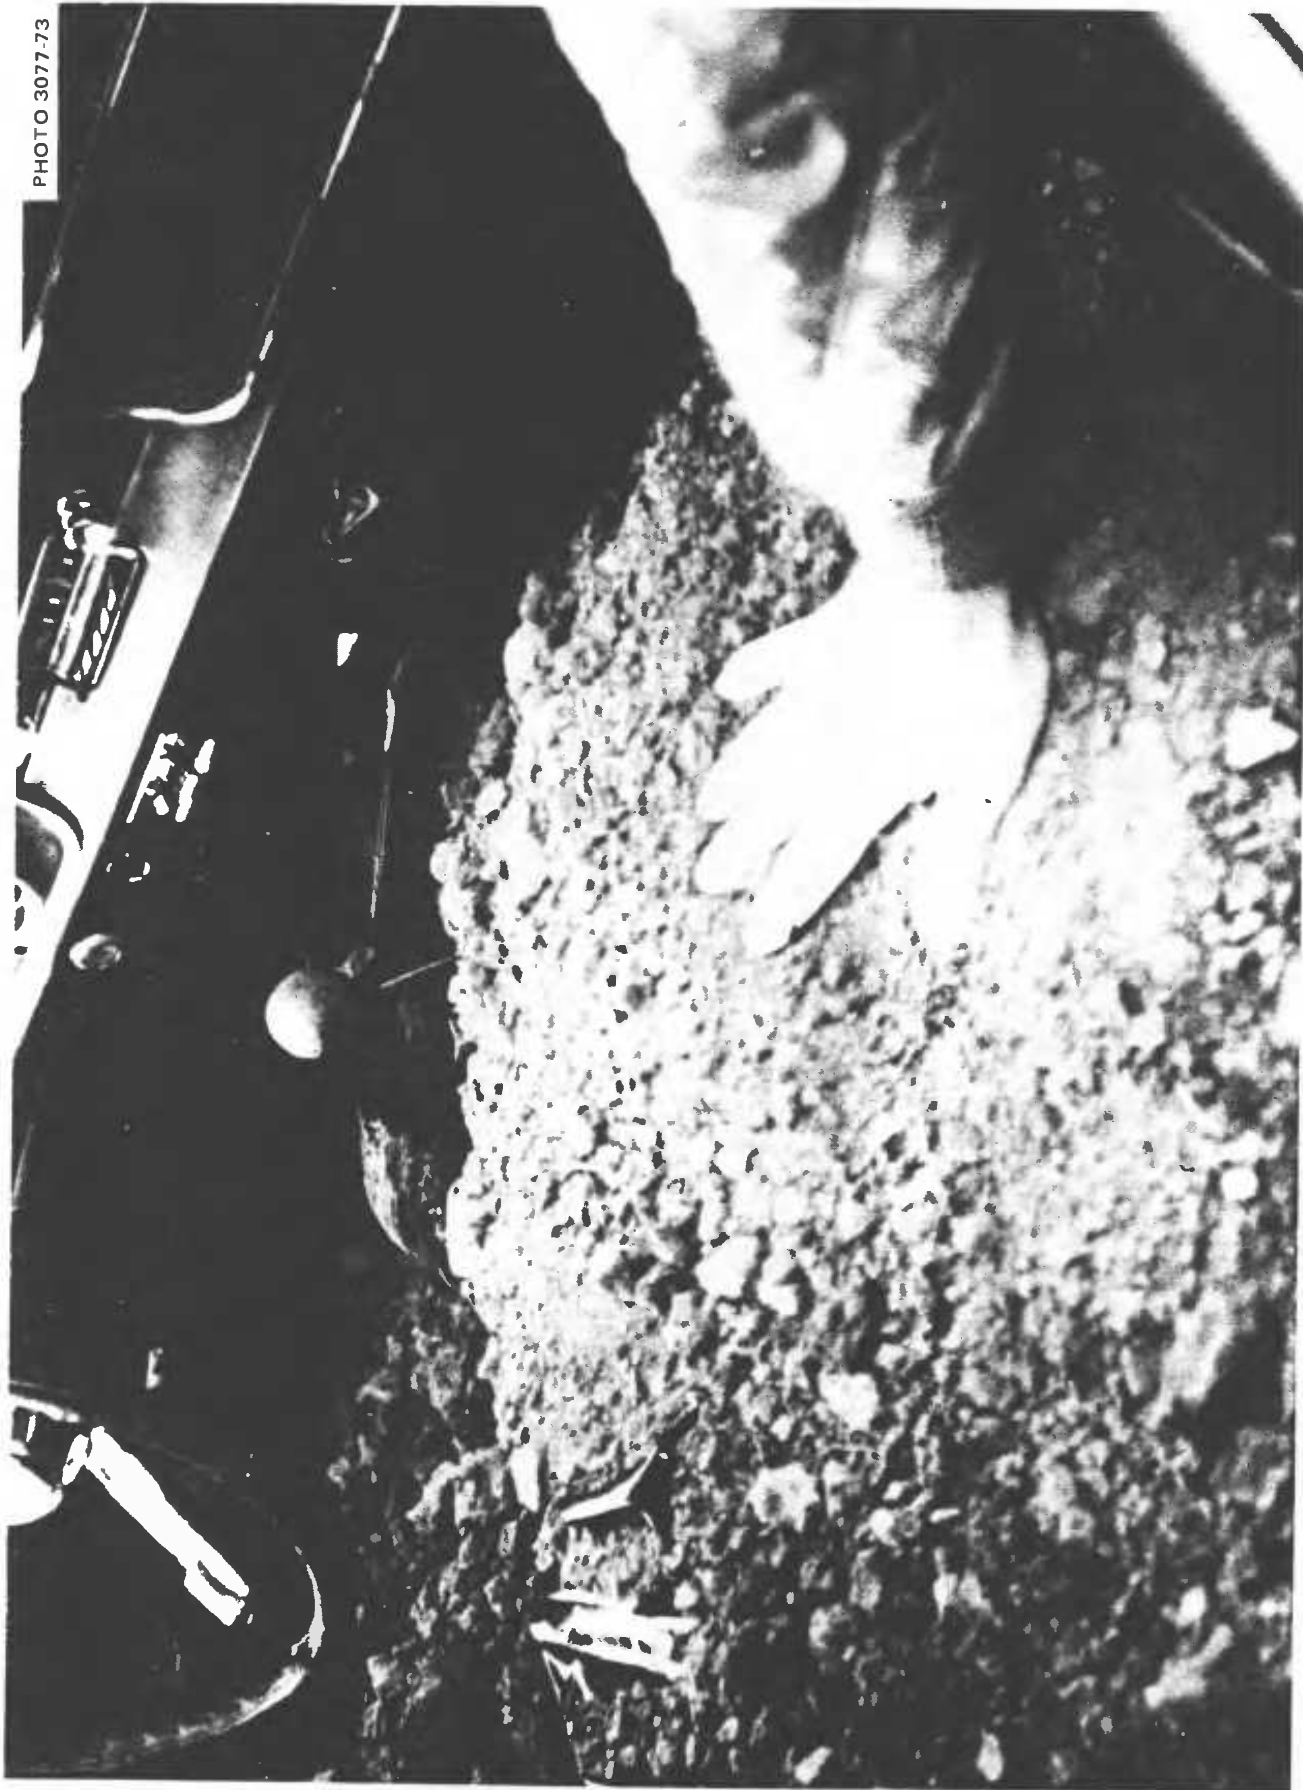
Fig. 6.11. About a foot of earth inside the car. Note the black plastic lining under the earth. Kearny, after several families had refused his offer of \$250 to build a Car Quest Trailer, built one for himself.
