ORNL-5039  
UC-41-Health and Safety

EXPEDIENT SHELTER CONSTRUCTION AND  
OCCUPANCY EXPERIMENTS

Cresson H. Kearny

MARCH 1976

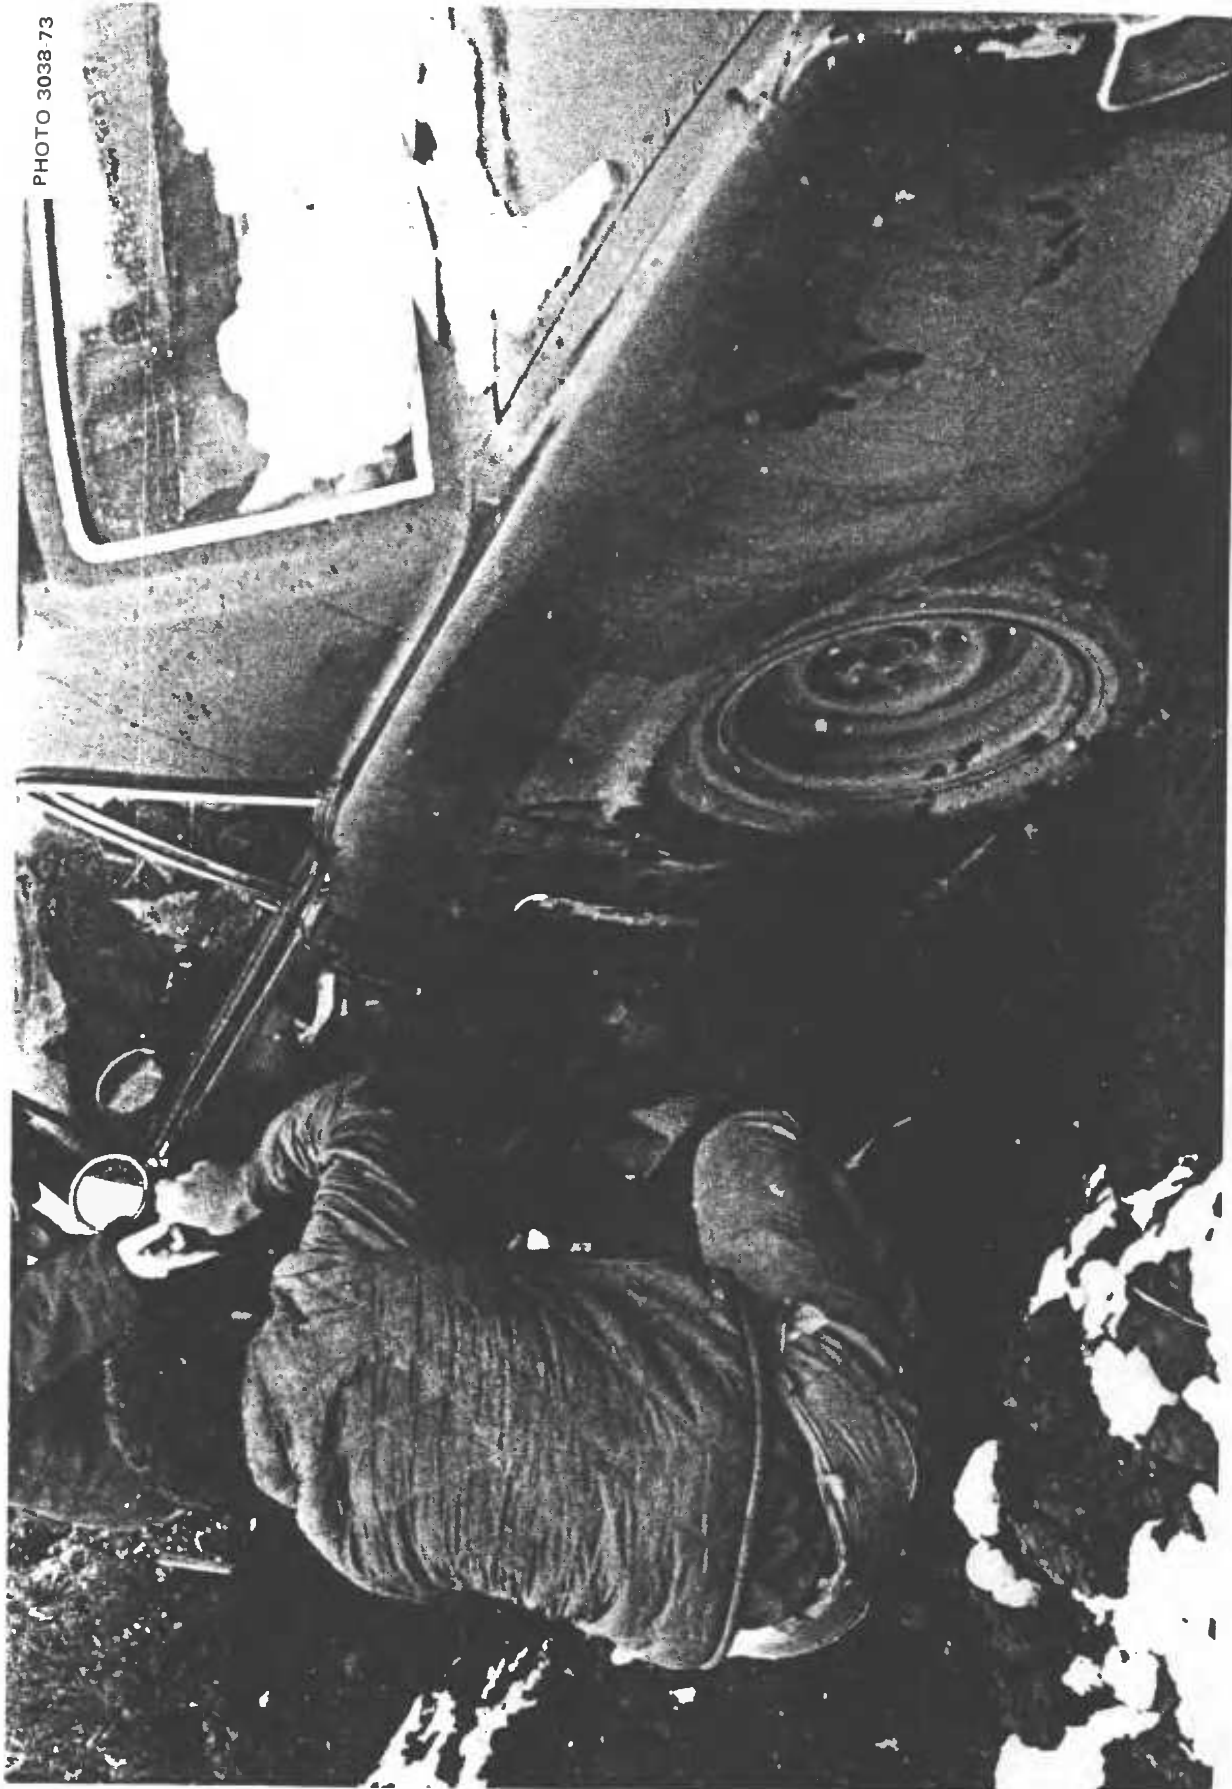
PHOTO 3038-73

Fig. 6.12. Taping split-open plastic garbage bags to the sides of the car, for want of other waterproof material to keep some of the dry earth to be mounded around the car from running under the car onto the storage "shelf" areas around the edges of the trench, or into the trench. Fortunately, the father had some waterproof duct tape, and cleaned the dirt off the spots on the car to which he planned to tape the plastic. However, because he did not tape all of the upper edges of the pieces of plastic, if water had run down the sides of the car, much of it would have run under the upper edges of the plastic and into the shelter space under the car.

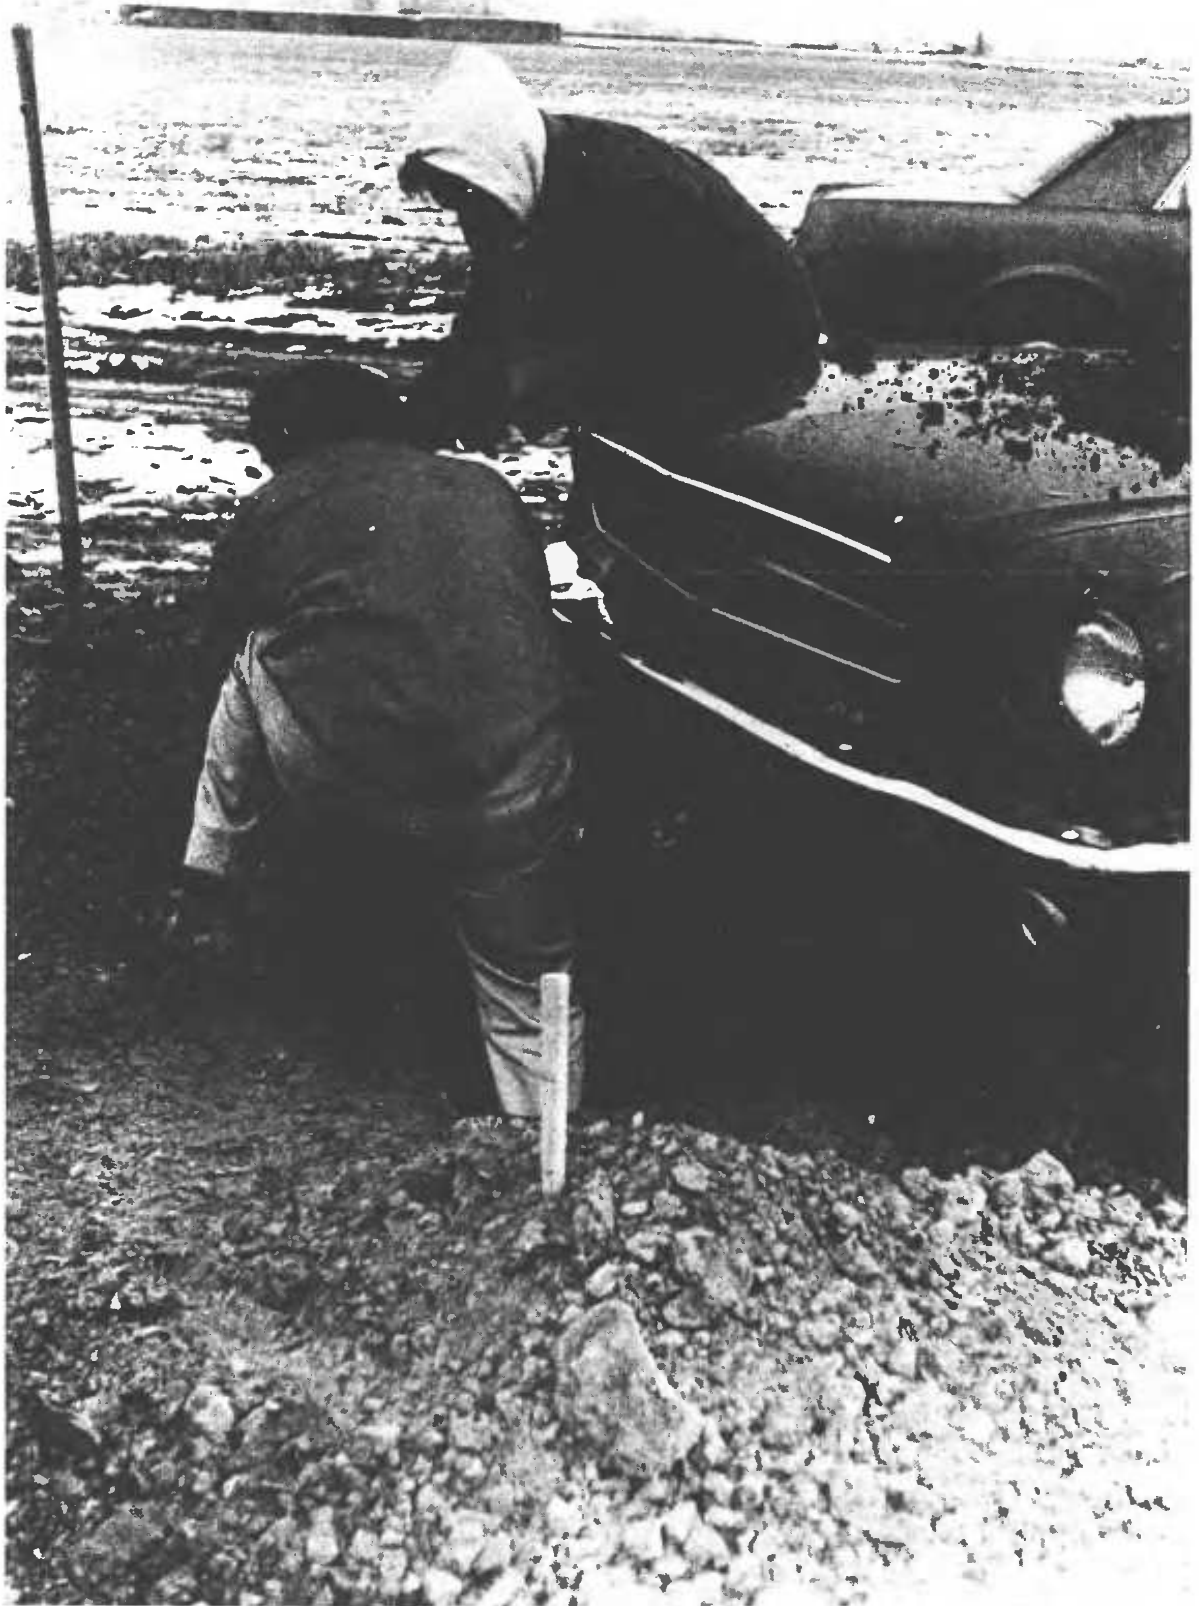
**Fig. 6.13. Placing earth-filled plastic garbage bags around the edges of the entryway trench.**  
The mother was able to remain on the site all of the second day and do some work – thanks to a borrowed pair of insulated boots that kept her feet from getting painfully cold.

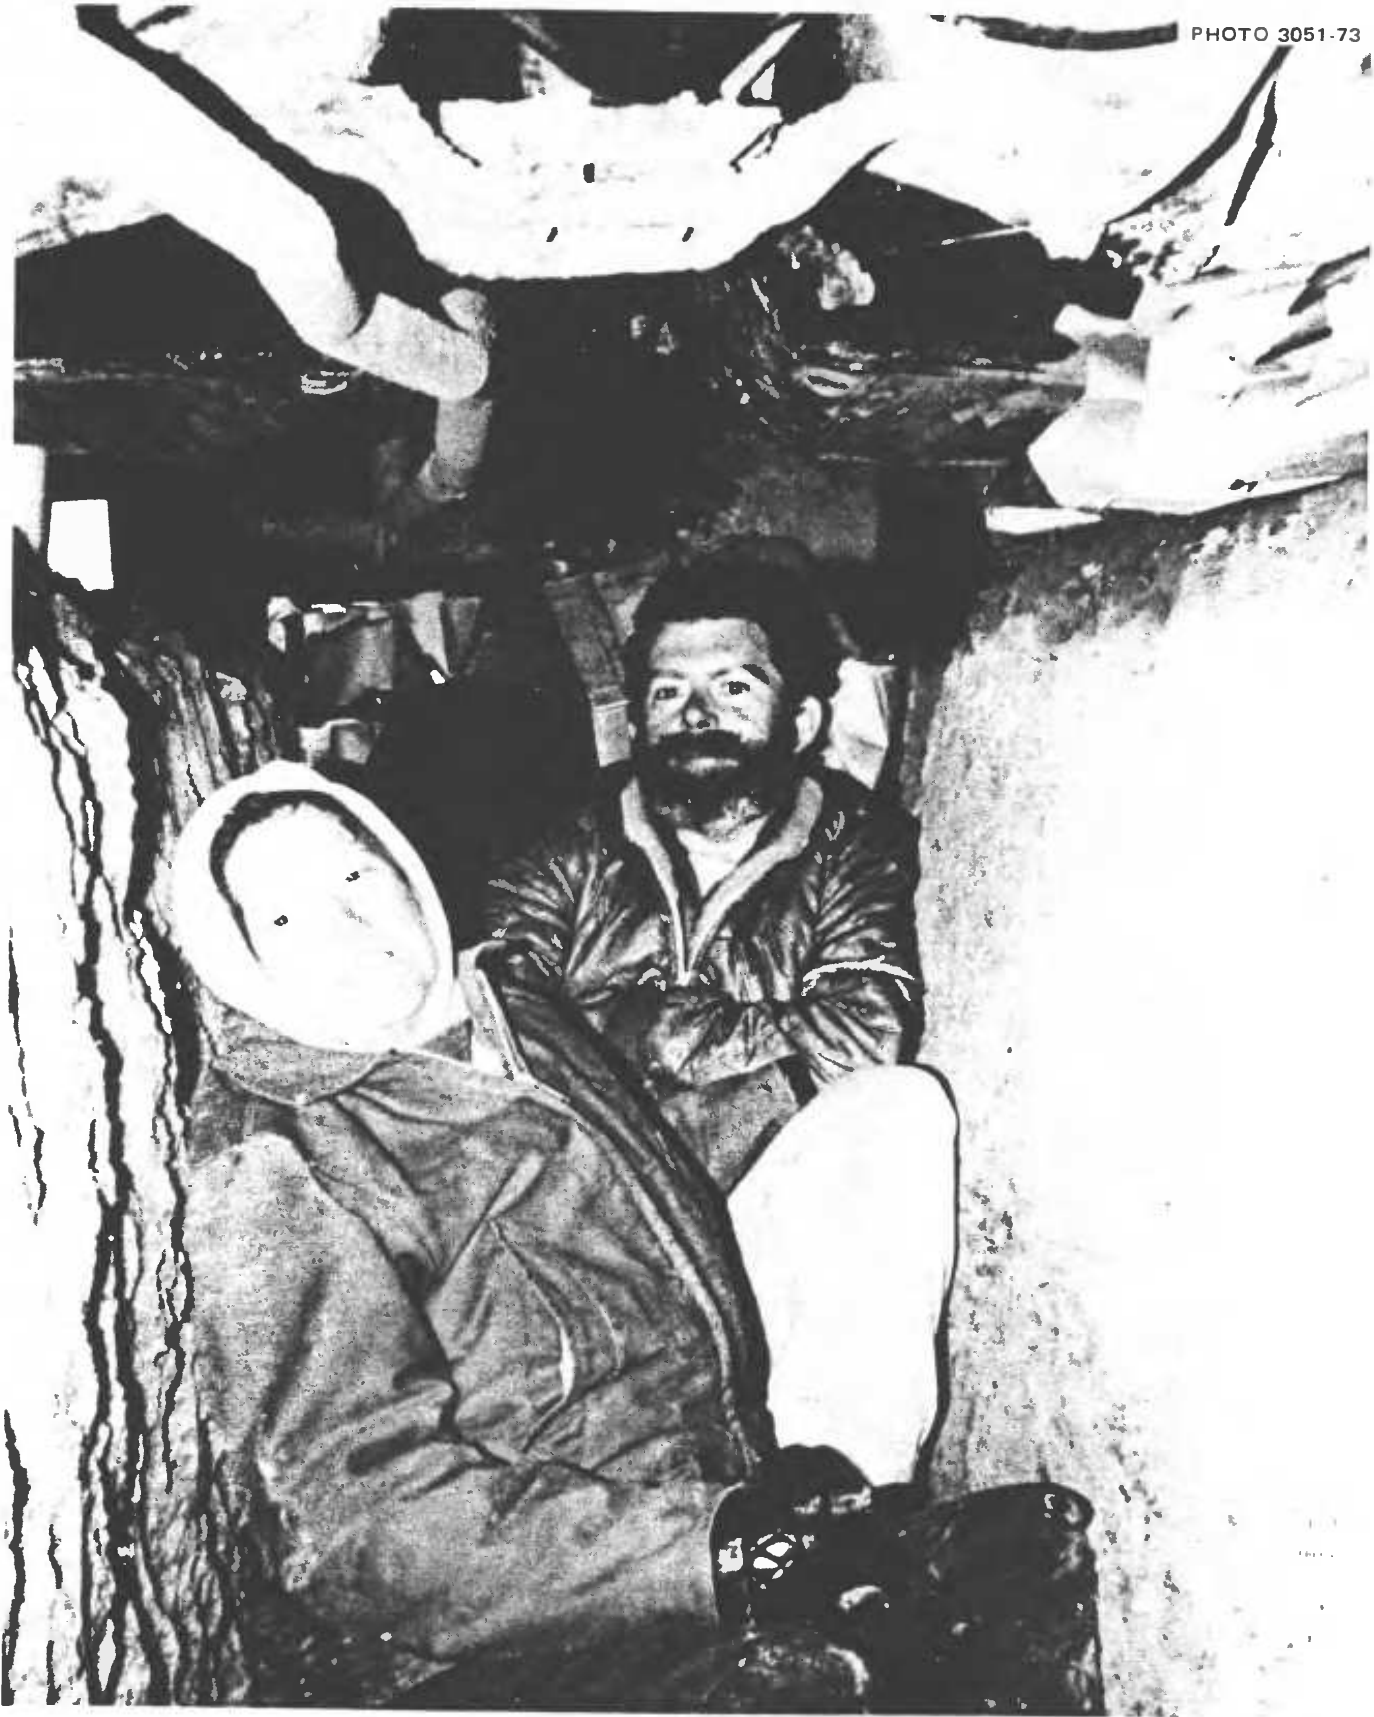
Fig. 6.15. The father (sitting on a box) and the mother in their 40-in.-deep, 28-in.-wide shelter. Enough room remained (occupied by the photographer's leg when this picture was taken) for the small daughter and the family poodle. All of their supplies had been placed under the car.

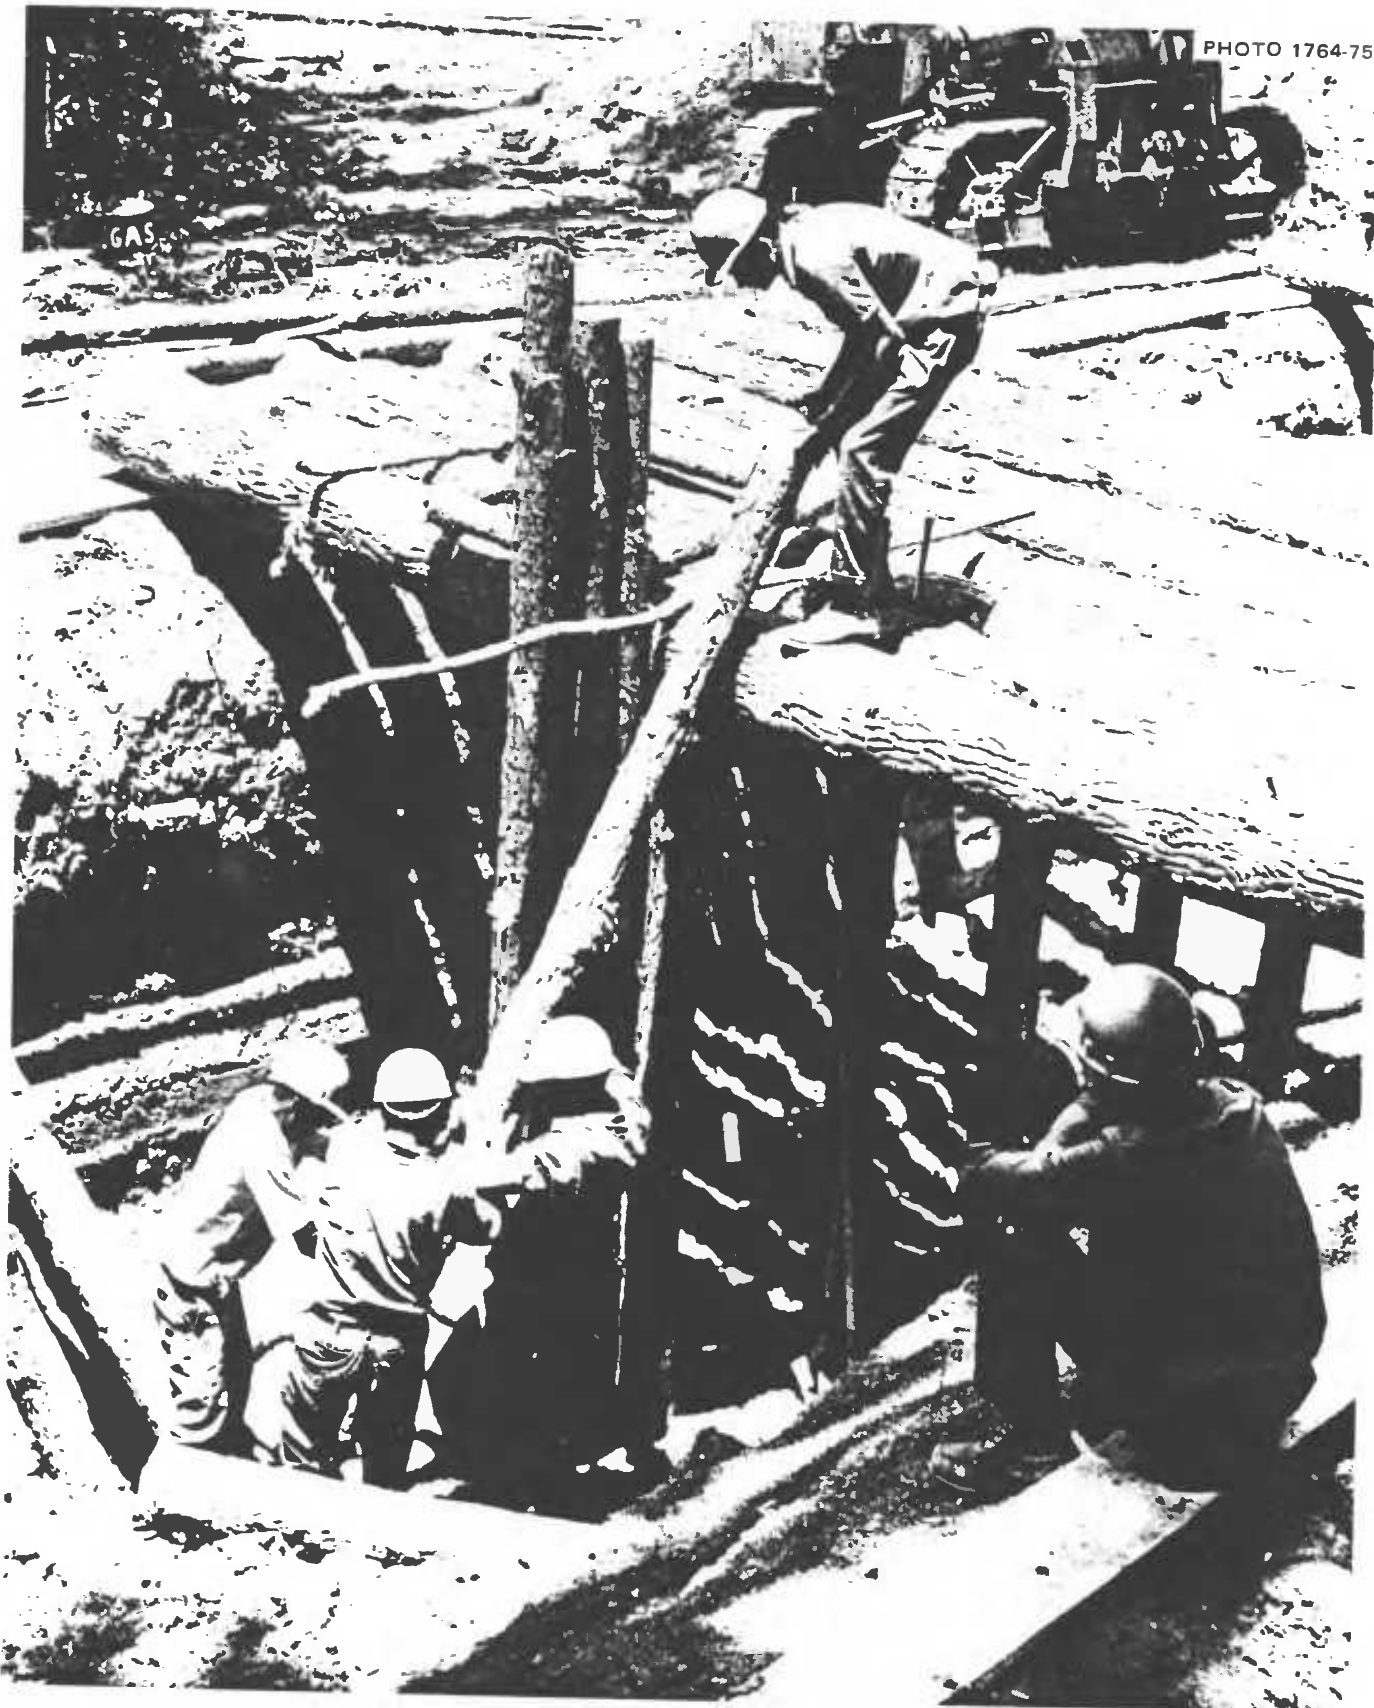
Fig. 7.2. Starting to erect one side of an entryway, after all of the 22-ft roofing logs had been positioned. A vertical entryway was placed at each end of the 12 × 42 ft shelter room.

Note the line of log columns down the center of the trench. These log columns, which rested on a plank footing and were spaced 4 ft apart, supported a horizontal center log. The centers of all the roof logs rested on this horizontal center log.

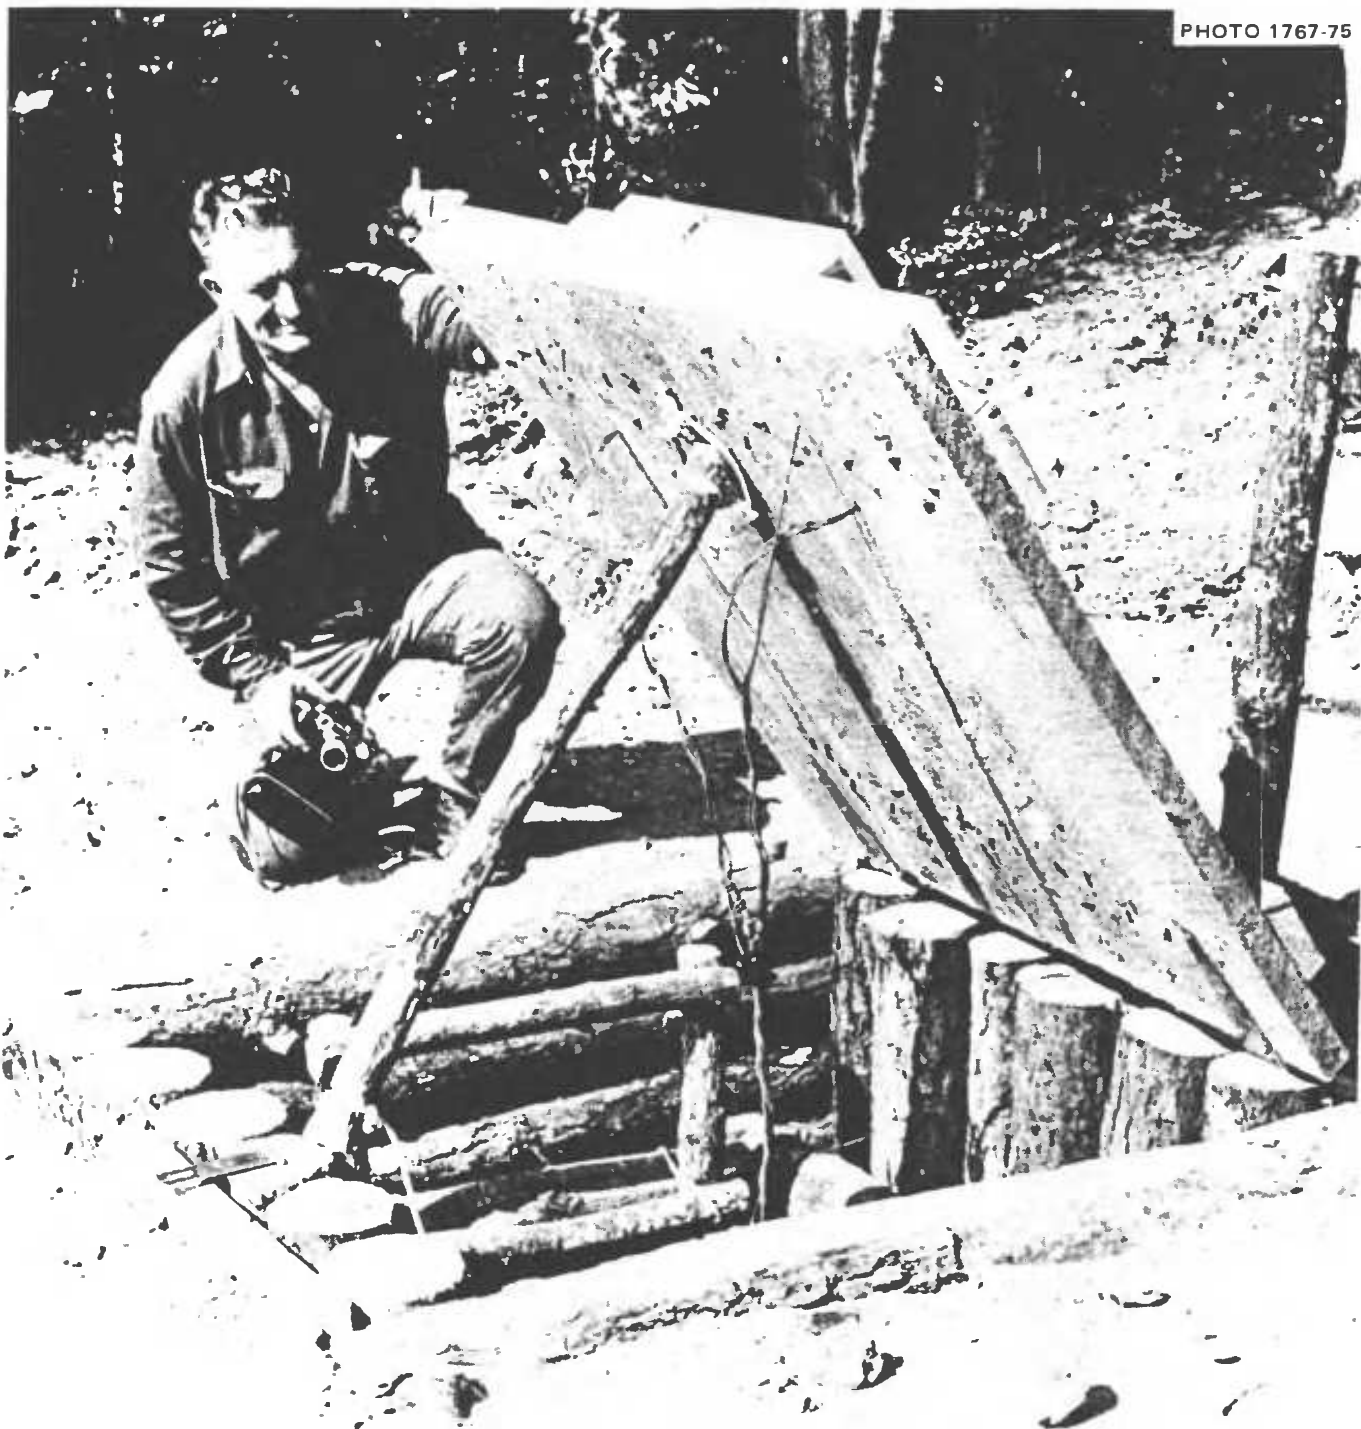
Fig. 7.4. One of the two completed vertical entries, with its expedient blast door made of 2-in.-thick rough lumber. Its hinges were made of strips of worn auto tires, spiked to each of the vertical entryway posts on the hinged side. A door of this type successfully withstood a blast overpressure of 17 psi.\* The other blast door was made of 3-in. planks and may have been able to withstand higher blast over pressures than would collapse the earth walls of this covered-trench shelter.

The roof logs had been covered with roofing to keep earth from falling through the cracks. Then about 2 ft of clayey earth had been packed over the whole roof, on which a sloping "buried roof" of 4-mil polyethylene film had been laid for waterproofing. Finally, another 1 to 2 ft of earth had been placed and packed over the "buried roof."
